Characterization of oxide layers formed on 10CrMo9-10 steel operated for a long time in the power industry

Abstract. This paper presents the results of diagnostic examinations conducted on the coils of super-heaters made of 10CrMo9–10 steel that were operated in industrial conditions at 480°C for 130 thousand hours. The tube was exposed in a coal-fired boiler. The chemical and phase composition of the oxide/deposit layers formed on both sides of the tube walls (outside – flue-gas side and inside – steam side) and their sequence was examined using optical microscopy, scanning electron microscopy with electron backscatter diffraction and energy-dispersive X-ray spectroscopy, and X-ray diffraction. The changes in the mechanical properties caused by corrosion and aging processes were concluded from the hardness measurements. In addition, the nature of cracks in the oxide layers caused by pressing a Vickers indenter was determined. The results of these examinations have shown a high degradation of steel on the flue-gas inflow side and identified the main corrosion products and mechanisms.

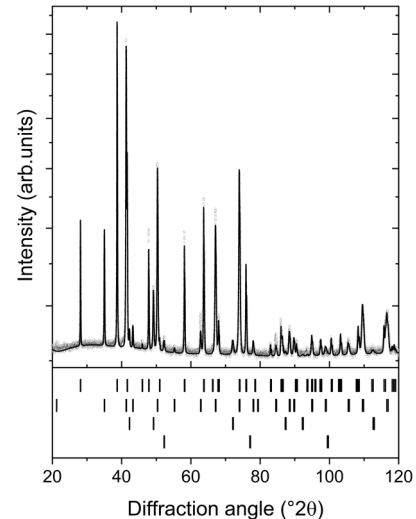
According to the XRD pattern depicted in Fig. 2, the inner side of the pipe contains Fe_2O_3 (hematite), Fe_3O_4 (magnetite), FeO (wustite) and α - Fe (ferrite/ α' -martensite). The refined lattice parameters of ferrite and iron oxides are summarized in Table 1. Assuming an increasing oxygen concentration between the core of the tube and its surface, it is expected that Fe_2O_3 is located at the sample surface and followed by Fe_3O_4 and FeO . As the XRD measurements were performed on the sample surface and the penetration depth of X-rays reaches approx. 10 μm in iron oxides, the amounts of the phases located near the sample surface are overestimated in Table 1, while the amounts of the phases located deeper in the samples are underestimated. The optical micrographs of the inner surface confirmed an initial stage of the oxide layer formation (Fig. 3). The macroscopic tests performed showed that the oxide layers formed on the tested steel were discontinuous in places. Superficial damage is clearly visible over a large area of the layer surface in places of small cracks, which then take a more developed form with irregular shapes, reaching deep into the layer.

Fig. 2. Diffraction pattern of the inner side of the pipe (small circles) and the Rietveld fit (solid line). The bars in the bottom part of the figure mark the positions of the diffraction lines from Fe_2O_3 , Fe_3O_4 , FeO and α - Fe (from the top to the bottom)

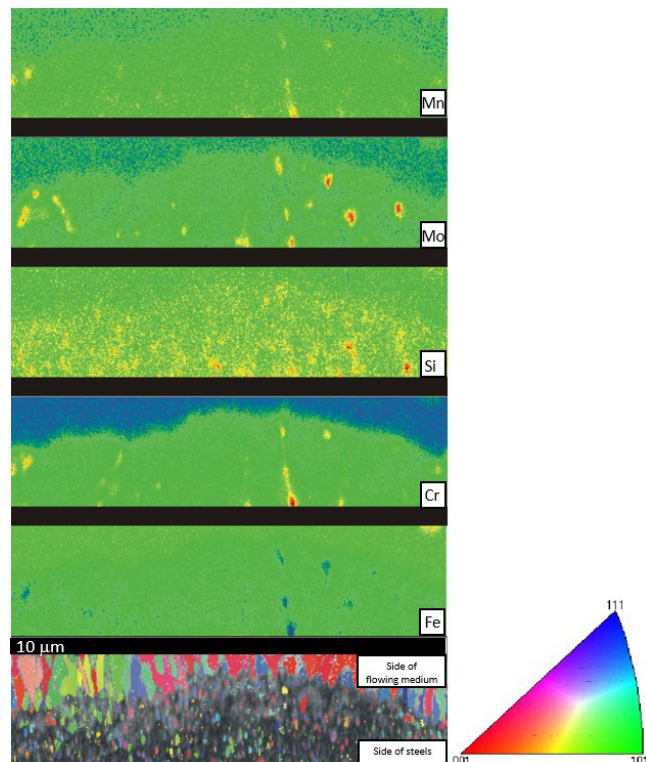
In the interior of the tube directly from the steel side, the magnetite structure is close to the equiaxial, but it becomes columnar with much larger grains from the steam side (Fig. 5). In the interior of the tube directly from the steel side, magnetite with equiaxial grains is enriched with chromium, silicon,

Fig. 5. Upper panel: EBSD analysis of magnetite, the inner side. Different colors indicate different orientations of magnetite grains (s. color map). Other panels: Local concentrations of Fe, Cr, Si, Mo, and Mn

molybdenum, and manganese. In the case of columnar magnetite, other elements precipitate outside of magnetite. On the outer side of the pipe, hematite (Fe₂O₃), magnetite (Fe₃O₄) and bits of ferrite or alpha-martensite were found as well (Fig. 6 and Table 2). However, the dominant crystalline phase was calcium sulphate (CaSO₄), as it covers the outer surface of the worn pipe. CaSO₄ is a product of the reaction of SO₂ emitted from the burned fuel with CaCO₃ (8).

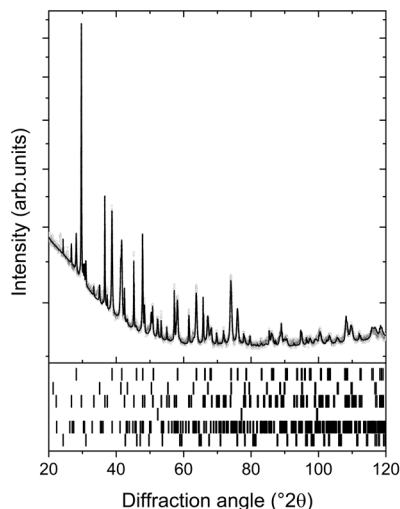
Fig. 6. Diffraction pattern of the outer side of the pipe (small circles) and the Rietveld fit (solid line). The bars in the bottom part of the figure mark the positions of the diffraction lines from Fe_2O_3 , Fe_3O_4 , CaSO_4 , $\alpha\text{-Fe}$, "sillimullite" and low quartz (from the top to the bottom)

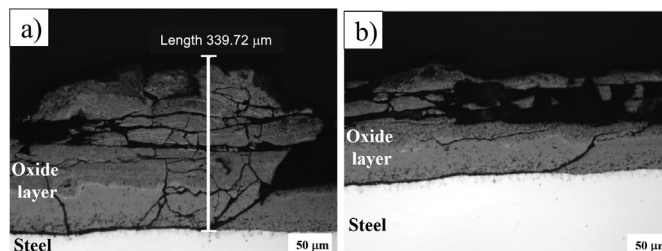
The optical microscopic observations carried out on the cross-section of the oxide layers (Figs. 8a and b) have shown

that the oxide layer is seriously degraded on the flue-gas inflow side. Numerous fissures and cracks occur directly on the flue-gas inflow side. The cracks run mainly parallel to the substrate (steel). Additionally, some cracks propagating perpendicularly to the substrate can be observed to a small extent. The oxide layer losses occur mainly in the oxide layer directly on the flue-gas inflow side. On the steel side, cracks have been observed that propagate into the oxide layer. Directly on the steel side, also the oxide layer porosity is smaller, and increases towards the layer interior.

Fig. 8. Optical micrographs of the cross-section of the oxide layers formed on the outer side – different positions (a, b)

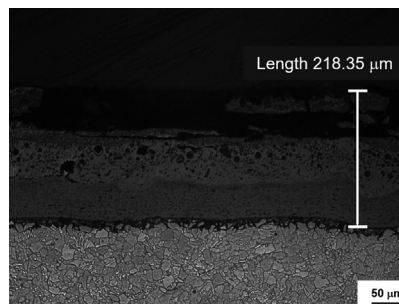
In addition, substantial degradation of the bainitic structure can be observed on this side as compared with the inside of the tube wall (Fig. 9). In the case of unstable pipe parameters such as temperature and pressure and considering different thermal expansion coefficients of metal oxides and CaSO_4 enriched molten salt, the layer of this salt will easily fall off. After the layer falls off, the flue gas will react with metals, which will result in the pipe resistance to sulfur corrosion [24]. According to the literature [25], the destruction of the oxide layer occurs according to two mechanisms. In the first case, cracking of the layer occurs when the volume of the oxide is much smaller than that of the material on which the oxide has formed, and as a result, the oxide will break, reducing its own deformation. If the volume of the oxide is much larger, it will tend to reduce the deformation energy by breaking adhesion to the substrate material, which will result in flaking and chipping. Corrosion occurs on this side, mainly along the boundaries of the former austenite grain.

Fig. 9. The delamination between the oxide layer and the steel as seen by optical microscopy on the outer side

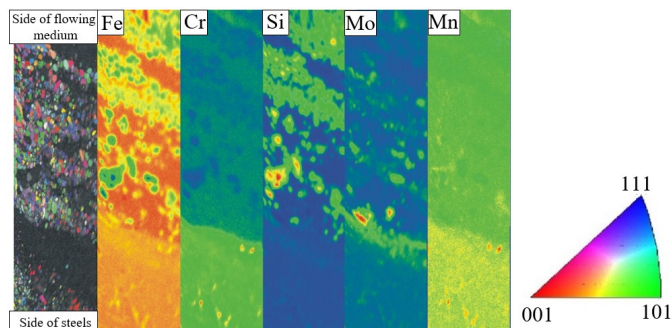
The EBSD examinations performed on the magnetite layers that formed on the outer (Fig. 10) side of the tube have shown the magnetite grains are nearly equiaxial. On the outside, di-

rectly on the flue-gas inflow side, areas enriched in silicon oxide (SiO_2) can be observed apart from the iron oxides. Moving towards the original steel substrate, the magnetite layer is enriched with chromium and manganese.

Fig. 10. Left panel: EBSD analysis of magnetite, the outer side. Different colors indicate different orientations of magnetite grains (s. color map). Other panels: Local concentrations of Fe, Cr, Si, Mo, and Mn

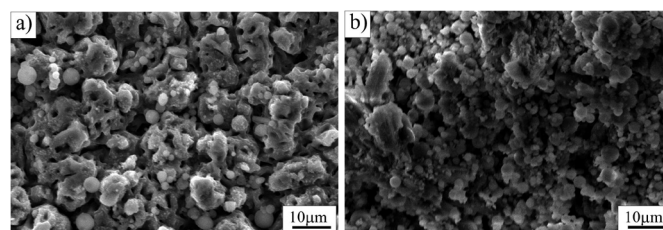
tion, as in Fig. 12. The SEM measurements performed on the respective surface (Fig. 13) revealed a mixture of the iron oxides on the steam side and a mixture of the iron oxides and deposits on the gas side. In the case of the outer side, local damage of the deposit layer can be observed. Figure 13 presents SEM images of the inner and outer surfaces of the steel tubes which illustrate the structural changes caused by chemical corrosion. Both images reveal lumpy, well-developed surfaces covered with regular bits of solid material, although with different morphological characteristics. Inner surface (Fig. 13a) is made of a mixture of particles the vast majority of which approaches 10 μm in diameter. Approximately half of these particles are regular, smooth spheres, while the remaining half takes the form of irregular, pitted pieces of the material. On the other hand, the outer surface of the tube is covered with many rounded, tiny grains not exceeding few micrometers in diameter. Because of their small sizes, these particles are not covered with holes, although they tend to aggregate into larger clusters.

Fig. 13. SEM images ($85 \times 58 \mu\text{m}^2$) of the corroded surfaces of the pipe: (A) inner surface, (B) outer surface

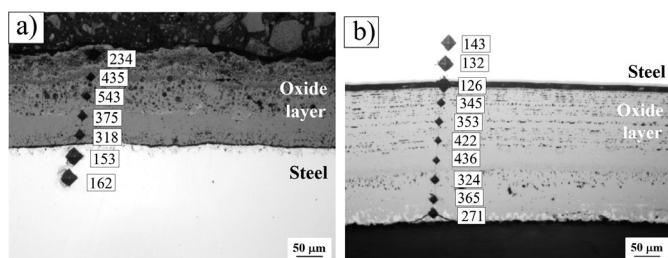
Indentation experiments performed on the outside and the inside have shown that in both cases, there are microcracks, regardless of the hardness values. A greater spread of microcracks was observed in the sediment layer directly from the side of the exhaust gas inflow (Fig. 14). Microscopic observations showed that this layer was brittle and prone to cracks (Figs. 8 and 9). A similar effect was observed on the boundary between the oxide layer and the steel. Less development of microcracks was observed in the dense oxide layer with a small number of pores. In the oxide layer formed on the steam side, the largest microcracks have been observed on the boundary between the oxide layer and the steam.

Fig. 14. The indentations produced during the Vickers hardness measurements (HV0.1) on the outer (a) and inner side (b) of the oxide layer
