DOI: <https://doi.org/10.24425/amm.2022.137787>A.C. BERBECARU¹, G. COMAN¹, S. CIUCĂ¹, I.A. GHERGHESCU^{1*},
M.G. SOHACIU¹, C. GRĂDINARU¹, C. PREDESCU^{1*}

RESEARCH ON THE DEGRADATION PROCESS OF RAILWAY RAILS DUE TO LIFESPAN EXCEEDING

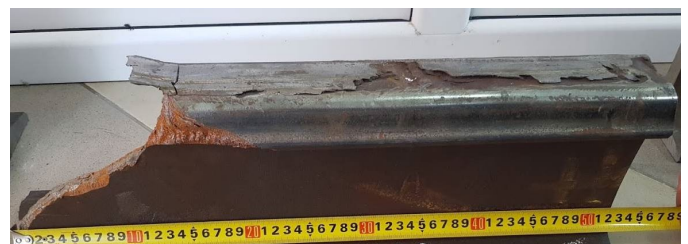
The present research aimed to determine the causes that led to the degradation of the railway tracks as a result of exceeding their lifespan, which led to the occurrence of a railway accident. The investigated material was a line rail coupon in the breaking area that showed numerous defects of the contact surface. Figure 1 shows the aspect of this tested and analyzed sample.

Fig. 1. Coupon aspect in the fracture zone

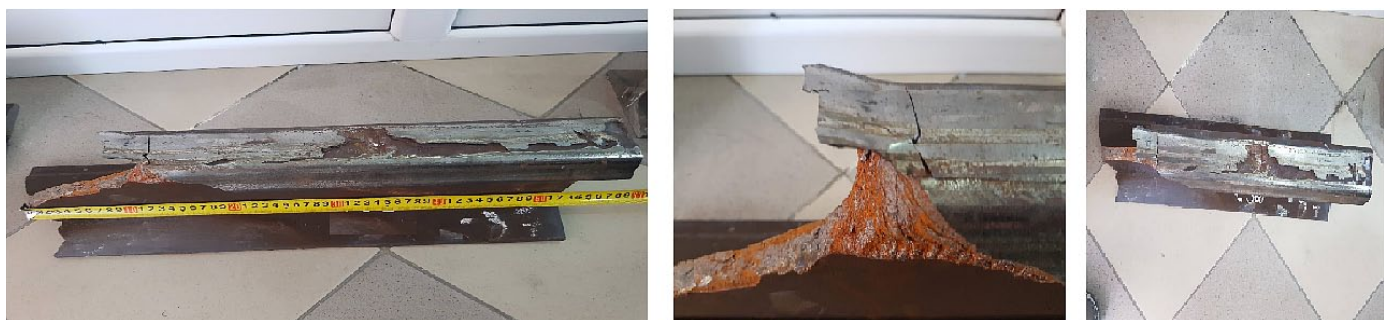
Figure 2 shows the breaking areas and surfaces of the line rail that were macroscopically examined.

The macroscopic analysis of fracture surfaces suggests a classic type of rolling contact fatigue fracture under alternating cycles.

Thus, in the upper part of the line rail (rail head), several microcracks appear which, under stress, are propagating slowly and intermittently. In that region, the appearance of the surfaces separated by the crack has a smooth character, which shows that the fracture was advancing through the ductile mechanism. Once the effective section has been exceeded, the rupture progresses rapidly, according to the fragile mechanism. The advancing direction is uncontrolled, exhibiting a jag or spaced faults feature, quickly traversing the rail web and ending in the rail base. The feature in these areas is grained, rough, specific to fragile rapid rupture. Considering our line rail coupon and evaluating the surface quality of the rail head in longitudinal plan but also from a side view, its advanced wear is very clearly highlighted.

Fig. 2. Aspect of macroscopically analyzed areas and fracture surfaces

The crack initiation and propagation processes resulting from a mechanical loading have been widely studied [5-9]. Thermally damaged surface layers, called white etching layers (WELs), also contribute to crack initiation [10-13]. Cracks nucleating in or close to WELs can develop into so-called squats and studs on the rail head [4], leading to delaminations, which are numerous on our studied coupon.

There are many areas where the metallic material shows cracks, damaged surface layers and severe delaminations. From the side view one may see the specific gauge corner (fillet) zones being very asymmetrical, with different fillet radii and uneven opening angles that suggest advanced wear.

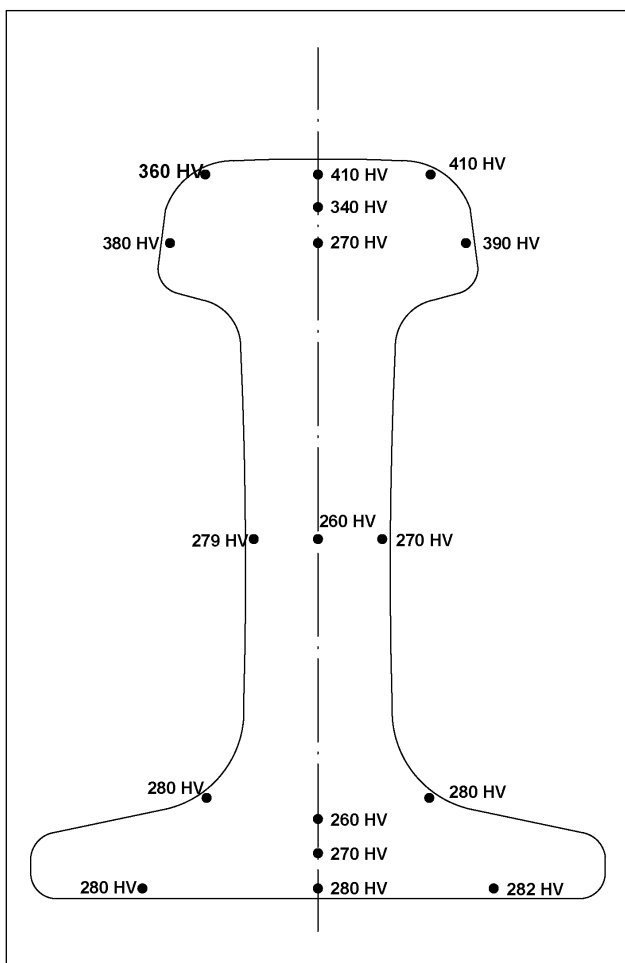
Vickers hardness tests were chosen in order to establish the hardness distribution in the sample's cross section. Figure 3 shows the hardness distribution diagram in the line rail cross-section.

Fig. 3. Vickers hardness values distribution on the line rail sample cross-section

- RAIL HEAD – in the upper part one can find higher values (360-410 HV) that lower down to a stable value of 270 HV in its core zone;
- RAIL WEB – the average hardness values are of approximately 270 HV;
- RAIL BASE – the average hardness values are of approximately 280 HV; these average values of approximately 270 HV are characteristic for the equilibrium structure of a slightly hypereutectoid, light alloyed steel, such as the line rail that is under investigation.

The hardness values recorded on the top of the rail head and on the gauge corner and symmetrical zone (fillet zones) suggest the modification of the structure over time by surface hardening phenomena, meaning a *strain hardening*, phenomenon consisting in a hardening under load. It is also known as *work (cold) hardening*: in a steel structure submitted to a load, the ferrite flattens and the cementite lamellae fragment, becoming preferentially oriented along with the ferrite crystals (or lamellae), respectively perpendicular to the load direction. It is the stress type the line rails are usually submitted to in service.

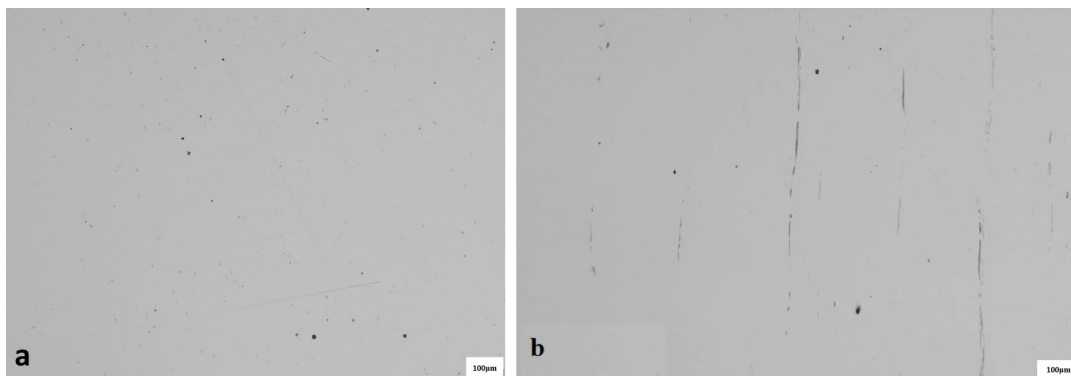
Fig. 4. Optical micrographs of the unetched samples: a) cross-section, b) longitudinal section, 100×

can observe either dispersed, crushed inclusions with angular edges, considered to be alumino-silicates resulted from specific deoxidation reactions taking place along the smelting process, or continuous, elongated inclusions identified as plastic inclusions of MnS, also forming on smelting from desulfurization reactions. All inclusions, without exception, show a preferential orientation being aligned along the hot rolling stress direction, the deformation process being part of the line rails manufacture technology.

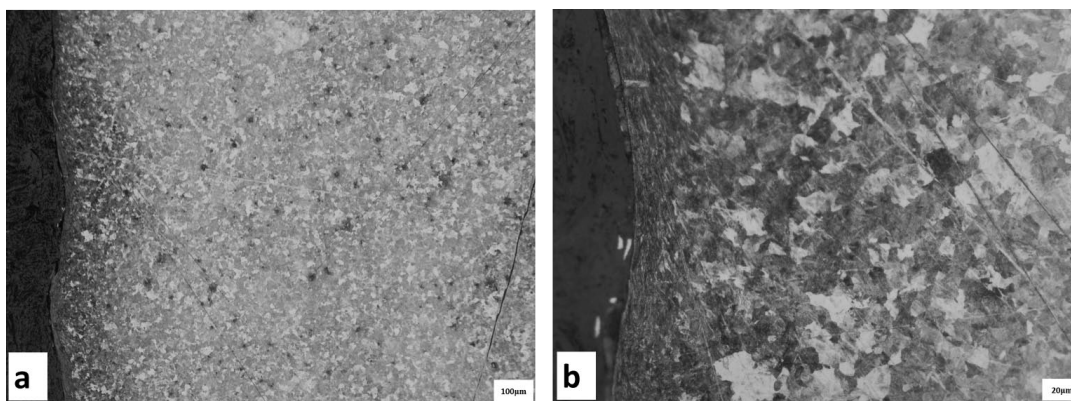
In Figure 5(a), the microstructure recorded in the superficial area a very thin layer on the line rail head.

Figure 5(b) reveals better the superficial layer, having a depth of 20-40 µm and a rather fine needle – like feature, that is, in fact, deformed pearlite. Consequently to a very long time load application, perpendicular to the top of the rail head, the ferrite lamellae flatten, the cementite lamellae shatter, becoming preferentially oriented along the thinned ferrite lamellae, also perpendicular to the load application direction. The structure

Fig. 5. Optical micrographs of the line rail head, reagent Nital 2%, a) 100×, b) 500×

One may also notice in Figure 5 an irregular profile of the rail head exterior side and fillet, suggestive of an advanced wear process that took place in a long operating time of the line rail.

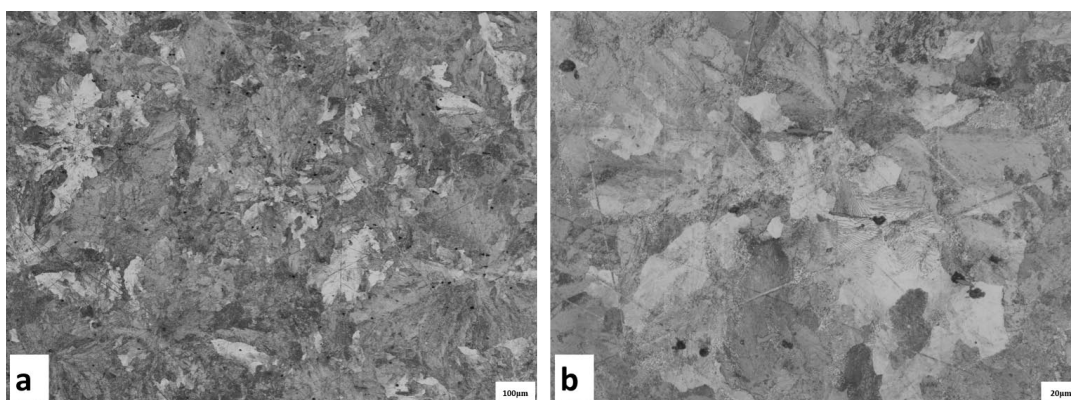
Fig. 6. Optical micrographs of the line rail web, reagent Nital 2%, a) 100×, b) 500×

The structures corresponding to the rail web and rail base zones (Fig. 6 and Fig. 7) are lamellar perlite equilibrium structures, expected to be found in a steel with this chemical composition.

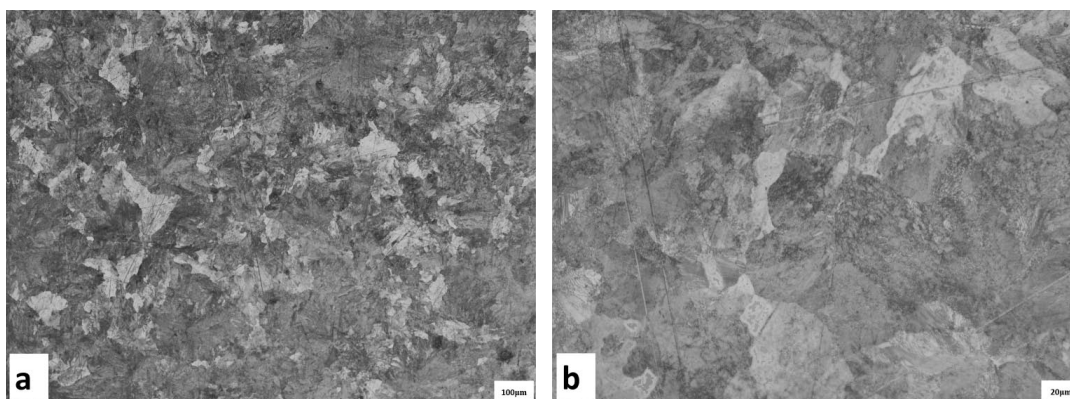
Fig. 7. Optical micrographs of the line rail base, reagent Nital 2%, a) 100 \times , b) 500 \times

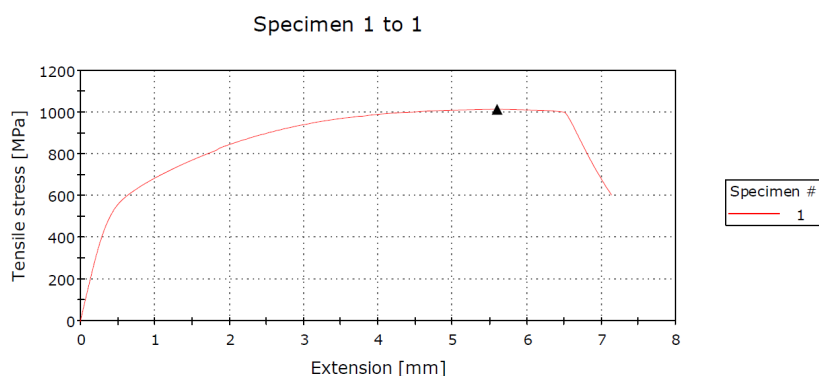
Figure 8 shows the stress-strain curve obtained by tensile testing as well as values of ultimate tensile strength (1014 MPa), elongation at break ($A = 13\%$), striction ($Z = 19\%$).

Besides these values, one can easily read on the diagram that the yield strength is approximately 500 MPa.

Fig. 8. Stress-strain curve obtained by tensile testing, values of yield strength and ultimate tensile strength, elongation at break ($A\%$), striction ($Z\%$)
