A. ZIELIŃSKI\*<sup>‡</sup>, G. GOLAŃSKI\*\***THE INFLUENCE OF REPAIR WELDED JOINT ON THE LIFE OF STEAM PIPELINE MADE OF Cr-Mo STEEL SERVICED BEYOND THE CALCULATED WORKING TIME****WPLYW NAPRAWCZEGO ZŁĄCZA SPAWANEGO NA TRWAŁOŚĆ RUROCIĄGU PARY ZE STALI Cr-Mo EKSPLOATOWANEGO POWYŻEJ OBLICZENIOWEGO CZASU PRACY**

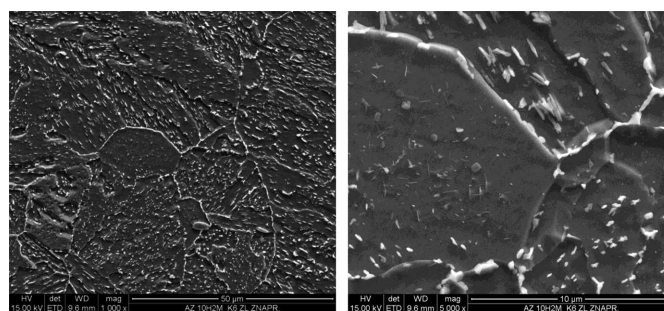
Figure 2 presents an example of the microstructure of the base material after service. After long-term service, the base material was characterized by a ferritic – bainitic microstructure. The dominant phase in the microstructure of the investigated steel was quasipolygonal ferrite with very fine numerous precipitates evenly distributed inside the grains. In bainitic areas, a considerable number of carbides of diverse size was observed, with a visible progressive coagulation process. On the boundaries of ferrite grains, there were precipitates of diverse size observed, forming “a continuous grid of precipitates” in some areas.

Fig. 2. Microstructure of base material after service

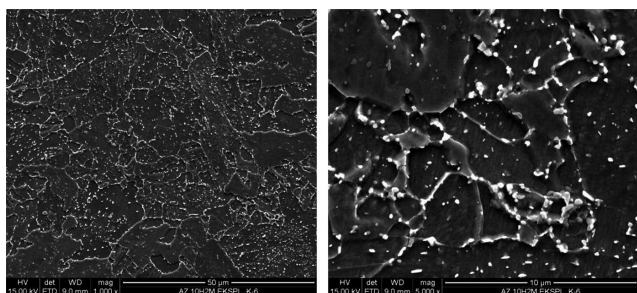
In the heat-affected zone (Fig. 3) of the joints after service, a microstructure consisting of ferrite with numerous precipitates of diverse size and shape close to spherical were observed, arranged inside the grains and on the grain boundaries. The precipitates located on the grain boundaries, similarly as in the base material (Fig. 2), in some areas, formed the so-called “continuous grid of precipitates”. Highly advanced process of degradation of this area of joint is mostly connected with the influence of welding process and heat treatment after welding on the changes in microstructure, and depends on the service to a smaller extent.

Fig. 3. Microstructure of heat-affected zone of welded joint after service

Advanced degradation of this area compared with the base material, among other things through the processes of polygonization of the matrix, and the precipitation and coagulation of  $M_6C$  carbides [14] can contribute to the formation of a joint of the so-called IV-type cracks in this area.

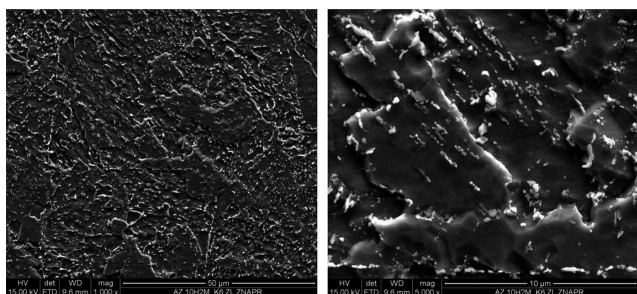
The microstructure of heat-affected zone (Fig. 4) of the repair joint was a ferritic – bainitic microstructure with numerous carbides of dominant lamellar shape.

Fig. 4. Microstructure of heat-affected zone of welded joint after repair

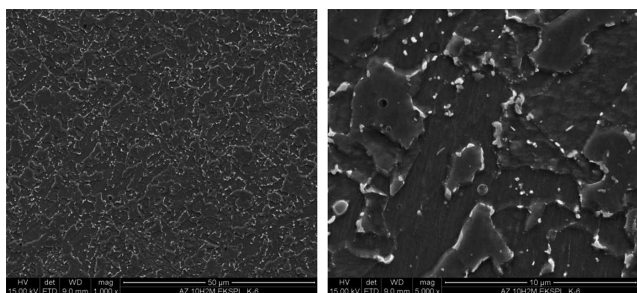
Fig. 5. Microstructure of weld seam of welded joint after service

The observed microstructures in the welded joint after long-term service (Fig. 5) and after repair (Fig. 6) were similar. In the bainitic microstructure of the weld seam after service (Fig. 5), however, more advanced precipitation processes were visible.

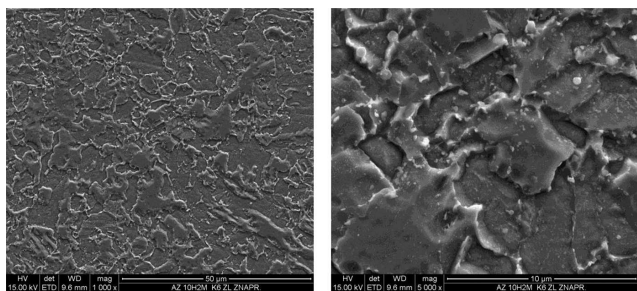
Fig. 6. Microstructure of weld seam of welded joint after repair

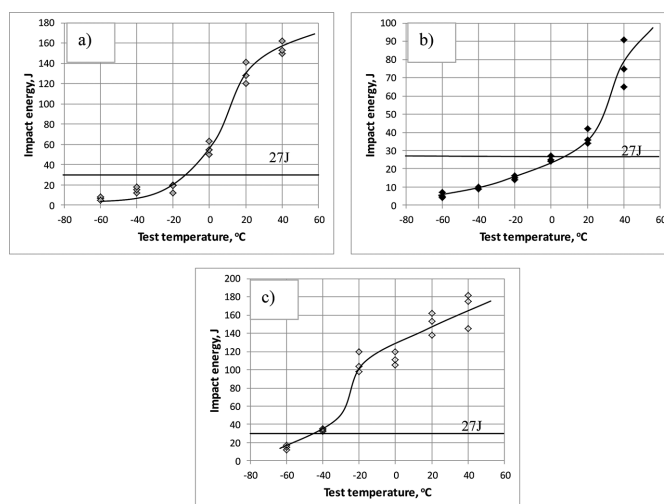
Fig. 7. Determined nil ductility transition temperature for: a) base material, b) material of weld seam after service, c) material of repair weld seam

towards higher temperature. The nil ductility transition temperature determined for the investigated materials, that is the base material, welded joint, and repair joint, amounted respectively to:  $-15^{\circ}\text{C}$ ,  $+10^{\circ}\text{C}$ , and  $-40^{\circ}\text{C}$  (Fig. 7). The low nil ductility transition temperature of the base material indicates a slight degree of degradation of the steel microstructure.

Higher impact strength and lower transition temperature of the repair joint in comparison with the joint after service probably results from the less advanced precipitation processes (Fig. 5, 6). Positive temperature of transition of the weld seam material of the welded joint after service puts an absolute obligation of fulfilling the required conditions when starting up and shutting down the boiler.

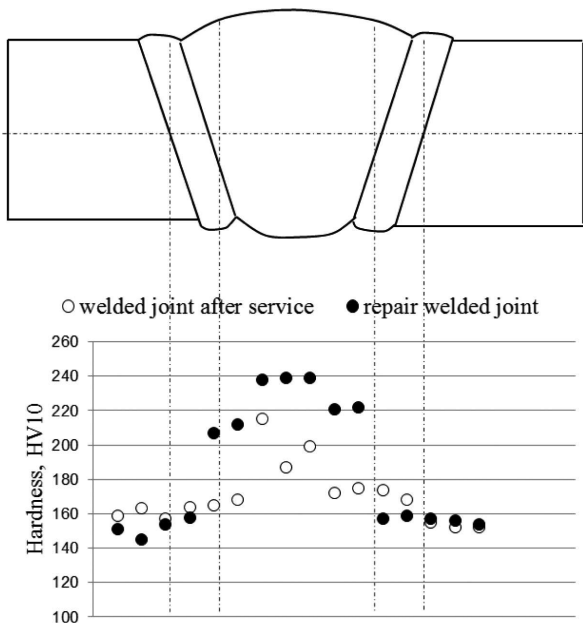
The measurement of hardness of elements of welded joint after service did not show any rapid changes at the transition through particular joint zones, unlike the elements of repair joint (Fig. 8). Hardness in particular zones of the joint after service differs by the maximum of around 55 units and does not exceed 220 HV10. Whereas hardness of the repair welded joint does not exceed the acceptable value of 350 HV10 and ranges from around 150 HV10 in the area of base material to around 240 HV10 in the weld seam.

Fig. 8. Distribution of hardness on cross section of welded joint after service and repair welded joint

A lighter course of changes in hardness on the cross section of the joint after service compared with the repair joint probably results from the changes running in the microstructure of this area during long-term service.

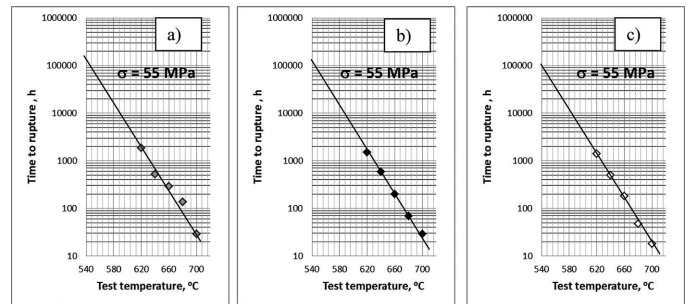
The results of short-time creep strength of the base material, the joint after service, and the repair joint are presented in Fig. 9.

Fig. 9. Creep-rupture strength of: a) base material, b) material of weld seam after service, c) material of repair weld seam

On the basis of the results of short-time creep tests, residual life and the disposable residual life were determined for the examined condition of materials, for the assumed parameters of further service,  $T_r = 540^{\circ}\text{C}$  and  $\sigma_r = 55 \text{ MPa}$ . Obtained results of tests are given in Table 3.

The base material was characterized by the bigger disposable residual life (90 000 h). Whereas the life of the repair welded joint (60 000 h) was lower than the disposable life of the joint after service (72 000 h) by 18%.
