## THE DEFECTS OF OXIDE LAYERS FORMED ON 10CrMo9-10 STEEL OPERATED FOR 200,000 HOURS AT AN ELEVATED TEMPERATURE

The paper contains results of studies into the formation of oxide layers on 10CrMo9-10 (10H2M) steel long-term operated at an elevated temperature ( $T = 545^{\circ}\text{C}$ ,  $t = 200,000\text{h}$ ). The oxide layer was studied on a surface and a cross-section at the inner and outer surface of the tube wall on the outlet both on the fire and counter-fire side of the tube wall surface.

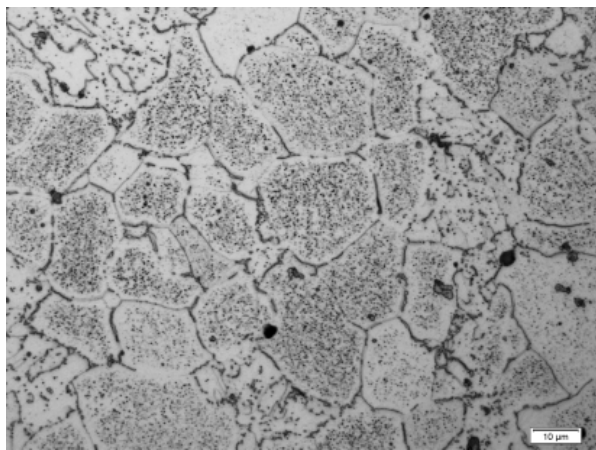
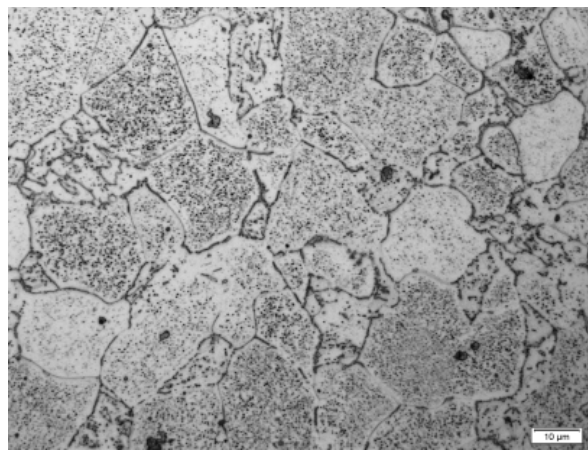
After a long-term operation ( $T = 545^{\circ}\text{C}$ ,  $t = 200,000\text{h}$ ) 10CrMo9-10 steel shows degradation of bainitic-ferritic structure. The extent of degradation on the fire side is much higher than on the counter-fire side, which is presented in Fig. 1. A substantial depletion of boundary areas in carbide precipitates is visible on the fire side. Instead, in both cases carbide precipitates create ‘chains’ along boundaries, in certain places there are also cases of etching around sulphide precipitates and sporadic creep micropores on the

Fig. 1. Microstructure of 10CrMo9-10 steel operated for 200,000 hours at the temperature of  $545^{\circ}\text{C}$ , LM: (a) fire wall, (b) opposite fire wall

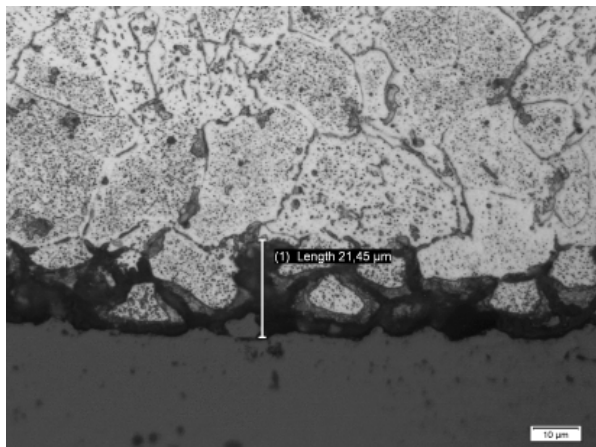
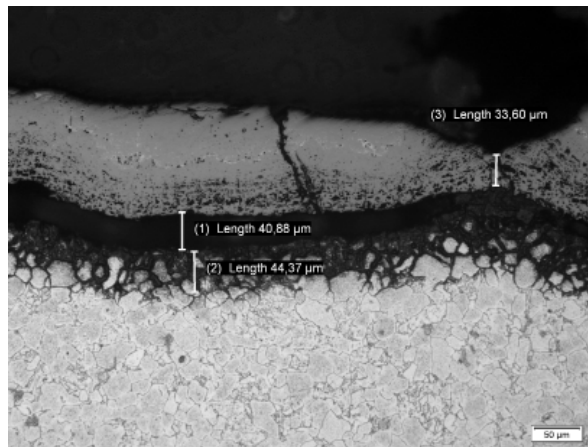
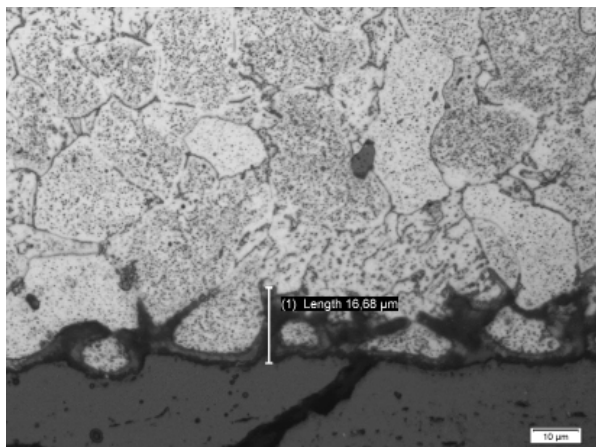
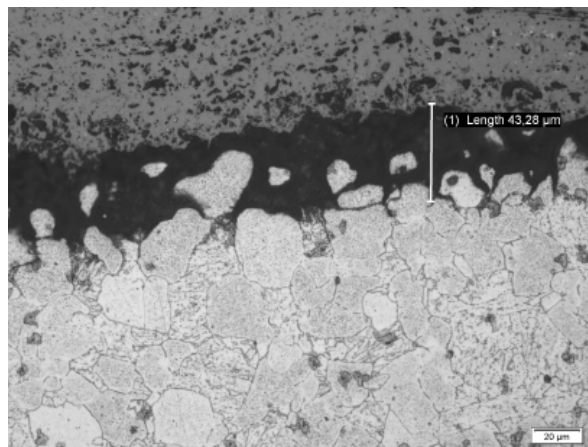
fire side. Corrosion on the grain boundaries also exists, both on the fire and counter-fire side, which is presented in Fig. 2. Such corrosion together with crevice corrosion to the largest extent occurs at the outside wall on the fire side, reaching  $84\ \mu\text{m}$  in depth. While on the counter-fire side at the outside wall corrosion exists on the grain boundaries to the depth of  $43\ \mu\text{m}$ . At the inside wall, on the fire and counter-fire side, corrosion on the grain boundaries exists to the depth of  $21\ \mu\text{m}$  and  $17\ \mu\text{m}$ , respectively.

Fig. 2. Corrosion on the grain boundaries at: (a) inner surface – fire wall, (b) outer surface – fire wall, (c) inner surface – opposite fire wall, (d) outer surface – opposite fire wall

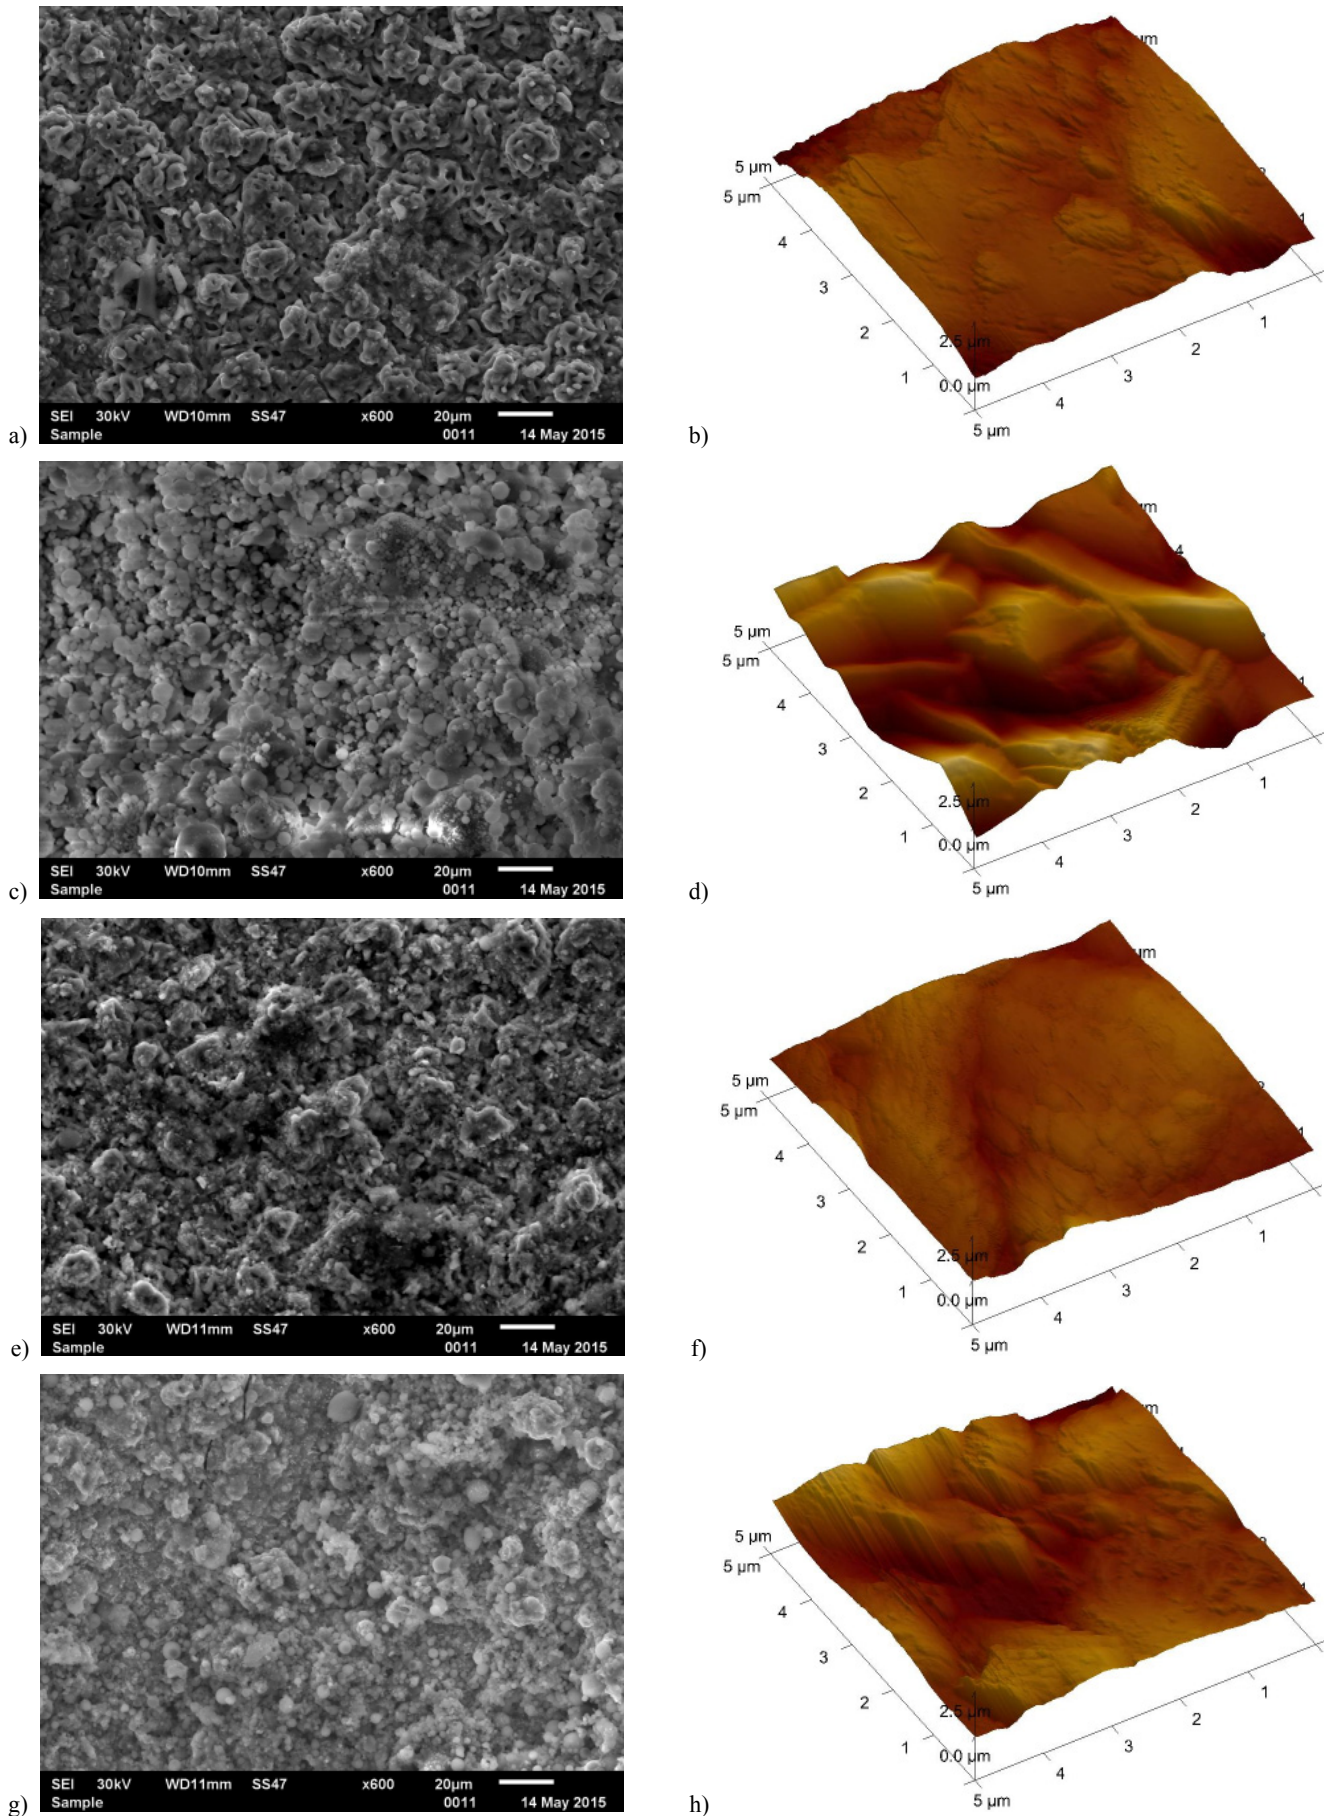
Fig. 3 presents results of surface microscopic studies, where a greater degradation on the outside of tube wall is visible.

Fig. 3. Oxides formed on 10CrMo9-10 steel operated at 545°C during 200,000 hours: (a) inner surface – fire wall, SEM; (b) inner surface – fire wall, AFM; (c) outer surface – fire wall, SEM; (d) outer surface – fire wall, AFM; (e) inner surface – opposite fire wall, SEM; (f) inner surface – opposite fire wall, AFM; (g) outer surface – opposite fire wall, SEM; (h) outer surface – opposite fire wall, AFM

Fig. 3d and h shows spalling of individual deposit/oxide layers on the outside. In the case of fire side, both on the inside and outside, a larger degree of surface development was observed (Fig. 3a and c).

The surface topography studies (Figs. b, d, f, h and Table 1) have shown that the largest degree of surface development occurred on the outside surface on the fire side, where  $R_a$  and  $R_{max}$  were 406 nm and 2790 nm, respectively.

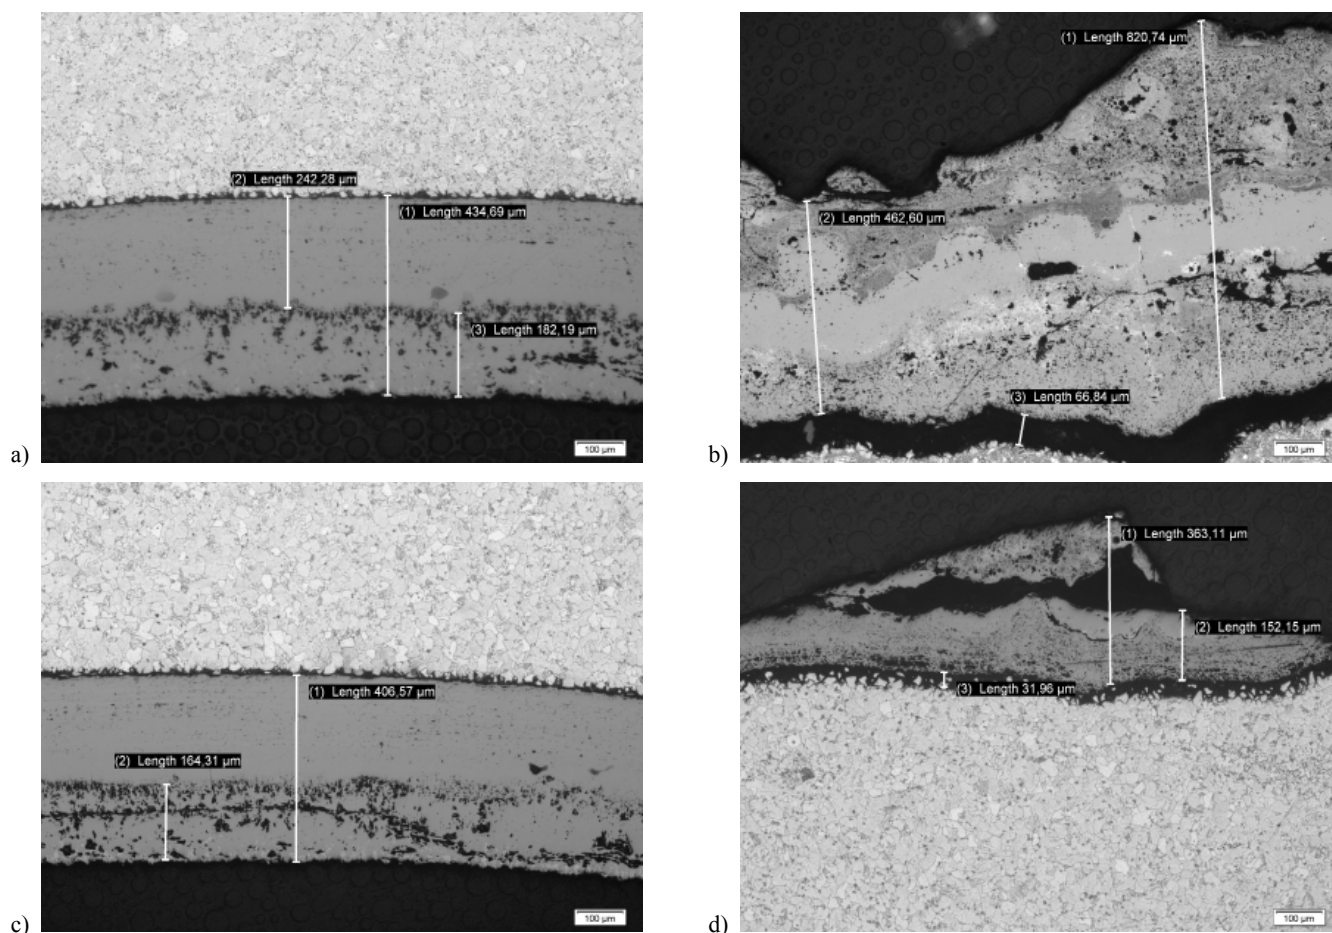
The oxides layer thickness together with deposits on the fire side was 435  $\mu\text{m}$  and 820  $\mu\text{m}$  on the flowing medium and

flue gas side, respectively (Fig. 4a, b). For the counter-fire side on the inside the oxides layer thickness is smaller by 30  $\mu\text{m}$ , while on the outside by as many as 460  $\mu\text{m}$  (Fig. 4c, d). The layer formed on the fire outside shows high degradation, which is presented in Fig. 5b, where a surface after spalling of a thick deposit layer is visible. In addition, a very large fissure reaching the depth of 235  $\mu\text{m}$  may be noticed. Instead, on the inside only local spalling in the oxides layer may be observed directly on the flowing medium side (Fig. 5a).

Fig. 4. The thickness of oxides layer formed on the steel examined, LM: (a) inner surface – fire wall, (b) outer surface – fire wall, (c) inner surface – opposite fire wall, (d) outer surface – opposite fire wall

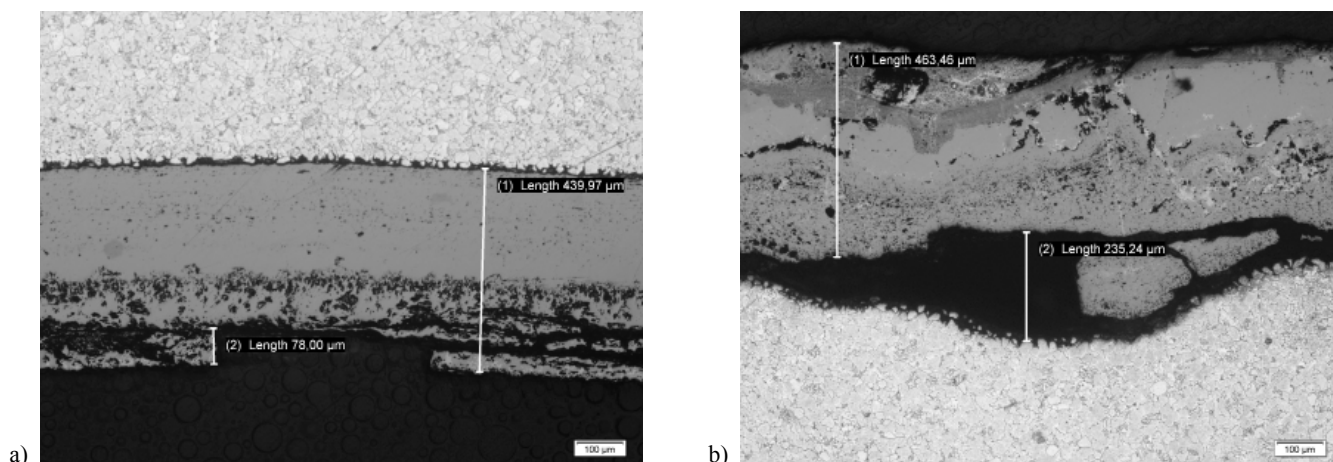
Fig. 5. The damage of oxide layer; cross section: (a) inner surface – fire wall, (b) outer surface – fire wall

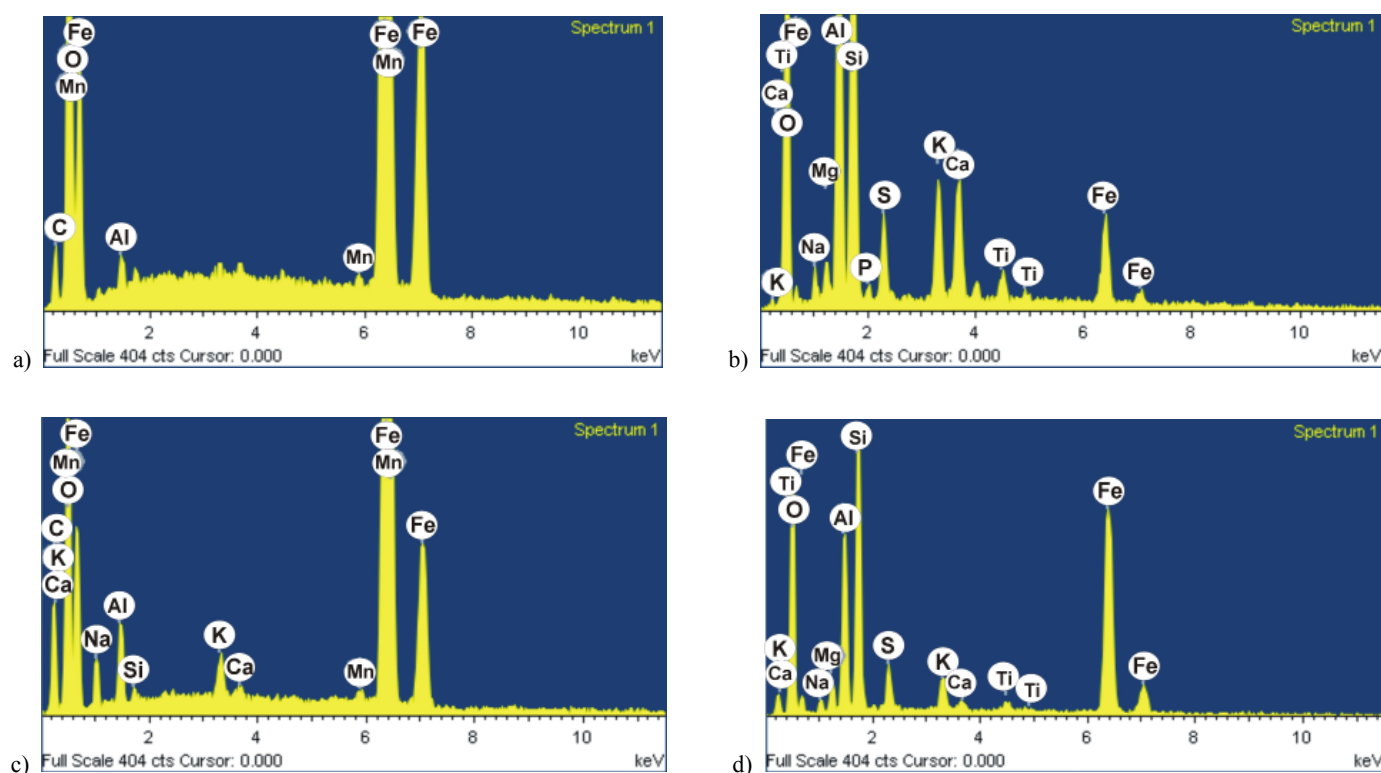
Performed EDS analysis of chemical composition (Fig. 6) combined with X-ray phase analysis (Fig. 7) has shown that oxides occur on the inside surface of tube. Based on DHN PDS and PDF4+2009 crystallographic database it has been found that the forming oxides are:  $\text{Fe}_2\text{O}_3$  and  $\text{Fe}_3\text{O}_4$  in accordance with the catalogue card numbers: 01-079-0007, 01-089-0951, respectively. In the case of the outside surface of tube from opposite fire wall apart from the aforementioned compounds also Al, Si, K, Ca, Ti, Mg, Na and S based compounds exist, such as:  $\text{Al}_2\text{SiO}_5$ . The other elements, such as K, Ca, Ti, Mg, Na, occur in small amounts. Instead, directly on the fire outside only  $\text{Al}_2\text{SiO}_5$  exists and small amounts of K, P, S, Ca, Ti, Mg and Fe. After removing the external deposit layer on the outside and repeating the XRD analysis it has been shown that the forming oxide layer is built of  $\text{Fe}_2\text{O}_3$  and  $\text{Fe}_3\text{O}_4$  (Fig. 8).

Fig. 6. EDS point microanalysis: (a) inner surface – fire wall, (b) outer surface – fire wall, (c) inner surface – opposite fire wall, (d) outer surface – opposite fire wall

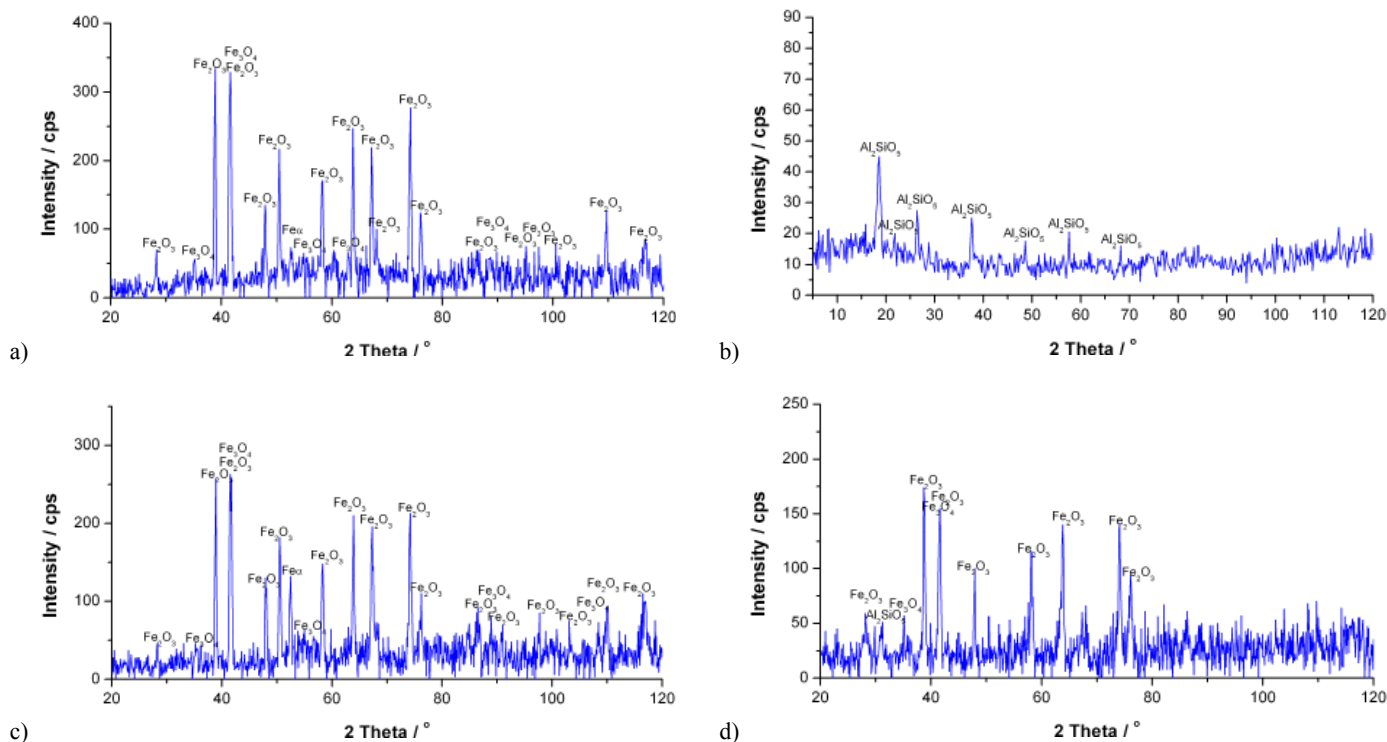
Fig. 7. Diffraction pattern of oxide layers obtained using the XRD technique: (a) inner surface – fire wall, (b) outer surface – fire wall, (c) inner surface – opposite fire wall, (d) outer surface – opposite fire wall

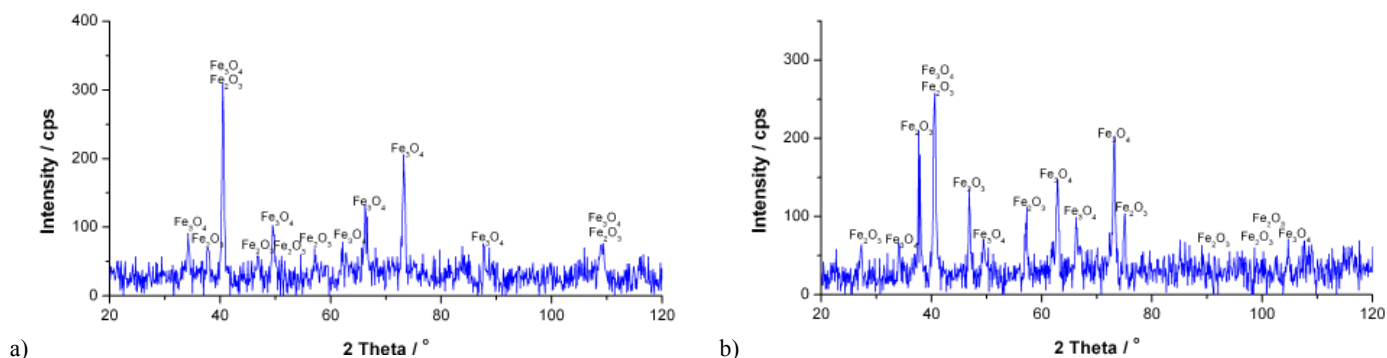
Fig. 8. Diffraction pattern of oxide layers after polishing obtained using the XRD technique: (a) outer surface – fire wall, (b) outer surface – opposite fire wall
