MARKÉTA LEDNICKÁ\*, ZDENĚK KALÁB\*

**DETERMINATION OF GRANITE ROCK MASSIF WEATHERING AND CRACKING OF SURFACE LAYERS IN THE OLDEST PARTS OF MEDIEVAL MINE DEPENDING ON USED MINING METHOD****OKREŚLENIE GRANIC WIETRZENIA MASYWU SKAŁ GRANITOWYCH I SPEKAŃ WARSZTAW POWIERZCHNIOWYCH W NAJSTARSZYCH CZĘŚCIACH ŚREDNIOWIECZNEJ KOPALNI, W ZALEŻNOŚCI OD STOSOWANYCH METOD WYDOBYCIA**

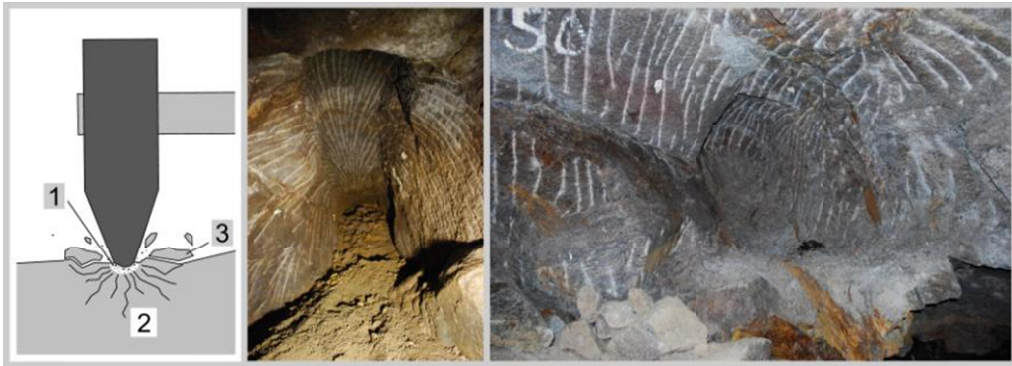
Fig. 2. Principle of rock ruptures after hammer blow (according Lehrberger & Gillhuber, 2007): (1) crushed zone, (2) cracked zone – radial cracks, (3) abruption of fragments; photos illustrate examples of mined out spaces using hammer blow in the Jeroným mine (*photo: Lednická*)

Cracking of rock massif is realized during mining to obtain better workability of rocks. In the oldest stages of mining in the Jeroným Mine, which began in the 16<sup>th</sup> century, hand tools were used for crumbling away the rock. Using this mining method, the rock cracked only in the contact zone of a hammer with the rock; the formation of cracks in a surface layer of rock massif was negligible. The principle of rock ruptures in the contact zone of a hammer with the surface of rock material during manual work is shown in Fig. 2. Surfaces formed like this have been preserved so far in the majority of historic parts of the Jeroným Mine and they have become the most valuable from the historical point of view. Typical examples are galleries with space-saving profile where the height is only about 1.5 m (see the example in Fig. 5a,b).

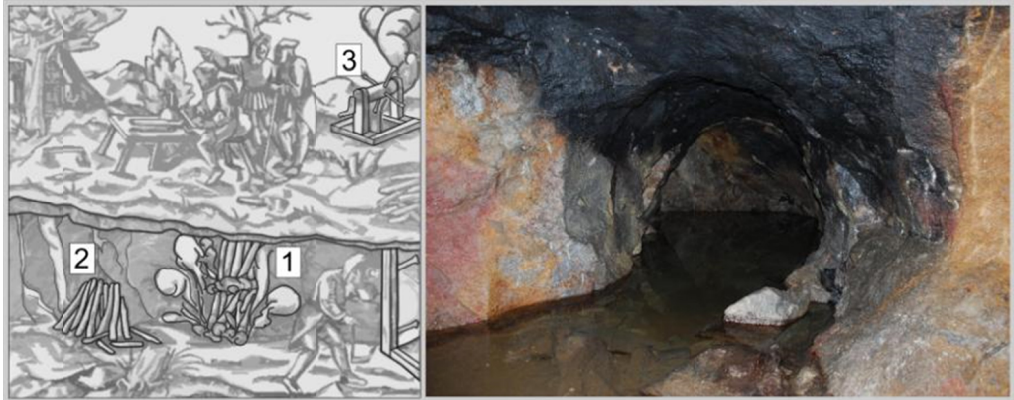
Fig. 3. Principle of fire-setting (according Agricola, 1556): (1) kindled logs, (2) heap of dried logs, (3) fumes ventilation; photo illustrates an example of the rest of soot on the roof of gallery (*photo: Lednická*)

Another method, used in the oldest stages of mining in the deposit, is called fire-setting which consisted in heating the rock using kindled logs (Agricolae, 1556). When the temperature changes, various minerals are subjected to volume changes at various speed resulting in development of stress at the boundaries among individual minerals. As a result, the surface layer of the rock cracked and it was easier to cleave it by iron tools. Typical phenomenon is the rest of soot on the roofs and walls of mine workings, which were used for fumes ventilation (Fig. 3).
