JÓZEF MARKOWICZ\*, SYLWESTER RAJWA\*\*, STANISŁAW SZWEDA\*

**EXPERIMENTAL TESTS OF PARAMETERS CHARACTERIZING THE COOPERATION OF POWERED ROOF SUPPORT BASE AND FLOOR OF LOW BEARING CAPACITY****DOBÓR PARAMETRÓW CHARAKTERYZUJĄCYCH POSTAĆ KONSTRUKCYJNĄ SEKCJI OBUDOWY ZMECHANIZOWANEJ W ASPEKTCIE JEJ WSPÓLPRACY ZE SPĄGIEM O MAŁEJ NOŚNOŚCI**

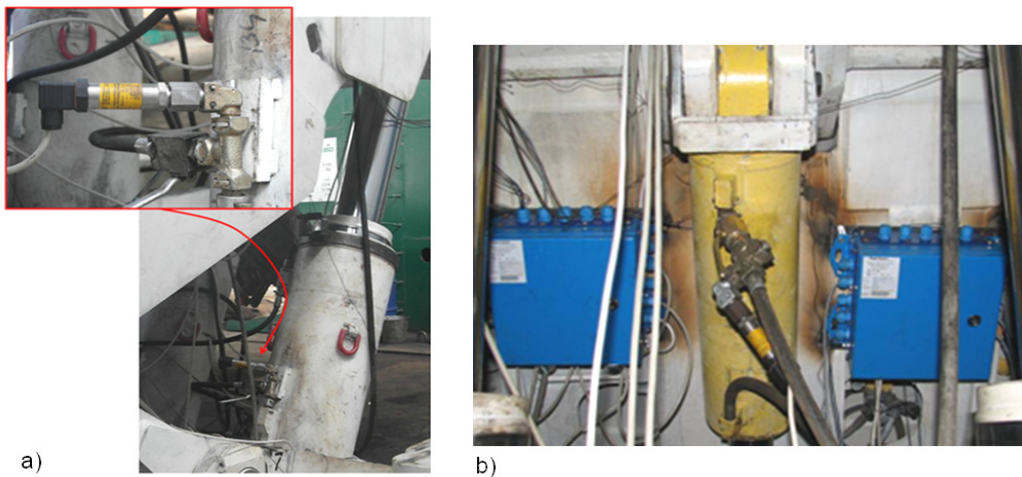
Fig. 1. Pressure sensors installed in BW 16/34 POz roof supports  
 a) in the hydraulic leg, b) in the canopy cylinder

- pressure in under-piston area of both the legs of roof support and canopy cylinder (Fig. 1),
- geometrical features of powered roof support determined in the result of using the five inclinometers installed on the following components: canopy, shield, lemniscate links, base and legs (Fig. 2),
- deformation in eleven selected points of different components of roof support, determined with use of electro-resistant strain gauges (Fig. 3).

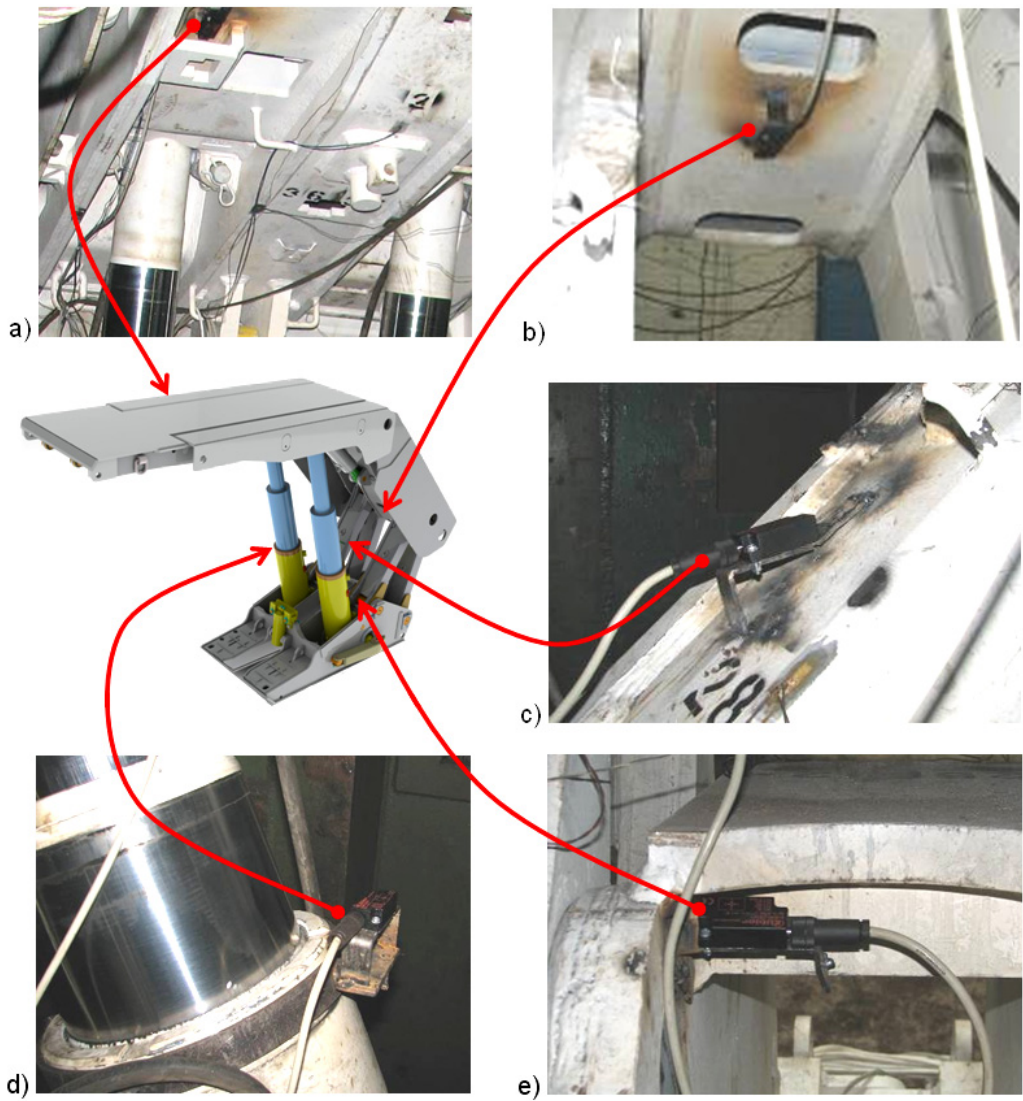
Fig. 2. Distribution of inclinometers on powered roof support  
a) on the canopy, b) on the gob shield, c) on the lemniscate link, d) on the hydraulic leg,  
e) on the base

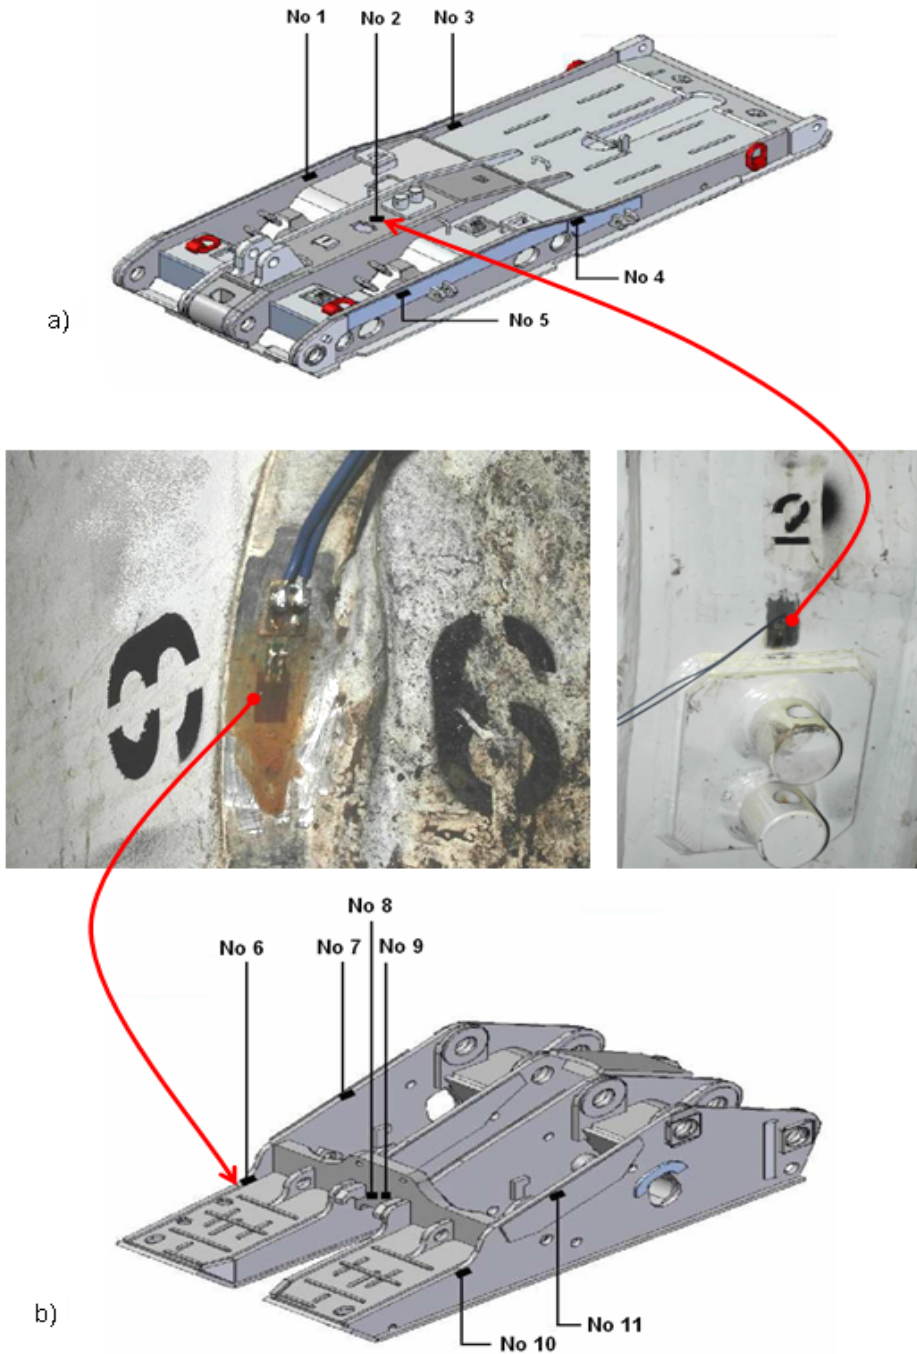
Fig. 3. Localization of strain gauges on powered roof support  
a) on the canopy, b) on the base

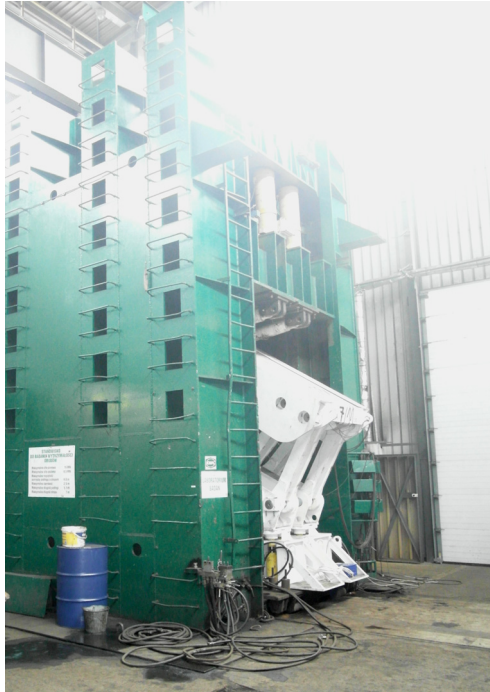
Fig. 4. BW 16/34 POz roof support placed in the test rig and founded on the “hydraulic cushion” at the KOMAG Institute of Mining Technology in Gliwice

Laboratory tests of BW 16/34 POz roof support were carried out at test rig at the KOMAG Institute of Mining Technology in Gliwice (Fig. 4). The rig enables loading the roof support through active movement of the roof, as it occurs in the longwall panel. To model the floor different bearing capacity during tests, the roof support set to load was founded in the rig on a “hydraulic cushion” (Fig. 5) built of 24 cylinders of individually controlled settings. The tests were carried out both for symmetrical and asymmetrical canopy load conditions (Fig. 6). The height of roof support set to load in the rig was 2.5 m and 3.3 m, what corresponds to the height of roof support in longwalls in PKW S.A. ZG “Janina”.

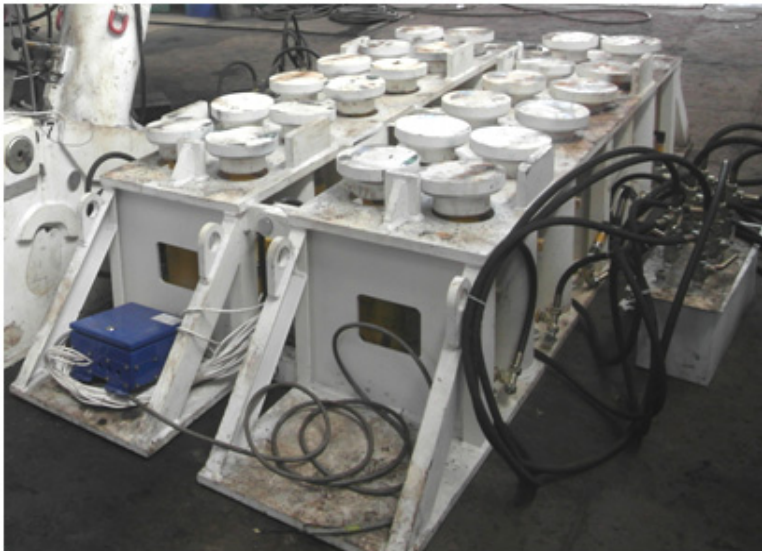
Fig. 5. Hydraulic cushion used during laboratory tests to simulate different values of compression strength of floor rocks and different arrangement of support scheme

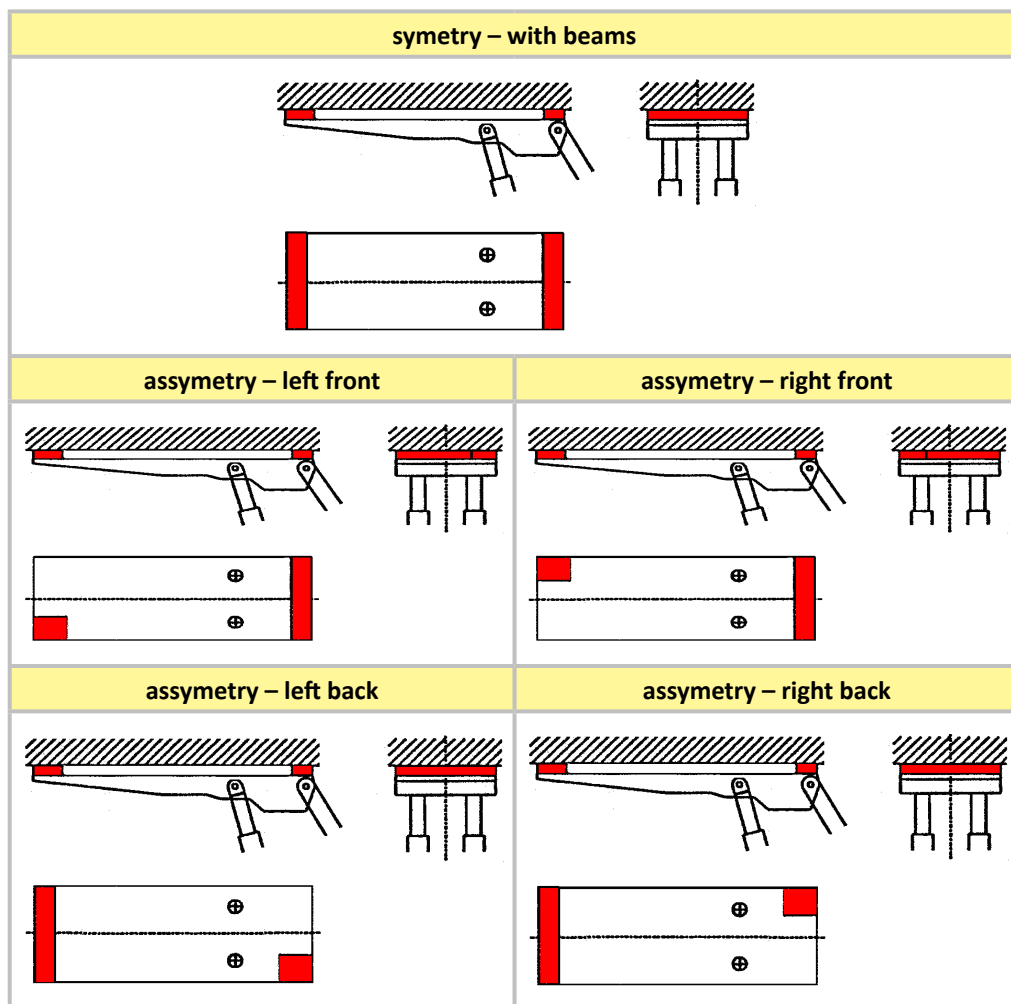
Fig. 6. Examples of load diagrams of powered roof support in the test rig

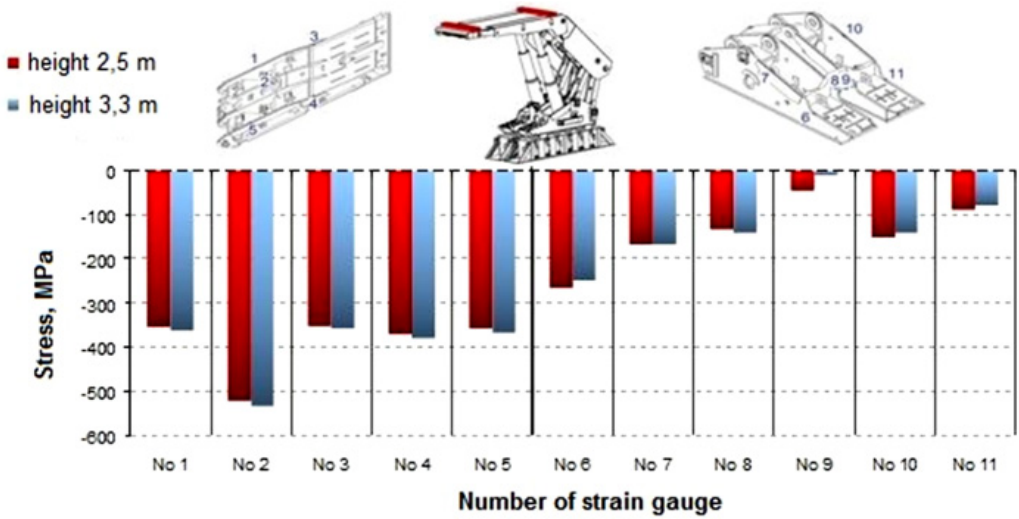
Fig. 7. Comparison of strain in each powered roof support point determined on the basis of tensometric measurements at symmetrical load

When analyzing the results of measurements of deformations in the selected points of roof support (Fig. 7) it was found that even at symmetrical loading of the canopy, confirmed by the readings of strain gauges 1-5 placed on the canopy, load to the base is asymmetrical, what results from comparison of strain gauges readings, e.g. No. 6 and 11 stuck to a side metal sheets of the base.

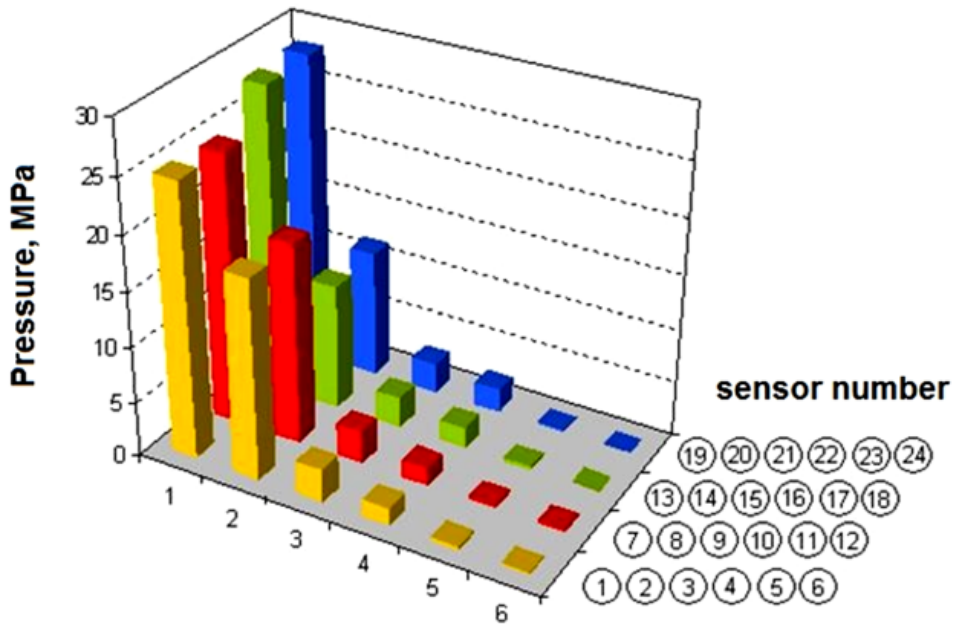
Fig. 8. Distribution of pressure in the cylinders of hydraulic cushion at symmetrical load to canopy during laboratory tests

Recorded distribution of pressure in each cylinder of hydraulic cushion at symmetrical load to the canopy is presented in Fig. 8.

Recorded distribution of pressure indicates asymmetrical distribution of base pressure on the floor, which neither was caused by asymmetrical load to the canopy, nor by differentiated settings of valve blocks in the cylinders of hydraulic cushion. Uneven distribution of load to kinematic nodes of roof support, caused by assembly clearances and manufacture inaccuracy of these nodes, is the most probable reason of asymmetrical pressure distribution.

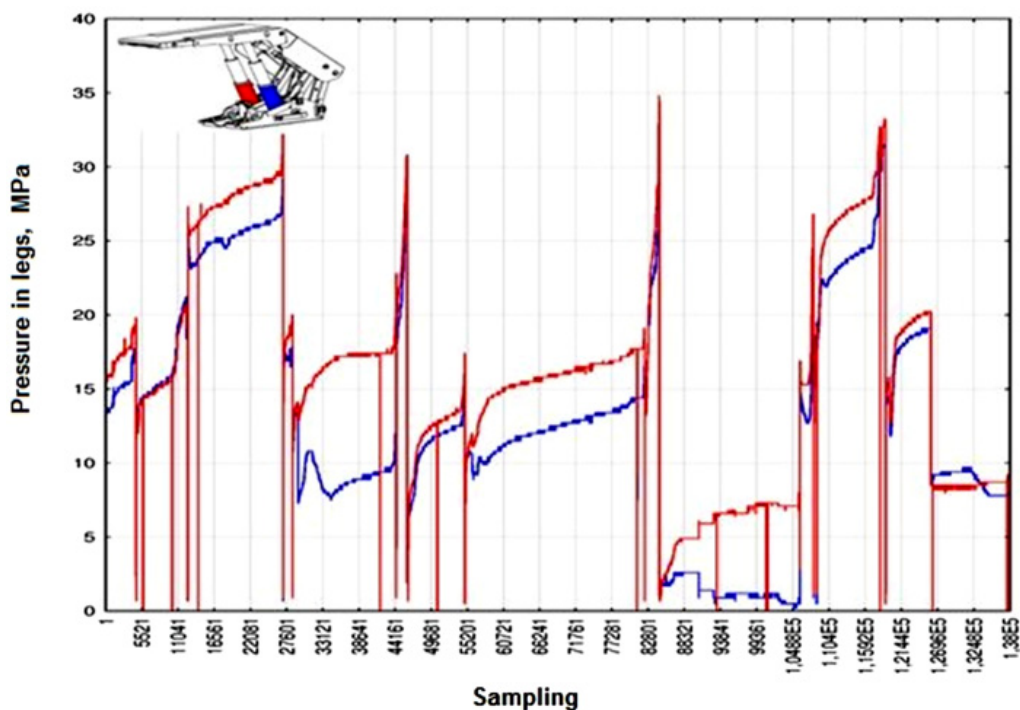
Fig. 10. Examples of pressure recorded in under-piston parts of legs of BW 16/34 POz powered roof supports operating in the longwall No. 136 – seam 119/2

Diagrams of pressure changes in the left and right leg of the roof support, which were recorded along the longwall panel, are given in Fig. 10.

From the presented diagram it results that momentary load to the roof support is asymmetrical. Value of load is significantly different in each cycle of roof support operation. It should be mentioned that during normal longwall panel operation, in conditions of lack of water inflow to the working, the structure of floor rocks was not damaged by the base, what would result in “pressing and sinking” of roof support in the floor of the working. The ground reaction enabled to reach the operational load bearing capacity of roof support.

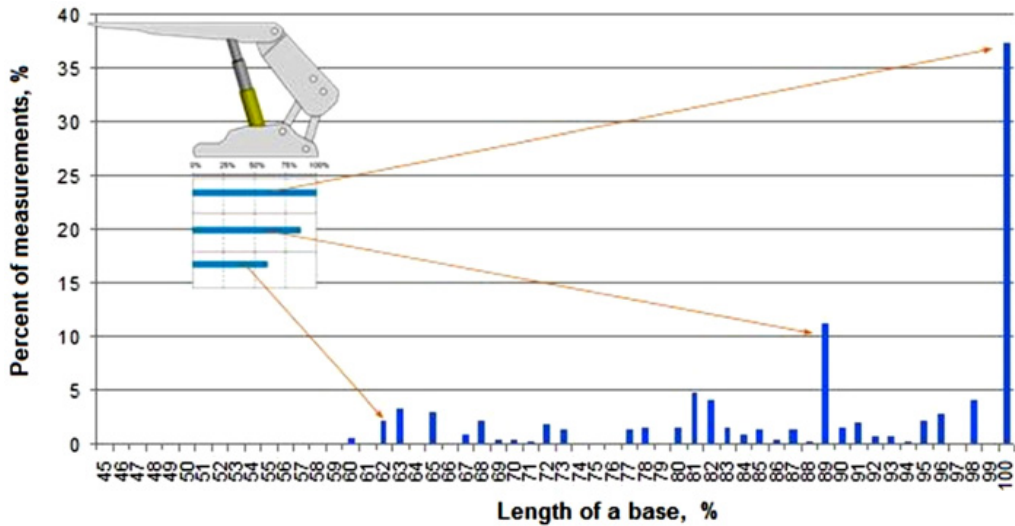
Fig. 11. Contact area between base and floor

Use of inclinometers enabled precise determination of geometrical form of kinematic chain of roof support set to load in longwall 136 and including this form in analysis of distribution of permanent loading on the base surface. In Fig. 11, percentage share of contact area between base and floor determined by measurements taken in the working is presented. From the diagram in Fig. 11 it results that e.g. in the 37% cases the base has full contact with the floor. The lowest recorded contact area between floor and base was 60% (about 1% of recorded cases).

From the tests it results that in the case of not watered floor of low bearing capacity the changes of geometrical form of kinematic chain of roof support cause that contact surface of the base and roof covers over 60% of the surface of lower metal sheet of the base.
