JOURNAL OF WATER AND LAND DEVELOPMENT  
 2018, No. 39 (X–XII): 61–65  
 PL ISSN 1429–7426, e-ISSN 2083-4535

## Assessment of drinking water quality of Kopiliq village in Skenderaj, Kosovo

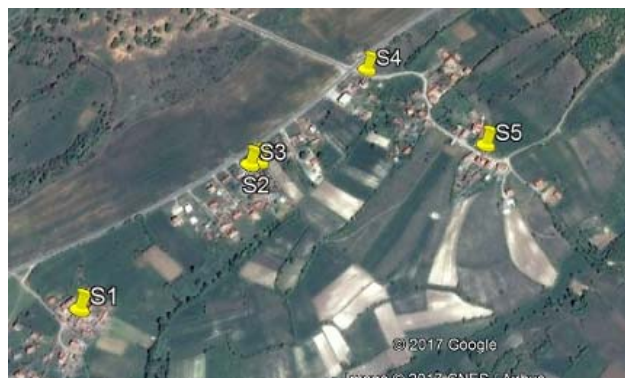
The monitoring network includes five monitoring points (S<sub>1</sub>, S<sub>2</sub>, S<sub>3</sub>, S<sub>4</sub> and S<sub>5</sub>), five water wells from which the families of this village are supplied. The monitoring network and coordinates of the five selected locations for this research have been presented in Figure 1 and Table 1.

Fig. 1. Monitoring network in the research area; source: Image © 2017 CNES / Airbus

Sampling points	Geographic latitude N	Geographic longitude W	Height above sea level (m)
S <sub>1</sub>	42°41'49.88"	20°42'11.85"	590
S <sub>2</sub>	42°41'58.81"	20°42'23.95"	607
S <sub>3</sub>	42°41'58.64"	20°42'23.21"	607
S <sub>4</sub>	42°42'05.01"	20°42'32.07"	620
S <sub>5</sub>	42°41'59.56"	20°42'41.63"	628

Explanations: S<sub>1</sub>–S<sub>5</sub> = sampling points as in Fig. 1. Source: own elaboration.
