FOLIA MEDICA CRACOVIENSIA

Electrode ingrowths revealed during cadaveric dissection of a 5y old implanted pacemaker — the case report

Abstract: Increasing numbers of implanted cardiovascular electronic devices, results in a need for lead extractions, which has increased to an annual volume of over 10,000 worldwide. We present a cadaveric dissection body with a single chamber pacemaker implanted 5y before death.

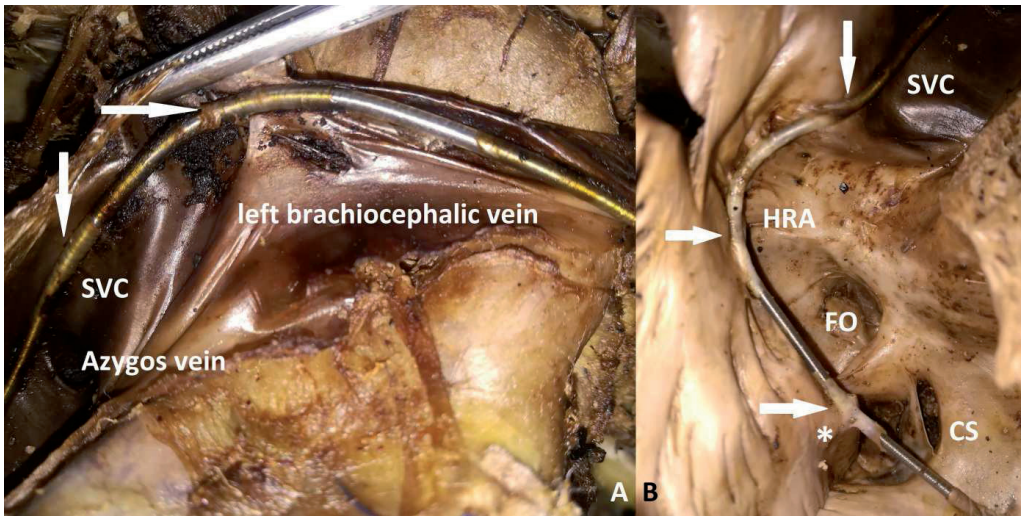
Fig. 1. **A** — an uncovered course of the electrode via brachiocephalic vein and superior vena cava (SVC); **B** — entrance through SVC to the right atrium, HRA — high right atrium, FO — foramen ovale, CS — coronary sinus, with white arrows marked places of ingrowths into heart endothelium, * Todaro tendon.

After uncovering the electrode, we found epithelial lining throughout the course of the electrode and an ingrowth in the beginning of the superior vena cava (SVC), on the right aspect, close to the left Brachiocephalic vein access (Fig. 1A), in the end of the SVC just before the entrance to the right atrium (Fig. 1B) and in the cavotricuspid isthmus — over Todaro Ligament (Fig. 1B). The length of ingrowth was also impressive — high right atrium — beginning of SVC — 5 cm, the superior aspect of SVC– brachiocephalic connection — 2 cm, ligament of Todaro 1 cm, tricuspid annulus 0.5 cm. After the electrode trespassed the tricuspid annulus, impressive tissue was found layering over the silicone cuff (Fig. 2A, 2B), between the septal and posterior cusp of the tricuspid valve. From the described position, the electrode was directed toward the interventricular septum.

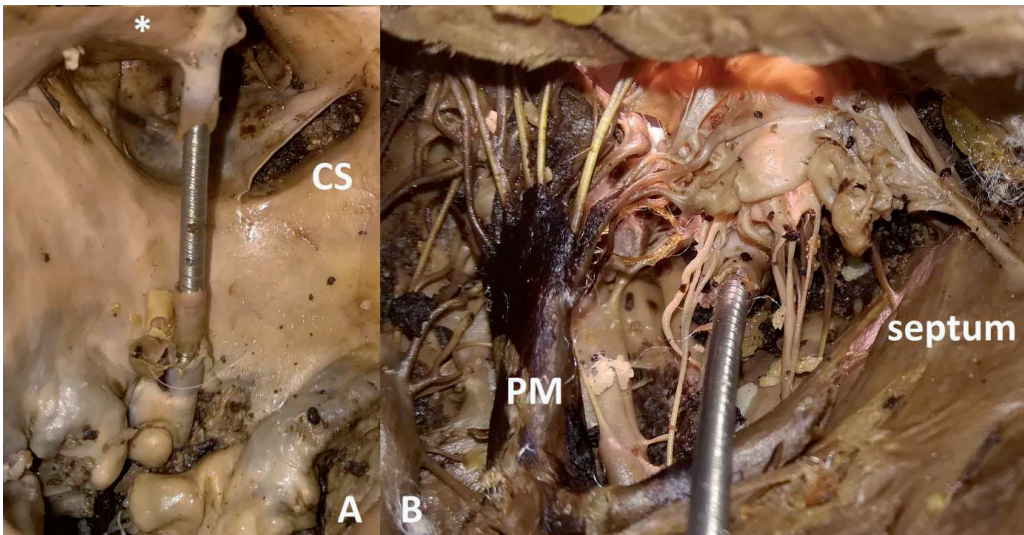
Fig. 2. **A** — view of the electrode from right atrium; * Todaro ligament, CS — coronary sinus; **B** — view from the right ventricle, PM — papillary muscle.
