COMPARATIVE STUDIES ON DEGRADATION OF VARISTORS SUBJECTED TO OPERATION IN SURGE ARRESTERS AND SURGE ARRESTER COUNTERS

The paper presents results of investigation of microstructure and micro-hardness for material of ZnO varistors applied to 110 kV surge arrester and surge arrester counter. The research combined two pairs of varistors, each consisted of one varistor subjected before to operation, while the other one was brand new unit and constituted a reference. All varistors were made of the same material by the reputable manufacture. The tests revealed a different degree of the material degradation for varistors subjected before to operation. This also refers to different degradation mechanism observed for the material of these varistors, if typical effects of degradation of aged ZnO varistors were considered as a reference. Physical state of spinel in the microstructure had a significant impact on the material degradation, however a considerable loosening of the microstructure associated with bismuth oxide was observed too. It was surprising, since the precipitates of the bismuth oxide phase most often showed very good binding to the ZnO matrix and high resistance to associated

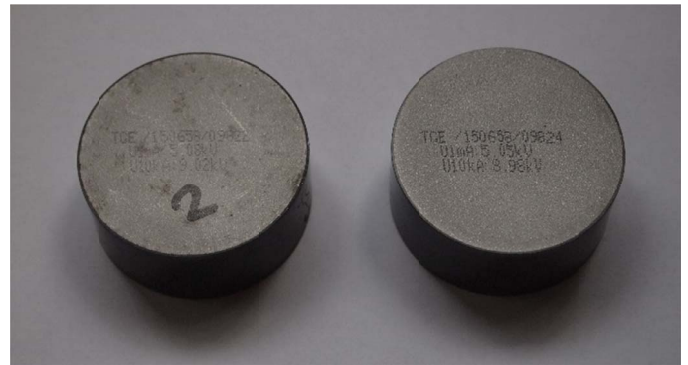
Fig. 1. First pair of samples – varistor from a surge arrester counter on the left and an analogous – reference varistor that was not used

The first pair of tested components comprised two smaller varistors, one of which was removed from a surge arrester counter after several years of operation and a significant number – approx. 1000 – of operations. The other one, identical as the first one, was not used and served as a reference sample. The first pair of samples is presented in figure 1. The second pair comprised two varistors with larger dimensions. The first one was removed from a damaged surge arrester. The second one was identical, but was not used and, as in the case of the first pair, served as a reference sample. The second pair of samples is presented in figure 2. Figure 3 presents the close-up of the lateral surface of the used varistor – from a surge arrester working in a 110 kV power transmission network after failure – presenting a loss in the protective layer as a result of strong short-circuit current flow.

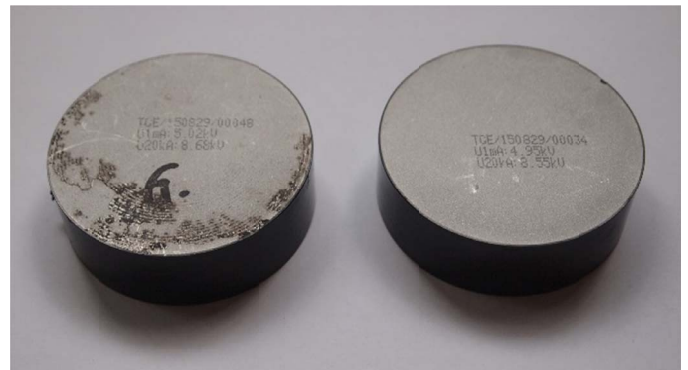
Fig. 2. Second pair of samples – varistor from a damaged 110 kV surge arrester on the left and an analogous – reference varistor that was not used

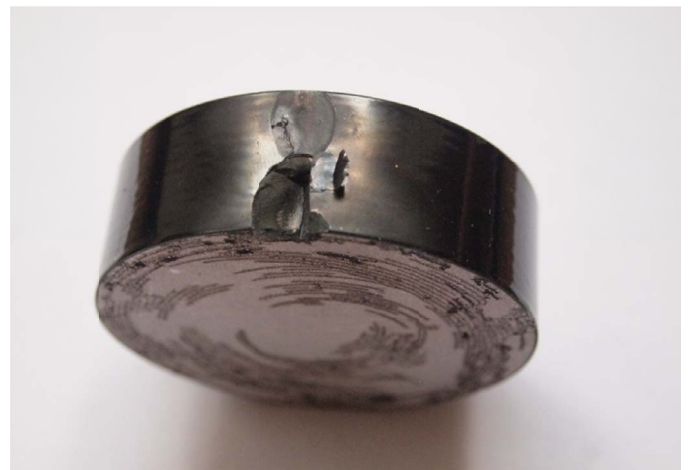
Fig. 3. Varistor from a surge arrester after a failure, with a well visible loss in the protective layer which resulted from strong short-circuit current flow

damaged surge arrester and on its lateral surface an overburning with a protective layer loss was visible. This resulted from the flow of strong short-circuit current which damaged the surge arrester. The test sample was cut out from the external varistor area, 5 mm from the overburning trace. It was expected that in this area the material was subject to significant degradation effects.
