Evaluation of the operational effectiveness and feasibility of small-scale water supply systems in the hinterlands in Ethiopia: Case of Afar Regional State

Melese C. Shumie

Debre Berhan University, Department of Civil Engineering, Debre Berhan, PO Box 445, Ethiopia

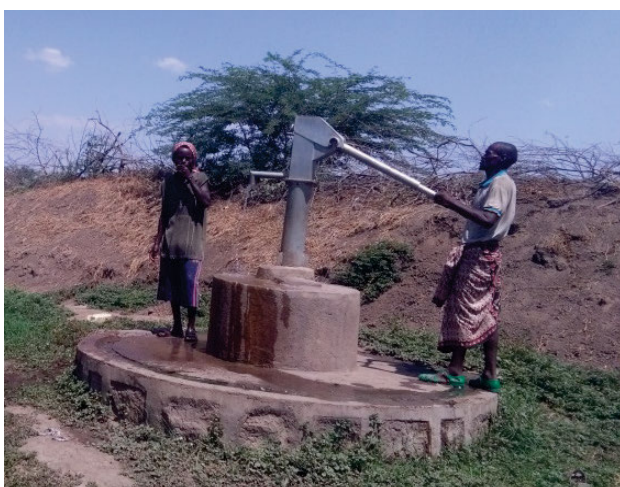
Photo 1. Community hand-dug well (HDW) – Kodea Village (phot.: M.C. Shumie)

The study area's hand-dug wells have 10 m average well depth, 3 m water depth and 1.2 m diameter. The internal well wall is encircled by a concrete ring and sealed by a concrete slab at the top. The wellhead is constructed by a composition of masonry and concrete materials. The water pump is a mechanical hand pump that lifts water by rotodynamic mechanisms. It uses the centrifugal force of rotating devices (called impellers) to increase the kinetic and pressure energy of the water. The water spring from the nearby aquifer is filtered by sand and aggregate material capped between the well concrete wall and the subsurface ground wall. Almost 93% of the studied hand-dug wells are excavated near rivers that help to feed water to the wells. The expected project population is 150 people per scheme per day. Eight hand-dug well schemes are surveyed and studied. The design drawing of the HDW scheme is shown in Figure 2 and its construction photo is shown in Photo 1.

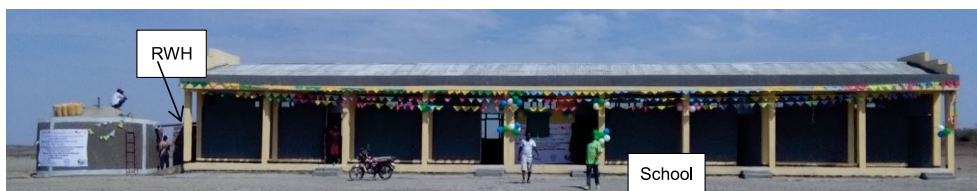
Fig. 4. Roof water harvesting (RWH) water tank and its water source – the school at Dababuraburi (phot.: M.C. Shumie)

The quality of the water is checked by the district water expert by using different water purifying chemicals like chlorine before it is supplied to the consumers. The quality of water is governed by both the Ethiopian and the World Health Organization's potable water quality standards. When the rain comes and pours onto the roof, the first 10 to 15 minutes of roof water does not flash into the tank for the purpose of improving the quality of water. The design drawing of the RWH scheme is shown in Figure 3 and its construction photo is shown in Figure 4.

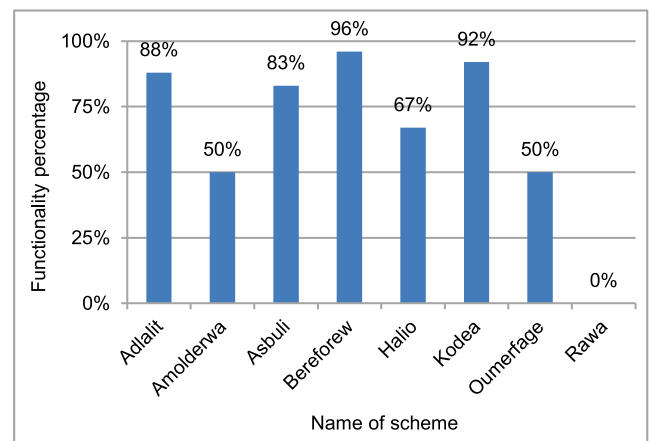
As the result has shown in Figure 5, the average functionality status of the surveyed HDW water schemes is 65.75%. The figure indicates that the schemes fall more or less in a good stance as a functional scheme which is greater than 50% [ABBOTT 2013]. Half (50%) of the schemes are almost fully functional, 37.5% are partially functional and the remaining 12.5% are non-functional.

Fig. 5. Hand-dug wells' (HDWs') schemes functionality status in percent; source: own study

The study centred on 10 non-functionality parameters for HDW schemes. As per the response of the distributed questionnaire, the maximum and the minimum weighted value of the parameters are 9.75 and 5.32 respectively (Tab. 2). These values are not such a far figure from the weighted average of all of the parameters, which is 7.94. So, all parameters have a pronounced effect on the scheme's performance and provision of continuous water supply.

As the study has shown, the lack of comprehensive water scheme investigation and study before construction is the foremost and main non-functionality parameter of HDW schemes. According to CLAYTON *et al.* [1995], a site investigation is vital to the success of any construction project, since inadequate investigation can lead to very large construction cost overruns and unexpected output. As a result, the study indicated, that due to the lack of detailed schemes investigation, Rawa HDW is dry and non-functional. As per the researcher, practical site observation and professional comment, lots of hand-dug wells in the near environment from the study area became dried because of the construction of the schemes without critical site investigation. Therefore, a detailed HDW site study and investigation have to take place before the enhancement of excavation.
