INFLUENCE OF THE REPETITIVE CORRUGATION ON THE MECHANISM OCCURRING DURING PLASTIC DEFORMATION OF CuSn6 ALLOY

This paper presents the research results of CuSn6 alloy strip at semi-hard state, plastically deformed in the process of repetitive corrugation. The influence of process parameters on the mechanical properties and structure of examined alloy were investigated. Examination in high-resolution transmission electron microscopy (HRTEM) confirmed the impact of the repetitive corrugation to obtain the nano-scale structures. It has been found, that the application of repetitive corrugation increases the tensile strength (R_m), yield strength ($R_{p0.2}$) and elastic limit ($R_{p0.05}$) of CuSn6 alloy strips. In the present work it has been confirmed that the repetitive corrugation process is a more efficient method for structure and mechanical properties modification of commercial CuSn6 alloy strip (semi-hard) as compared with the classic rolling process.

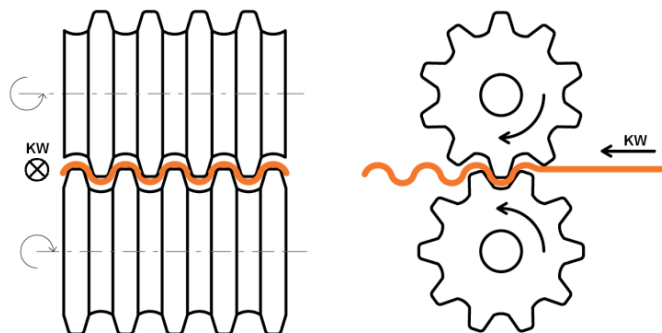
a direction transverse to the rolling direction and a pair of bending rolls for deformation of strip in the direction of rolling (Fig. 1)

Fig. 1. Layout of bending rolls

The studied material consisted on non-annealed commercial CuSn6 alloy (table 1) strips, at semi-hard strengthening state, which size is 0,75x20x130mm. To produce a series of samples a Repetitive Corrugation and Straightening plastic working station was used. The procedure consists of the set of bending and straightening rollers. The bending roller includes a pair of toothed wheels for deformation of strip in

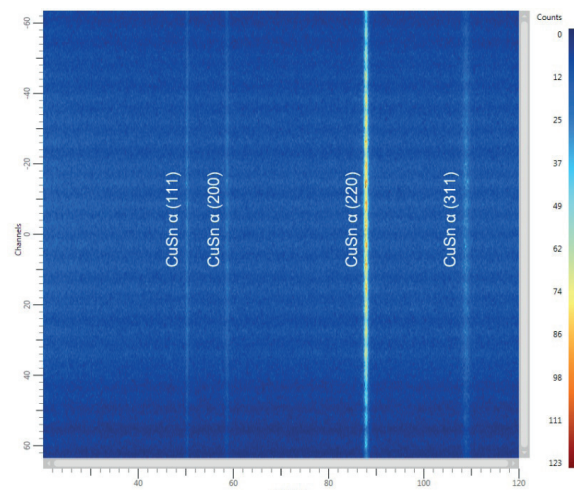
Fig. 2. Two-dimensional X-ray diffraction pattern of CuSn6 strip after repetitive corrugation process (detector PIXcel 3D)

The X-ray diffraction analysis carried out using the two-dimensional detector mode (Pixel 3D), allowed to obtain information about the structure and extent of plastic deformation of the crystal lattice of investigated CuSn6 strips. The diffraction lines of crystal planes with Miller indices (111), (200), (220) and (311), characteristic for the structure of the CuSn- α solid solution, were observed on recorded two-dimensional diffraction pattern (Fig. 2). For the strongest diffraction line (220), spots with a distinct blurring was observed the. This is the result of structure deformation consisting in the bending or twisting of the lattice of individual crystallites.

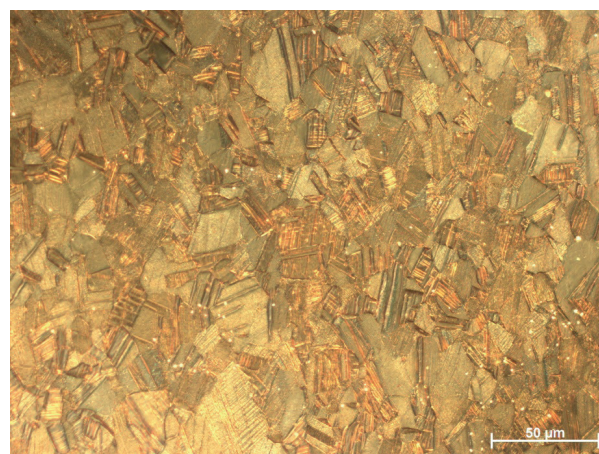
Fig. 3. Structure of CuSn6 alloy after repetitive corrugation process (magnification 500x, polarized light, optical microscope)

The microstructure of CuSn6 strip after repetitive corrugation, observed in polarized light technique and Nomarski differential interference contrast (DIC) is shown in Fig. 3 and 4. It was found that the structure of analyzed strip consists of grains of the solid solution α with annealing twins. Analyzed structures of CuSn6 strips after plastic deformation by using repetitive corrugation process are characterized by larger number of crossing slippage systems lines visible within the interior of grains. It can be assumed that unprivileged distribution of slip bands in the structure of the strip after repetitive corrugation, are the result of strengthening and block slip systems most privileged relative to the rolling direction and the gradual launching new slip systems. Another possible factor causing the increase in the number of active crystal planes involved in the mechanism of slip is critical shear stress in different directions, being the result of a complex deformation process.

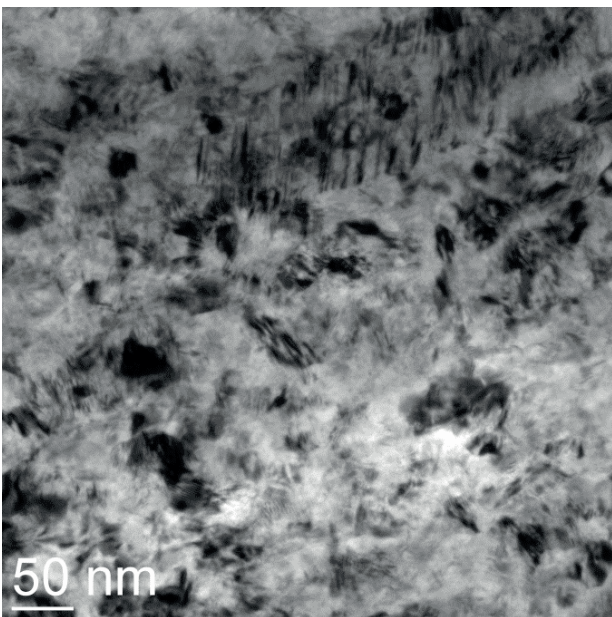
Fig. 5. Structure of CuSn6 alloy after repetitive corrugation process (TEM bright field mode, high-resolution transmission electron microscopy) [10]

The results of the high-resolution transmission electron microscope are shown in Figures 5 ÷ 9. The structure of the strip after repetitive corrugation process (Fig. 5 and 6), consists of a well-developed dislocation sub-structure. The dislocation cells are characterized in size from 10 to 100 nm, and low-angle boundaries, which in some case they evolve, by interacting with the moving dislocations and increasing of disorientation angle. This can be observe (Fig. 7) as a higher contrast of the boundaries, which is the result of accumulation and decreasing the distance between dislocations with the increasing of disorientation angle. The high-energy grain boundaries, formed in this way, are an obstacle to moving dislocations, and are a source of new dislocations. In the analysed structure of the CuSn- α solid solution, there are numerous nanometric deformation twins (Fig. 8), and the slip lines in several independent slip systems (Fig. 9).

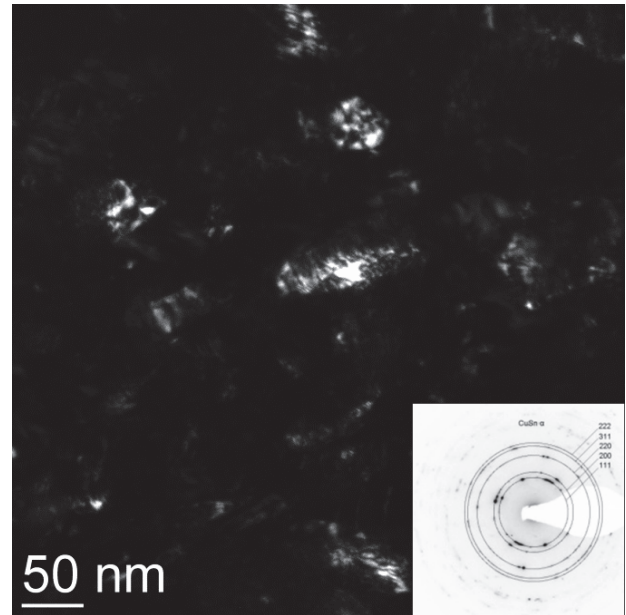
Fig. 6. Structure of CuSn6 alloy after repetitive corrugation process (TEM dark field mode, high-resolution transmission electron microscopy) [10]

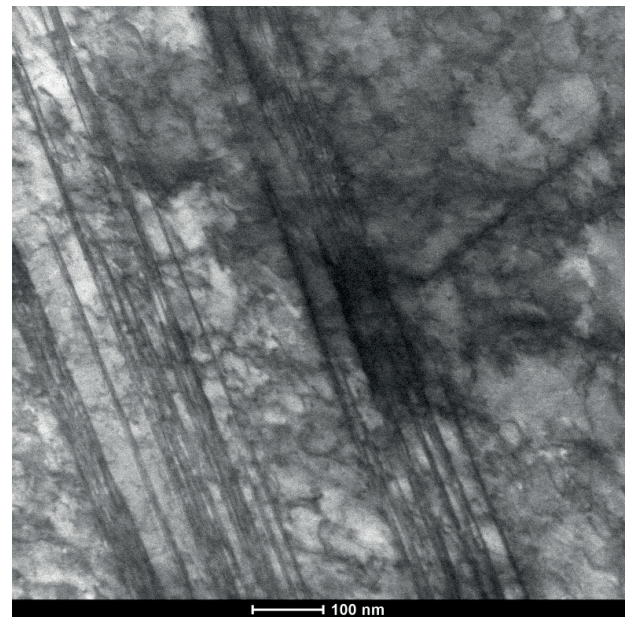
Fig. 7. Structure of CuSn6 alloy after repetitive corrugation process (STEM mode, high-resolution transmission electron microscopy) [10]

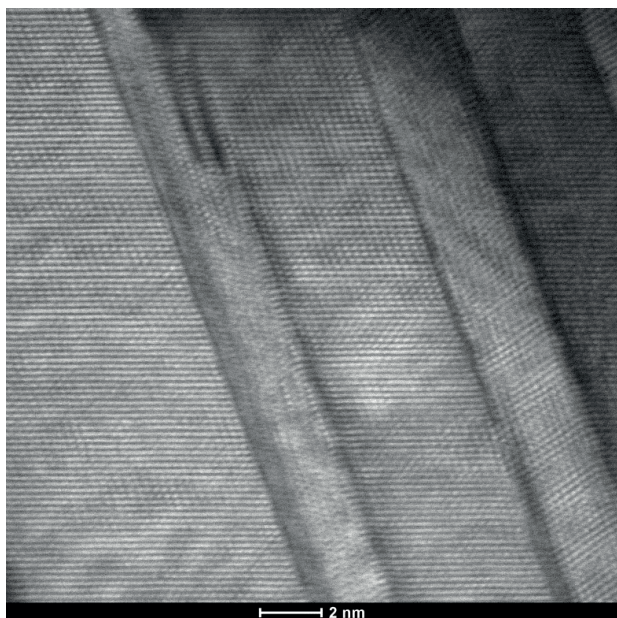
Fig. 8. Structure of CuSn6 alloy after repetitive corrugation process (STEM mode, high-resolution transmission electron microscopy) [10]

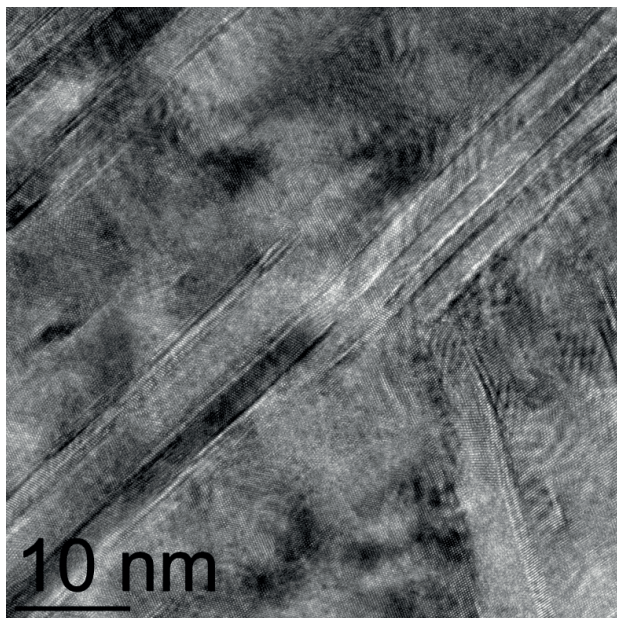
Fig. 9. Structure of CuSn6 alloy after repetitive corrugation process (HRTEM mode, high-resolution transmission electron microscopy) [10]
