STUDY OF FACTORS DETERMINANT OF SILICEOUS ELECTRICAL PORCELAIN RESISTANCE TO STRUCTURAL DEGRADATION

The subject of this study was investigation of the factors that have a decisive influence on the resistance of siliceous porcelain to degradation processes. There was tested material C 110 type, which is widely used for the production of low-voltage (LV) elements such as insulators and bushings. On the basis of mechanical-acoustic and microscopic research of small-sized samples, which were subjected to compression, there were distinguished successive stages of degradation of the material structure. In the authors' opinion, they have a reference to the ageing process, taking place during many years of work under operating conditions. Thus, it was possible to assess the structural factors that determine the durability and reliability of LV electroinsulating elements. The results were related to electrical aluminous porcelains.

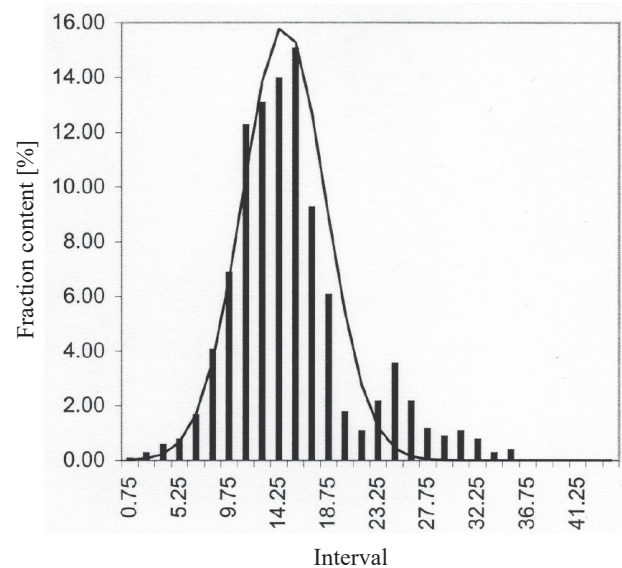
Fig. 1. The size distribution of quartz grains in the tested porcelain. The vertical axis - fraction content in percent, along the horizontal axis - an interval of particle size in microns. The distribution is dominated by two fractions - the size of a dozen or so and 20 - 30 μm . The value of the average is 14.7 μm

The content of quartz was equal to $20 \pm 2\%$. Considering the size of quartz grains – explicitly dominated fraction of dozen or so micrometers, nevertheless a significant part constituted the relics in the range of $20 \div 30$ μm . Figure 1 presents distribution of the quartz grains diameter. Unfavorable phenomenon was the presence of agglomerations of larger quartz grains. Additionally, a significant part of the relics exhibited disadvantageous lamellar morphology. In the structure of majority of electrical porcelains, the quartz phase is mainly responsible for internal stresses and the initiation and development of cracks. This is the basic cause of increasing ageing processes with time passing. Significant part of quartz grains contained cracks and was insufficiently associated with matrix. As a result a substantial part of relics fell out during the preparation of surface of the tested samples.

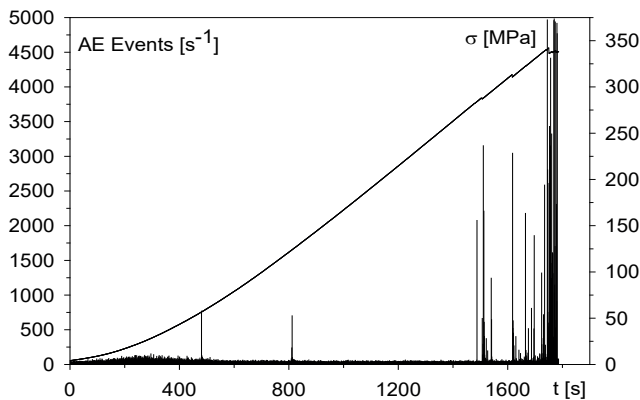
Fig. 3. Mechanoacoustic characteristics of the weakest specimen - compressive strength equal to 342 MPa. Linear scale of AE events

The mechanical-acoustic characteristics of the individual samples demonstrated considerable diversity. Nonetheless, there were recognized characteristic, successive stages of degradation - the preliminary, the subcritical and the last - critical stadium. Figure 3 presents the course of the rate of AE events versus the increase of compressive stress for the weakest sample. Figure 4 represents the rate of events energy of the other specimen.

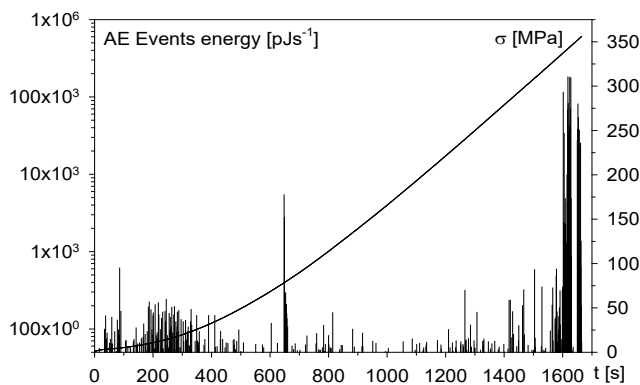
Fig. 4. The rate of events energy in one-second intervals as a function of the stress increase for the sample destroyed at 351 MPa. Logarithmic scale is used for the EA descriptor

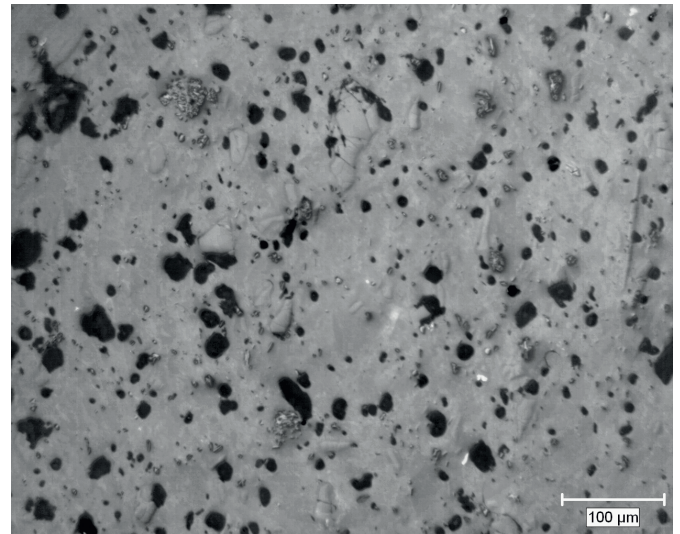
Fig. 5. The structure of siliceous material loaded up to the preliminary stage of degradation, magnification 200x. Numerous damages and crushed out grains of quartz are visible. Dark cavities cover about 10% of the surface

and crushing out of quartz grains was the source of AE signals. This effect referred particularly to the small grains - of the size of several microns. Susceptible to degradation were the grains with a lamellar morphology. The most resistant to failure and separation from the matrix were the grains of a middling size between 20 and 30 mm, distinguished by the regular shape and typical morphology. Besides quartz, there occurred crushing out of almost all particles of cullet. Mullite precipitates were not affected by degradation. They had a coherent structure and were well combined with the glass matrix. Damaged and crushed out elements of the structure covered over 10% of the area of tested surfaces of the stressed samples. In figure 5 is presented material of the sample loaded up to 60 MPa.

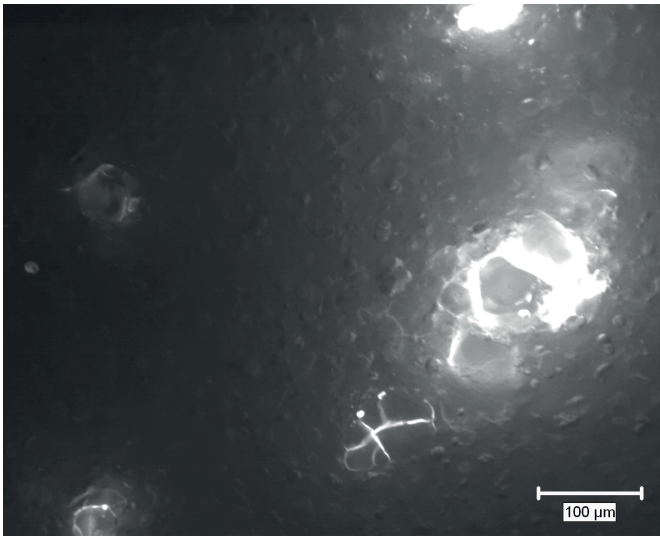
Fig. 6. Microscopic image of the material of the sample loaded up to 387 MPa, in UV light, at a magnification of 200 times. There is visible the area of loose structure - a cluster of large grains of quartz and distinctive grain cracking. Resin with addition of a UV fluorescent was used

Image analysis of the samples loaded up to 285 MPa and 387 MPa showed that further, relatively small degradation - in a wide range of stress - undergoes only the quartz phase. Circumferential and internal cracks are generated and increase in the grains. Thorough examination, using UV light, proved that in the material structure occur centres of cracks. These are the regions of loosened structure - the agglomerations of the larger grains of quartz, which crack with increasing stress and are being separated from the glassy phase. The cracks that can propagate into the matrix are initiated in these regions. These cracks, growing gradually in the matrix, are one of the most important factors in the process of degradation. Their rapid rise takes place during the critical stadium and leads to the sample destruction. Figure 6 presents the area of loose structure - the center of large cracks in the material of the sample, loaded up to 387 MPa.

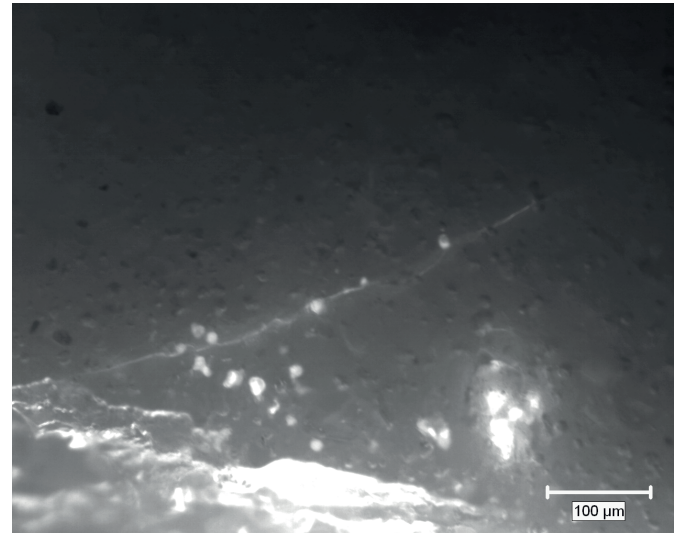
Fig. 8. Microscopic UV light picture of the material of the sample loaded up to 285 MPa, at a magnification of 200 times. The area in the immediate vicinity of the broken off fragment is visible. In addition to cracking, takes notice characteristic area of loose structure at the bottom right of the image. It is clearly visible due to applied resin with added fluorescent agent, visible under UV light

Sometimes, during the subcritical stage, a local fracture and splitting off the corners or even the whole wall of the stressed sample can occur. This effect is followed by strong AE signals, and is visible on the stress increase curves as a characteristic faults (leaps) – Fig. 3. In the vicinity of the broken off portion are then shaped large cracks. However they are typical for the critical stadium of degradation. Figure 8 shows a marginal area of the sample, loaded up to 285 MPa, in the area adjacent to the separated portion of the wall. Visible large cracks are not characteristic effect of the subcritical stage. There is also evident the typical area of loose structure.

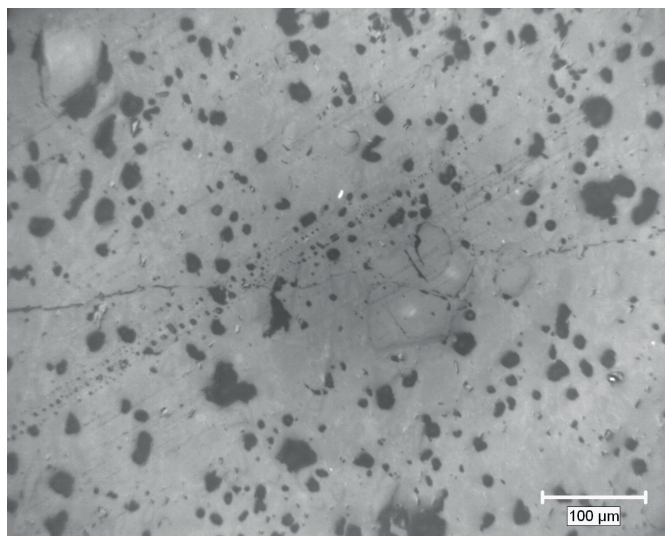
Fig. 9. Heavily fractured microstructure of the strongest sample fraction, at a magnification of 200 times. Separated and crushed out elements of the structure comprise about dozen percent of the surface

In the case of the sample with the highest strength (469 MPa), the agglomerations of the larger grains of quartz, forming a loose structure centers, occurred very rarely. The homogeneity of the material, observed in micro and semi-macro scales, was high. Therefore, the mullite phase distribution was the most advantageous, although very small number of individual crystals of mullite in the glassy matrix – typical for such type materials. This structure showed high resistance to compressive stress, even higher than in the case of the typical strength of aluminous C 120 kind material of the traditional, older type - generally about 400 MPa (in the case of modern material - over 500 MPa) [4]. Figure 9 shows the highly cracked microstructure of the fraction of the strongest sample. Beside the distinctive macro-cracks, plurality of the parallel cracks of the matrix are visible. Characteristic course of the cracking is a reflection of the loading direction.

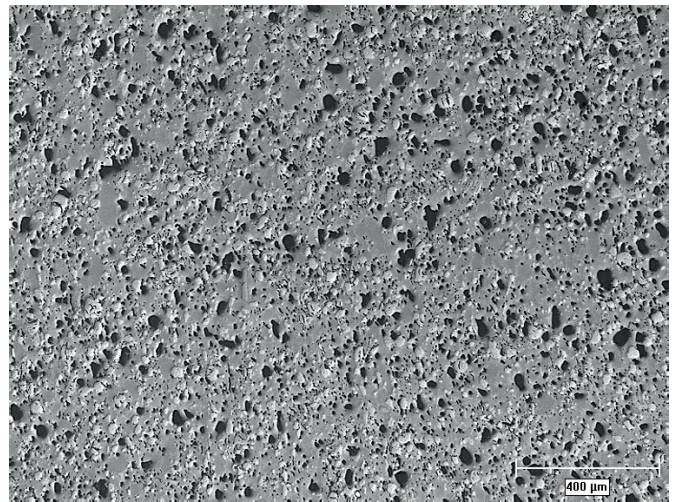
Fig. 11. The image of C 120 type porcelain of HV line insulator after about 30 years operation period, at a magnification of 50x. The effects of the degradation of the structure appropriate to the subcritical stage, with a high degree of advancement. Over 1/3 of the quartz grains (nearly 9%) was separated and crushed out from the structure. In the vicinity of the relics of quartz are present numerous micro-cracks in the glassy matrix

disintegration. In figure 11 is presented typical image of aged aluminous material of domestic line insulator after about 30 years operation period. Advanced degradation processes are visible. They are a consequence of high and diversified amount of the quartz phase in the material structure - initial average content 24%. This phase was the main source of internal stresses, initiation and growth of micro-cracks.
