THE PROPERTIES OF TERRESTRIAL LASER SYSTEM INTENSITY IN MEASUREMENTS OF TECHNICAL CONDITIONS OF ARCHITECTURAL STRUCTURES

Terrestrial laser scanning (TLS) is one of the instruments for remote detection of damage of structures (cavities, cracks) which is successfully used to assess technical conditions of building objects. Most of the point clouds analysis from TLS relies only on spatial information (3D–XYZ). This study presents an approach based on using the intensity value as an additional element of information in diagnosing technical conditions of architectural structures.

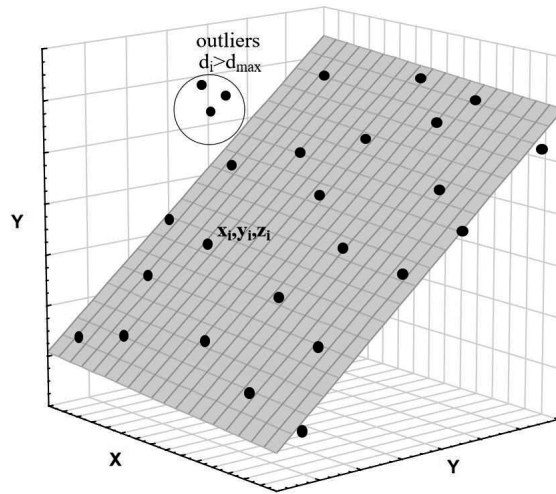
To locate defects on flat surfaces one can use an algorithm based on *Mean Sum Error* (MSE) presented by Chen [17]. A regression used in this method enables to find an optimal reference surface $Ax + By + Cz + D = 0$ of the analysed area, obtained from the measurement data in the form of a cloud of points (x_i, y_i, z_i) . The discussed surface fulfils the condition $\sum_{i=1}^n d_i^2 \rightarrow \min$, i.e. that the sum of distances of all measurement points from the analysed surface approaches minimum. Next, the distances d_i of all points from a reference surface are calculated. Imperfections are located by selecting all data out of the cloud of points which do not meet the criterion $d_i \leq d_{\max}$. The value of d_{\max} depends on the depths of the projected imperfections and is specified by an individual user. The concept of functioning of the algorithm is presented in Fig. 1.

Fig. 1. A scheme of the MSE method.

This method requires the undamaged surface of the analysed area to constitute a larger part than the defected one to make the determined reference surface close to the undamaged area. There are some limitations of this approach. Therefore, the reference surface in chosen cases might be determined by manual indication of a selected area which is free of damages. It needs to be stressed that the presented algorithm will precisely detect cavities in the plane surfaces of a structure. In the case of more extensive flat surfaces this condition may not often be fulfilled, so it is advisable to divide them into sub-areas and analyse them separately. The value of the interval of the horizontal and vertical division of the analysed surface is determined by surface unevenness and it is specified individually for each object.

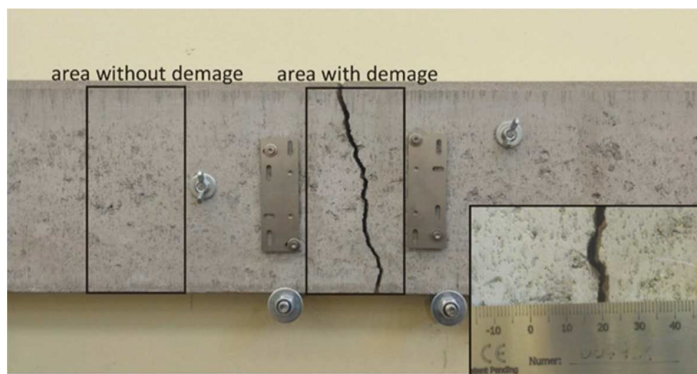
The measurements were carried out on a concrete specimen with a crack (1.00×0.25 m) and from a distance of 10 meters using the maximum scanning resolution. The aim of laboratory tests was to verify the theoretical assumptions that the power of laser beam reflectance will differ in the area on which the specimen has been damaged (cracked) from the undamaged ones, as well as to assess the effectiveness of automatic detection of defects on a concrete surface by the use of the MSE method. The tested specimen on which the statistically analysed and compared areas have been marked is presented in Fig. 4.

Fig. 4. The tested concrete specimen.

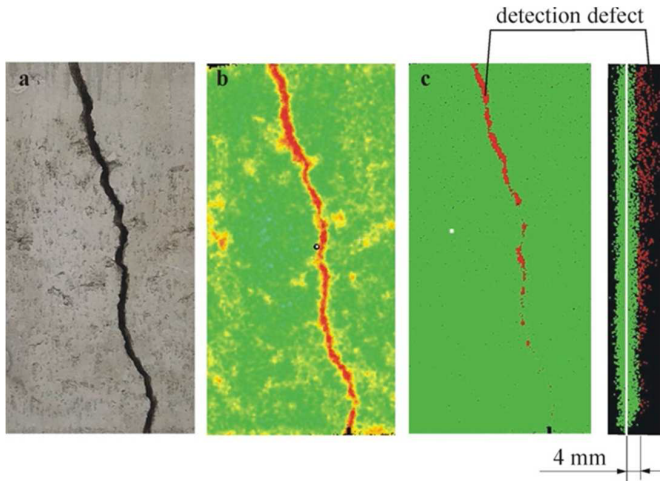
Figure 6 shows a photo of a defect (a), the intensity data (b) and the identified set of points with defects (c).

Fig. 6. A cloud of points of the tested concrete specimen.

The analysis of Fig. 6 leads to the conclusion that the algorithm properly detected the set of points included in the cracked area.

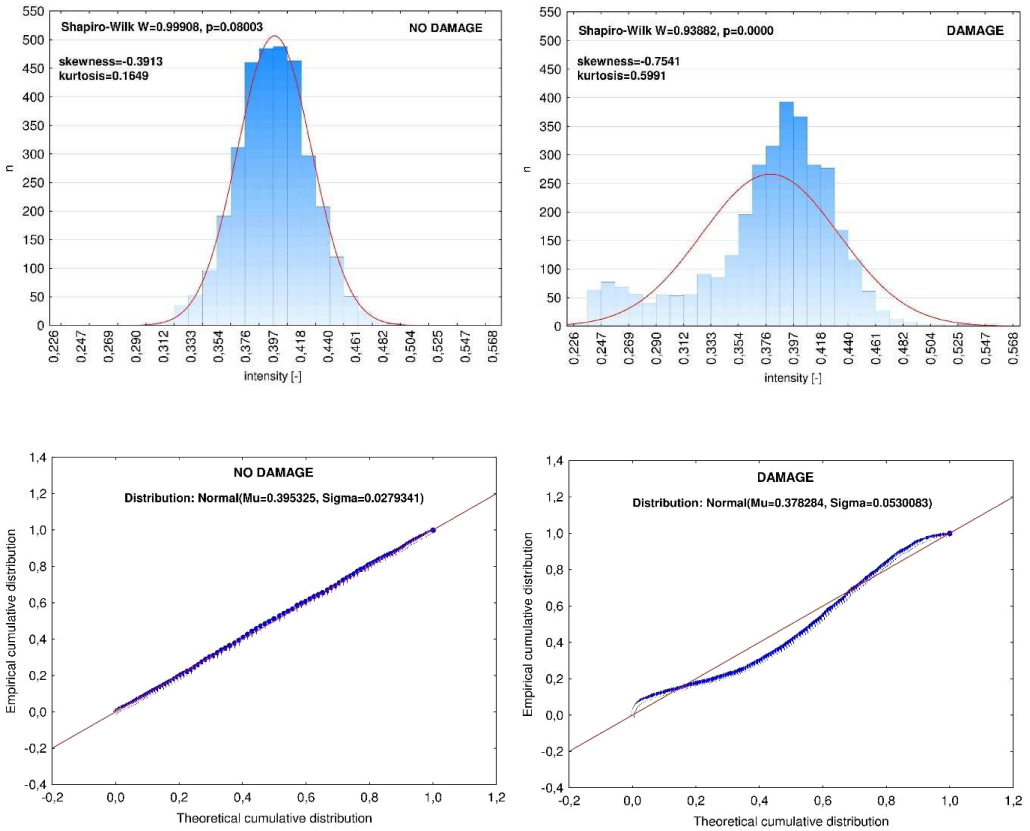
The next phase of the examination was to analyse the distribution of intensity for the successive points on the areas with and without damages. Histograms of distributions of power intensity values for both areas and probability-probability plots are presented in Fig. 7. The horizontal axis presents the intensity values divided into 25 even categories, the vertical axis – their numbers (n).

Fig. 7. Histograms of intensity value distributions and probability-probability plots of areas without and with damages.

The decrease of the power of laser beam reflectance in the area where the specimen is cracked is caused not only by the change of roughness and colour, but also by surface discontinuity, resulting in so a called “edge effect” [29]. In this case the power of laser beam reflectance slightly decreases.

When analysing visually the histogram of the intensity coefficient value for the area without defects we may observe that it has an even distribution which might be regarded as a distribution close to normal. The probability-probability plot also indicates a very good match of empirical and theoretical distribution functions as all points are positioned on a diagonal. The additional Shapiro–Wilk test for distribution normality resulted in $p = 0.08003$. According to this test, when the obtained value reaches $p > 0.05$, the distribution is normal. In the case of area with damages the situation is reversed. From the visual analysis of the histogram and the distribution of points on the probability-probability plot we may positively conclude that no normal distribution was confirmed by the Shapiro–Wilk test ($p = 0$).

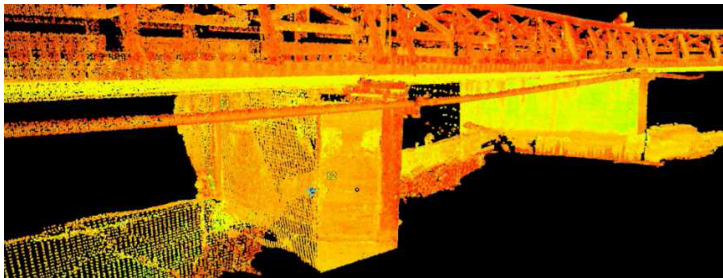
The second phase of research was carried out in the field conditions. The measured object was situated in Vilnius, Lithuania (Fig. 8). The object was characterized by a poor technical state, and for diagnostic purposes it was analysed with the use of TLS.

Fig. 8. A cloud of points of the examined object.

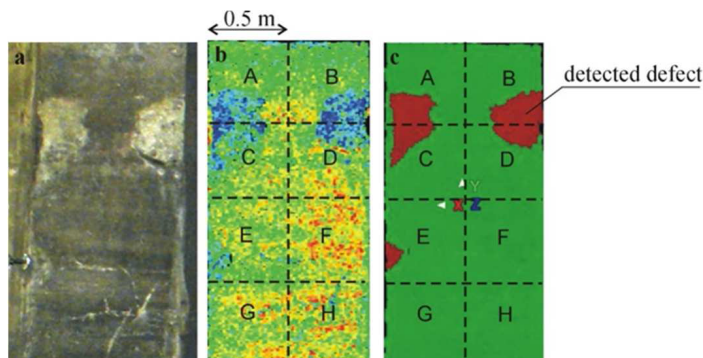
Due to the data standardization the change of the power of laser beam reflectance was mainly dependent on the change of the reflective properties of the scanned surface. Owing to the fact that the pillar surface significantly deviated from planeness, it was divided into 8 parts, each of which was analysed with the use of MSE method, taking the value $d_{max} = 10$ mm (see Fig. 1). The result of the described algorithm is presented in Fig. 9. The separated set of data on the cavities

is marked in red. Additionally, a real photo is presented (Fig. 9a) and an image with the intensity values of the cloud of points (Fig. 9b).

Fig. 9. a) A real photo; b) an image created by TLS using artificial colours for intensity and c) the identified set of points with defects.

Comparing, with the use of MSE method, the identified set of data located on the cavities (Fig. 9c) with the real photo (Fig. 9a) enables to conclude that the algorithm properly identified the defects. Moreover, it may be easily noticed that there is a change in intensity of the laser beam reflectance at the places of defects and beyond them (Fig. 9b). Fig. 10 presents histograms of intensity value distributions using 35 categories for eight analysed areas. Fig. 11 presents probability-probability plots.
