Research paper

Assessment of large-panel prefabricated buildings in the social aspect of sustainable construction

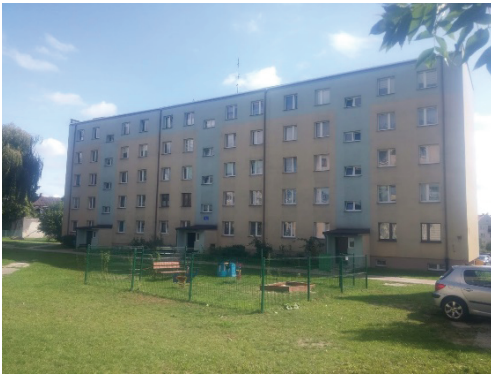
Fig. 1. Residential building (Kielce-Szczecin technology) Jędrzejów, st. B. Krzywoustego 8, 22.09.2019

The research was carried out in 2019 in 109 completed buildings in large-panel technology, which were created in 1958–1992 in Jędrzejów (Świętokrzyskie Voivodeship – Fig. 1) and Cracow (Lesser Poland Voivodeship). In addition to conducting direct surveys among residents, thanks to the courtesy of the cooperative employees, it was also possible to reach the technical documentation of the examined facilities and consult the maintenance and operation policy with technical employees.

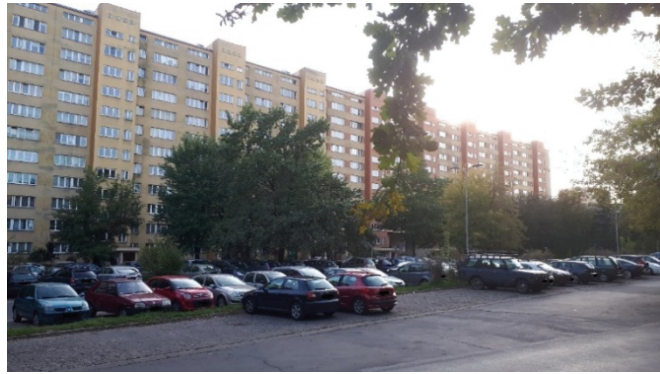
Fig. 2. The longest residential building located in Cracow at the Kościuszko 6 estate, 22.09.2019

Based on the technical data of the buildings, it was established that the tested objects were made in different technologies, i.e.: OWT – 75, W- 70, W-70 MK, WK- 70, WUFT – 67, WUFT – 68, WUFT – 69, PGS Skawina, Żerań, Świętokrzyska, Kielecko- Szczecińska. Large variations can also be seen in the volume. The smallest buildings have approximately 3660 m³, and the largest has a volume of 106 477 m³. Similarly, blocks with the smallest volume, have 20 apartments, the largest (the longest residential block in Krakow) has 474 apartments (Fig. 2). The number of residents was not possible to specify, because the number of people enrolled in the documents of a given housing association differs from reality, especially due to the numerous migrations and rental of housing. According to the data recorded in housing cooperatives, the number of inhabitants exceeds the standards set out in the Journal of Laws No. 75, 2002 concerning housing categories.

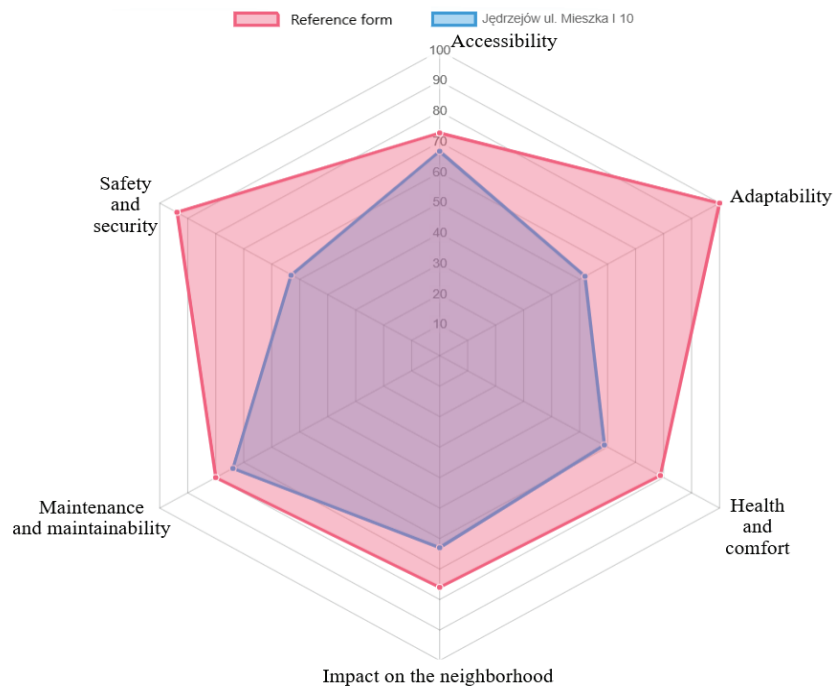
Fig. 4. Graph in the form of a spider's web of a building located at street Mieszka I 10 in Jędrzejów

In addition to the rating according to the table, the application generates charts in the form of a spider's web illustrating the ratings of individual categories and subcategories against the background of the maximum and reference rating. An exemplary list of grades and a graph are presented in Fig. 4.

By compiling detailed assessment results, it is possible to determine the weakest points of the examined object. Partial data on the object's compliance with social properties may help in the later planning of a rational renovation and modernization policy of the examined buildings.

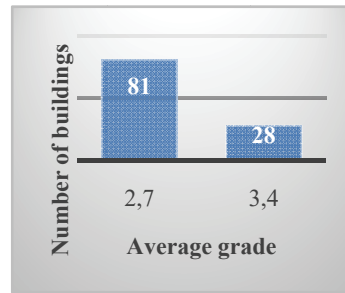
Fig. 6. Ratings obtained in the adaptability category

In category K_2 **Adaptability**, only two values of average building ratings were obtained: 2,7 and 3,4. These results depend on the height of the buildings, which is associated with the then regulations for the installation of elevators in buildings over 5 floors. 81 low buildings (5 floors and below) were tested – average 2,77 and 28 high buildings – average rating 3,4 (Fig. 6).

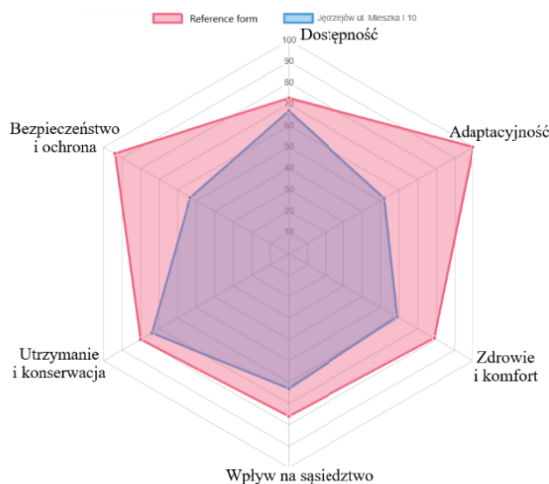
Rys. 1. Wyniki oceny socjalnej budynku z WP (Jędrzejów, ul. Mieszka I/10)

Na rys.1 przedstawiono wyniki podstawowych kategorii oceny socjalnej przykładowego badanego budynku, na tle oceny budynku wzorcowego/referencyjnego, a na rys. 2 średnią ocen poszczególnych kategorii dla wszystkich badanych budynków.

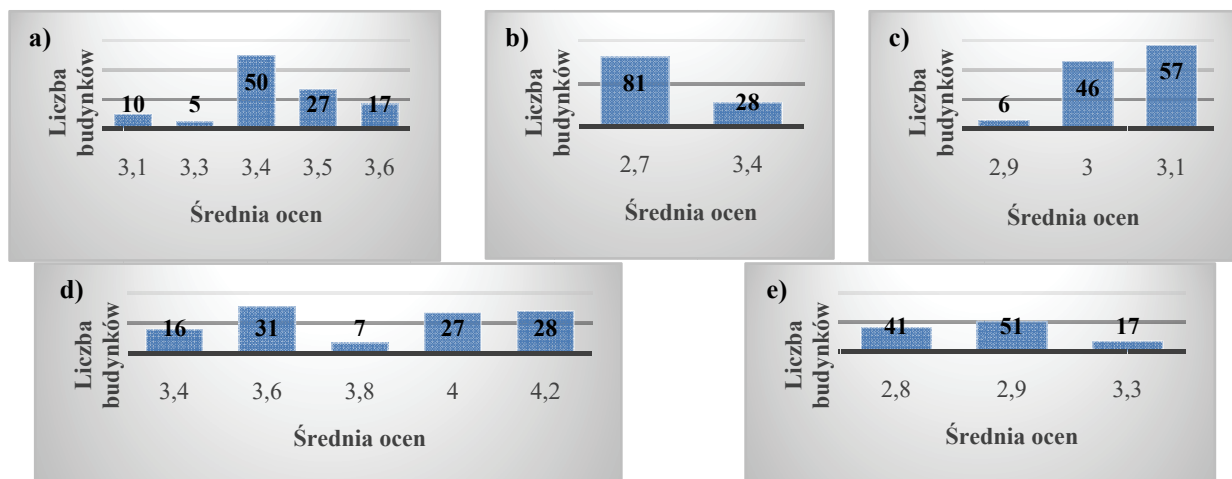
Rys. 2. Uzyskane oceny w kategorii: dostępność (a), adaptacyjność (b), zdrowie i komfort (c), utrzymanie i konserwacja (d), ochrona i bezpieczeństwo (e)

Badania wykazały, że większość budynków z WP uzyskała oceny poszczególnych kategorii socjalnych średnio ~ 3 w 5-stopniowej skali. Mimo wielu trudności w likwidacji występujących niedogodności podczas ich użytkowaniu (np. w wyposażeniu w windy, w adaptacji pomieszczeń), dobra lokalizacja osiedli z WP, ich wyposażenie w infrastrukturę społeczną (szkoły, przedszkola, przychodnie, lokale handlowe i usługowe) i rekreacyjną (domy kultury, place zabaw, zielen) dają zadowalającą łączną ocenę socjalną i przekonanie, że jeszcze przez wiele lat mogą dobrze służyć ich mieszkańcom. Jakkolwiek należy mieć świadomość kosztów, jakie niosą wszelkie zmiany w eksploatowanym już obiekcie. Na podstawie tych badań możliwe jest ustalenie najsłabszych punktów badanego obiektu. Częstkowe dane dotyczące spełnienia przez obiekt właściwości socjalnych mogą pomóc w planowaniu racjonalnej polityki modernizacyjnej badanych budynków.
