DOI: <https://doi.org/10.24425/amm.2022.141060>A. WILCZEK<sup>1</sup>, J. MORGIEL<sup>2\*</sup>, A. SYPIEŃ<sup>2</sup>, M. POMORSKA<sup>2</sup>, Ł. ROGAL<sup>2</sup>**SEM/TEM INVESTIGATION OF DEGRADATION OF BI-LAYER (Cr,Al)N/Cr<sub>2</sub>N<sub>3</sub> DUPLEX COATINGS EXPOSED TO ALSi ALLOY HIGH PRESSURE DIE CASTING CYCLES**

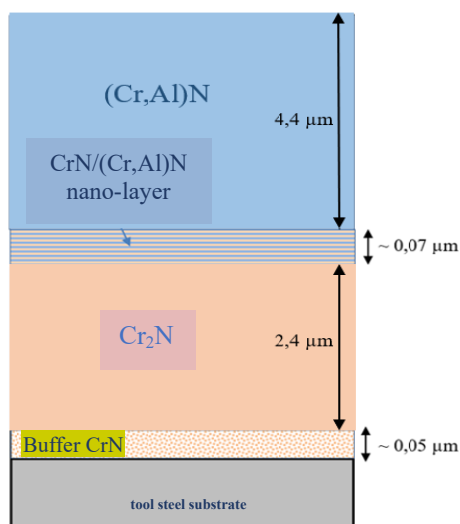
Fig. 1. Schemes of the CrAlN coating and of the investigated pin with marked places of the high (C1) and low (C2) flow of liquid aluminium alloy

within the coating and of the investigated pin with marked places of fast and low flow of the liquid AlSi alloy, i.e. 40 m/s and 7 m/s respectively were presented in Fig. 1, as well as its image taken after arc deposition process with the CrAlN is presented in Fig. 1.

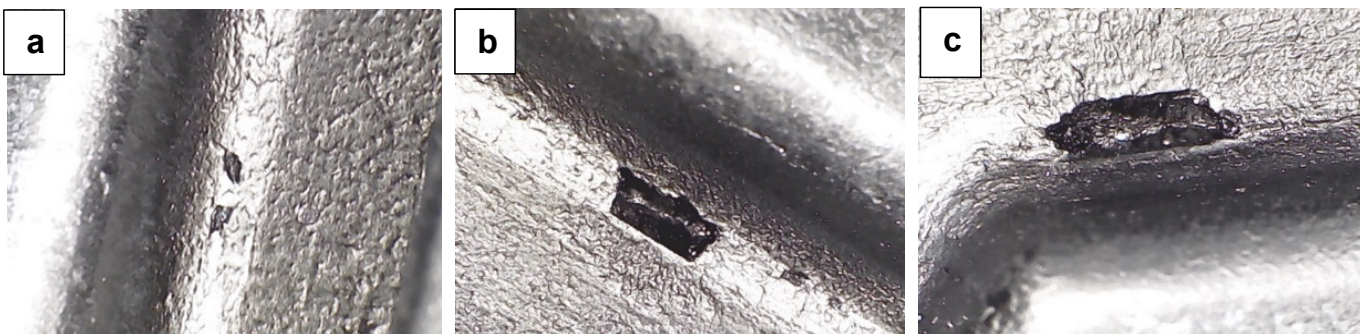
more damage (local chipping/ crumbling-outs of the substrate) was noted at the edges of the pin (Fig. 3). Even so the coating allowed to extend the die lifetime up to 3.6 times as compared with quenched and nitride one.

Fig. 3. Images documenting small (a) medium (b) and large (c) chipping damage to the pin surface after 19 500 injections (please note cracks spreading from the latter one)

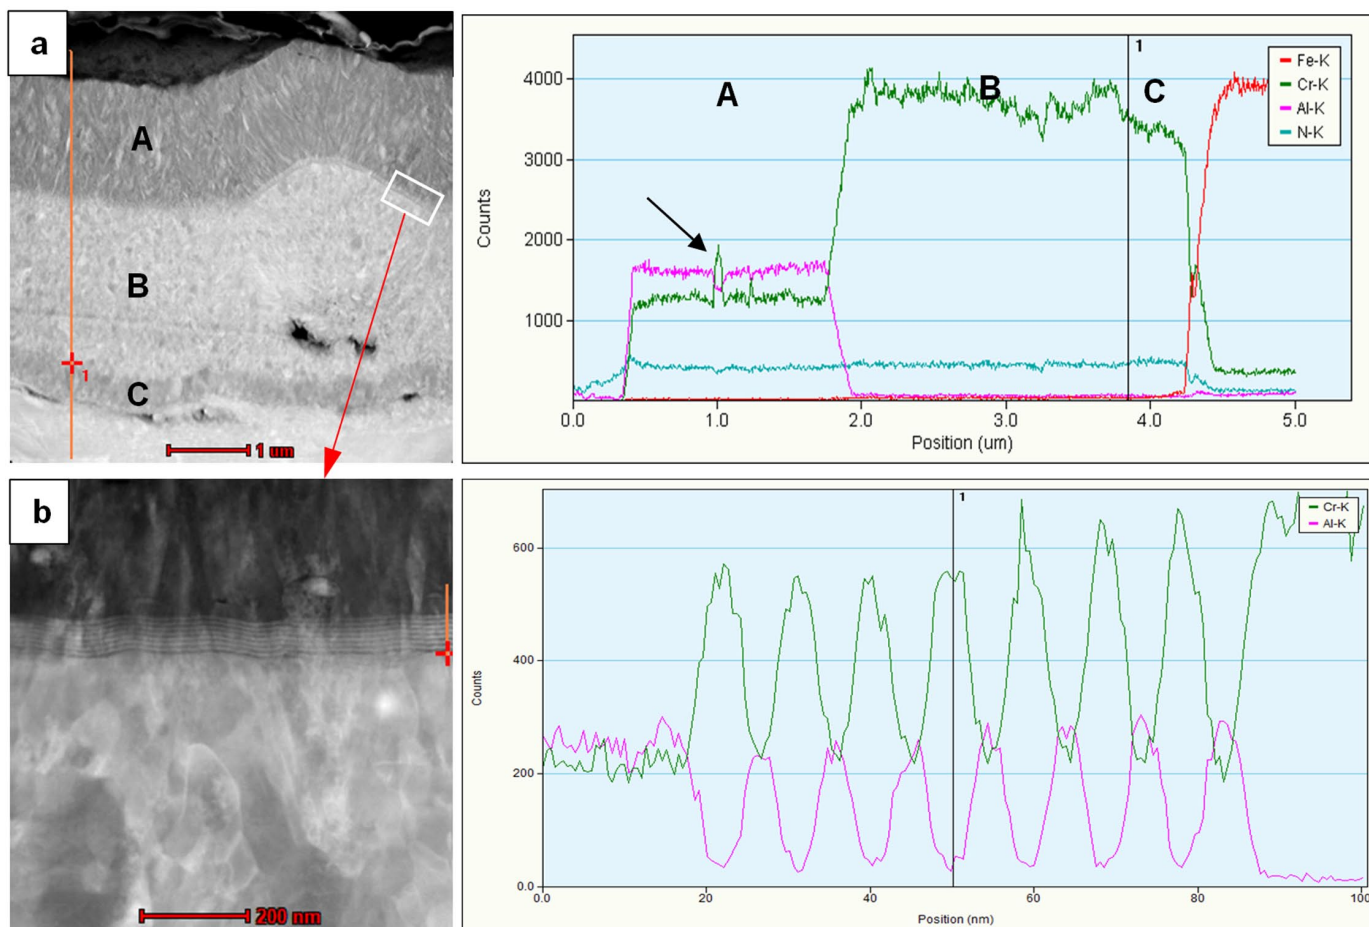
Fig. 5. STEM/HAADF image of cross-section of as deposited coating and accompanying profiles at medium (a) and high magnification of the bi-layer interface with adjoining profiles presenting distribution of N, Al, Cr and Fe along the line marked on the image. Position of the cross on this line is tied with that of the vertical line on the left marking the buffer/bottom layer interface. Black arrow pointing to local maximum in chromium concentration pinpointing position of chromium droplet buried in CrAlN layer

The STEM/HAADF observations of FIB lamella prepared from as-deposited coating helped to establish that the thickness of the bottom one (marked as B) is close to 2  $\mu\text{m}$ , while of the upper one (marked as A) only  $\sim 1.5 \mu\text{m}$  (Fig. 5a). In between both layers an intermediate thin ( $< 100 \text{ nm}$ ) nano-layer was inserted, while at the interface with the substrate a visibly thicker buffer layer ( $\sim 0.5 \mu\text{m}$ ) was deposited. A darker features at the buffer/substrate interface might be either pieces of glass beads imbedded in to it during the cleaning procedure or just some close porosity. The adjoining profiles presenting distribution of the elements of coating confirmed that starting from the substrate side it consist of Cr lean chromium nitride followed by Cr rich chromium nitride and finished with aluminium-chromium nitride. The local changes of chemical composition, like the one pointed by the arrow on the profile adjoining the Fig. 5a, are caused from presence of droplets imbedded in the layers. The high magnification STEM/HAADF image obtain from the interface between both the bi-layers showed that they are connected by a packet of nano-layers (Fig. 5b). The accompanying EDS profile helped to establish that the nano-layer composition changes accordingly to (Cr,Al)N/CrN formula.
