## Research paper

# A study of landslide body control of black bovine cave copper ore mining and beneficiation project

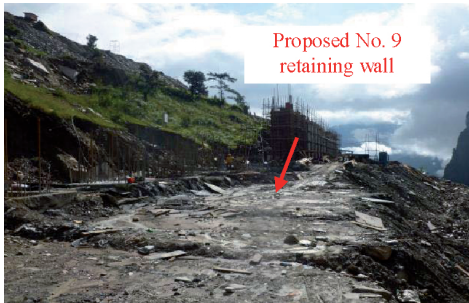
Fig. 2. Photo of No. 9 retaining wall at the leading edge of the landslide Fig. 3. Collapsed slope inside No. 9 retaining wall

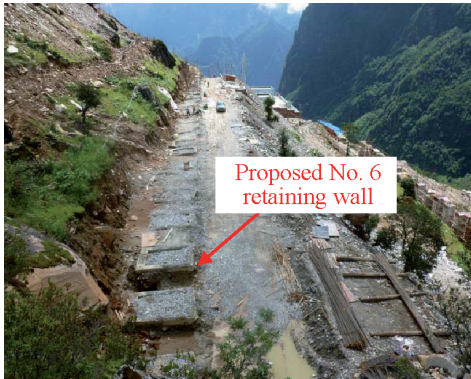
Fig. 4. Backfill of anti-slide pile holes with pebbles

of No. 4 and No. 6 retaining walls were obviously inclined and sank. In order to prevent the landslide from causing severe landslides, the construction unit has immediately backfilled the excavated anti-slide pile holes (see Fig. 4). The 1.0–3.5 m high obvious back wall can be observed at the rear edge of the landslide (see Fig. 5). The retaining wall for the road at the rear edge of the landslide is deformed and damaged, and the cracks in the wall body have been basically penetrated.

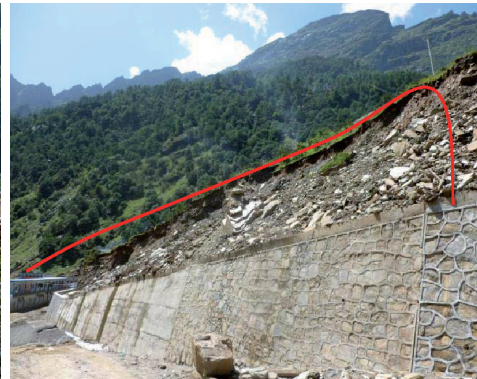
Fig. 5. Back wall of the landslide

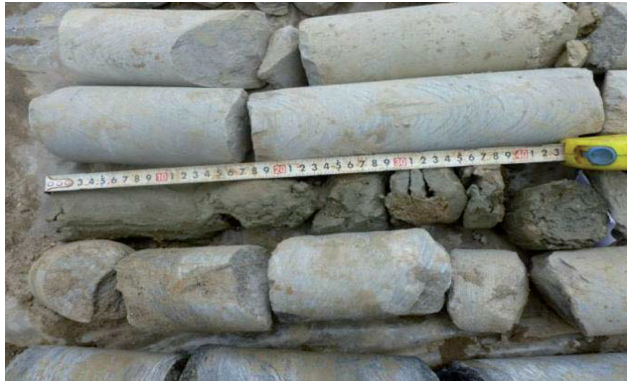
Drilling reveals that the sliding zone is mainly located in the Quaternary Qedol. The soil in the sliding zone is silty clay with gravels (see Fig. 6) with a thickness of 0.3–0.7 m. It is slightly wet to wet, and plastic. The soil in the sliding zone is slightly squeezed with crumpled traces.

Fig. 6. Core of the sliding zone
