## Research paper

# The influence of maintaining proper technical condition on the aging of multi-family residential buildings constructed in traditional technology

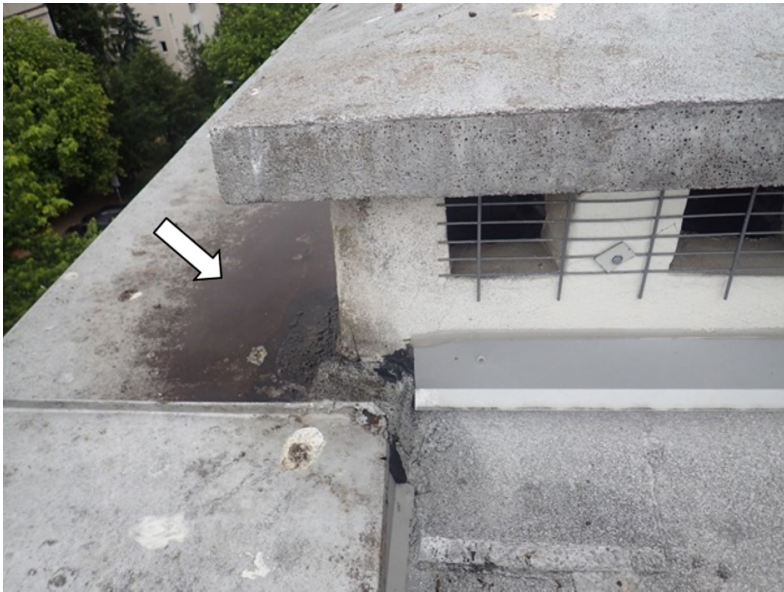
Fig. 1. Steel flashing of the attic at the chimney made in a way that prevents water from flowing out. There was moisture on the façade below

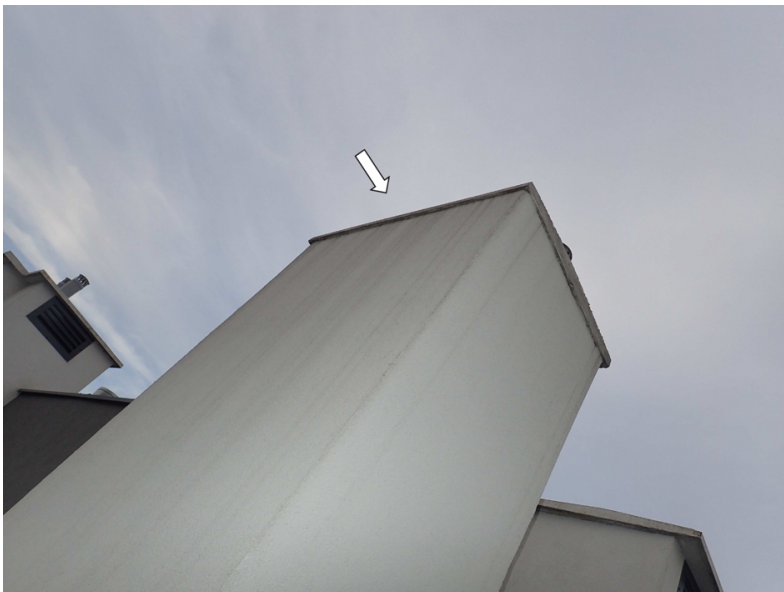
Fig. 2. Chimney caps with too small a drip causing stains on the chimney shaft

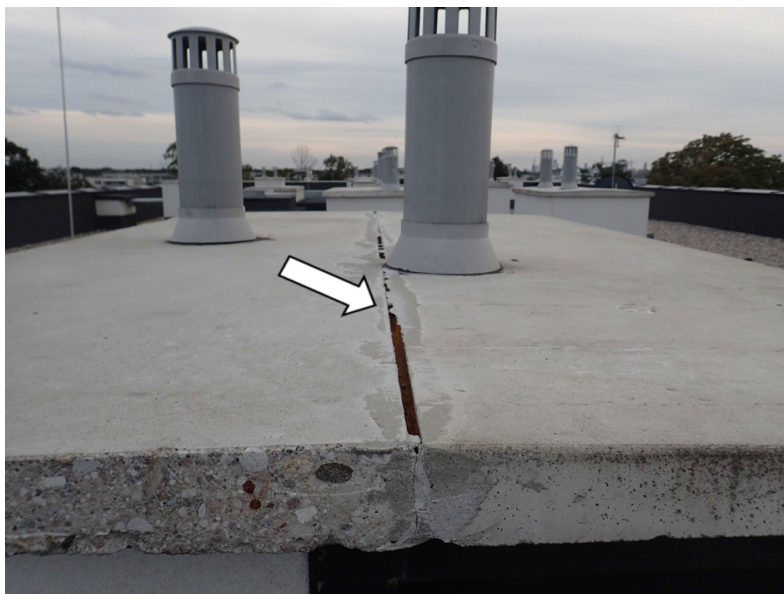
Fig. 3. The chimney cap is made of two prefabricated concrete slabs. Plates are not connected to each other, which let water inside the chimney
