# Experimental and numerical verification of the standard procedure for determining the load capacity of GFRP composite lighting columns

## Mirosław Broniewicz<sup>1</sup>, Filip Broniewicz<sup>2</sup>, Elżbieta Broniewicz<sup>3</sup>

Abstract: The main objective of the research was to validate the method for determining the load capacity of GFRP composite lighting columns under horizontal loads according to the EN 40-3-3:2013 standard. The work involved developing a numerical model of GFRP composite columns with an inspection hole while accounting for the columns' nonlinear behaviour before the failure phase. The model was verified by testing 11 GFRP lighting columns on a natural scale and material testing of the composite. A calculation method was used in accordance with the standards EN 40-3-3:2013 and EN-40-7:2002 to determine their bending resistance. It was discovered that the load capacity estimated experimentally is two to three times less than the load capacity estimated using the standard's procedure. Also, the load capacity calculated based on the developed numerical model of the column is about 2.5 times lower than the characteristic load capacity calculated based on

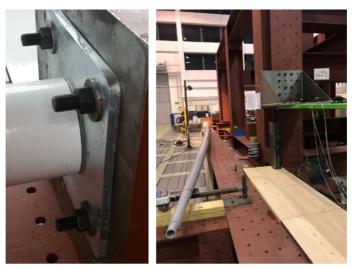
Fig. 4. View of the pole on the test stand

of the poles. S235JR steel, which has a tensile strength of 360 MPa and a yield strength of 235 MPa, is used to construct the base plates of GFRP lighting columns. Dimensions of the base's horizontal plate were  $295 \times 295 \times 10$  mm. A fillet weld with a thickness of 4 mm was used to join a stub made of a steel pipe measuring  $114.3 \times 4$  mm and 500 mm in length to the sheet. There were 200 mm-spaced holes for anchor bolts with a diameter of 22 mm in the base's horizontal sheet. S355 steel M20 plate anchors are available to secure the column to the foundation. Figure 4 depicts the column's view on the test stand.

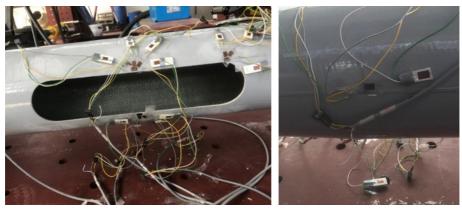
Fig. 5. Arrangement of measuring strain gauges

Strain gauges were installed on the compression side of the columns, on the external and internal surface of the wall around the inspection opening, and on the tension side, opposite

the opening. Three strain gauges were glued in each place to measure deformations in the longitudinal, circumferential and 45-degree directions (Fig. 5).
