# Sustainable rehabilitation of urban sewers using in-situ lining techniques

**Abstract.** This article investigates the impact of service-induced imperfections in underground pipelines on the structural performance of pipelines rehabilitated using Cured-In-Place Pipe (CIPP) technology. The novelty of the implemented research program is the expansion of knowledge regarding the safe use of pipelines, which in turn has a direct impact on the reduction of the number of failures of transport infrastructure. These irregularities in pipelines directly contribute to increased energy consumption in sewage treatment operations, higher exhaust emissions due to reduced vehicle speeds that are caused by infrastructure failures, and the elevated operational costs associated with road traffic disruptions. Therefore, maintaining underground pipelines in a proper technical condition is an extremely important issue that directly affects energy consumption. CIPP technology, which is the subject of this paper, can be classified as an eco-friendly urban solution that can reduce this consumption. Thanks to the data collected during the implementation of the laboratory tests described in this paper, it

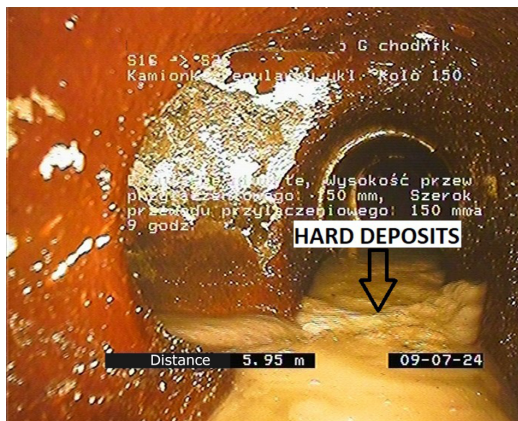
Fig. 2. Example of hard deposits

- deformations of the cross-sections of conduits, which are due to structural cracks (Fig. 1),
- reductions in the diameter of conduits, which result from the accumulation of hard sediments (Fig. 2). This in turn has an influence on the deterioration of hydraulic parameters,
- longitudinal and transverse crumbling of conduit walls. In the case of conduits made of brittle materials, this may lead to the failure of both the network and the surrounding infrastructure (Fig. 3).

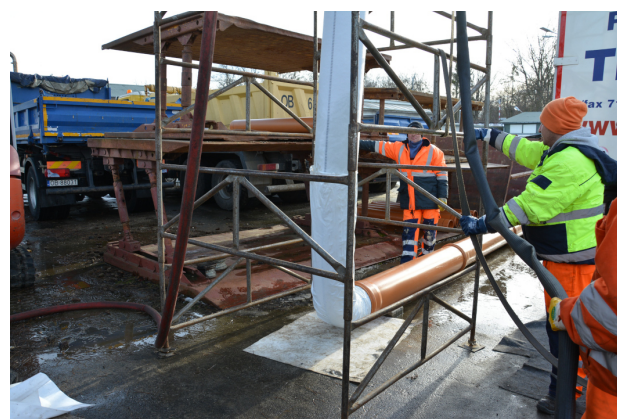
**Fig. 5.** Inversion tower and the insertion of the CIPP lining into the PVC pipe

- laying and stabilizing the model host pipeline (DN200 and DN300 PVC pipes) that had a length of 9 m,
- setting up an inversion tower to enable the insertion of the CIPP lining inside the host pipe,
- impregnating the CIPP lining with resin – performed in a mobile impregnation plant,

- inserting the lining inside the pipe's section using the pressure of a water column; the inversion was performed using a water column pressure of 5 mH<sub>2</sub>O, i.e. a hydrostatic water column pressure equal to 0.5 bar,
- pressing the lining to the host pipe's wall by applying the required value of internal pressure,
- carrying out the heating process of the lining, which in turn led to its hardening,
- completing the renovation process.

The production process of the samples is shown in Fig. 5.

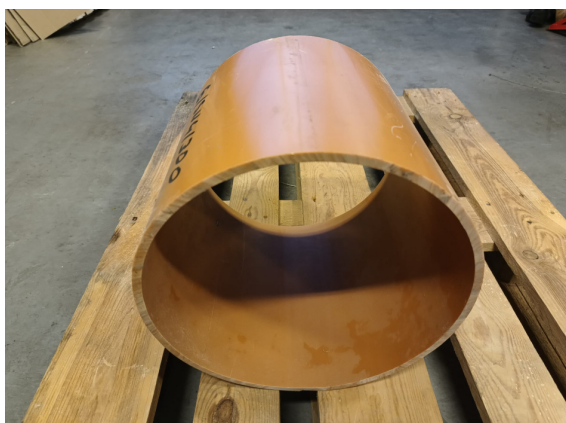
Fig. 6. PVC pipe

- PVC pipe – Fig. 6,
- CIPP lining – Fig. 7,
- Composite structure – Fig. 8.

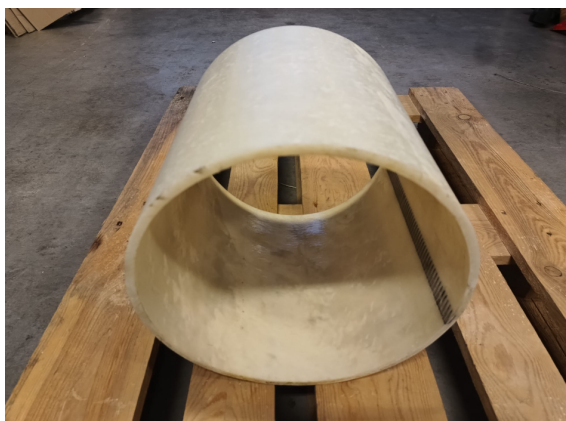
Fig. 7. CIPP liner

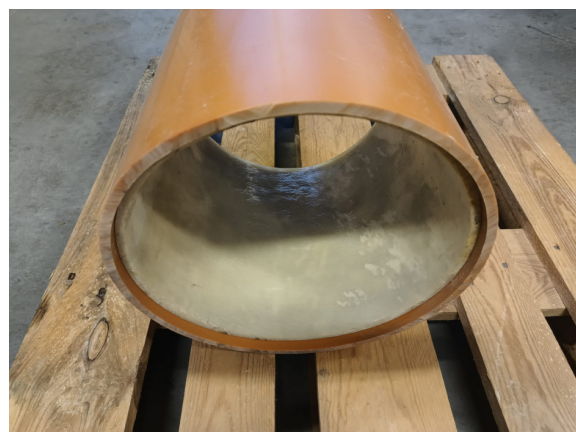
Fig. 8. Composite structure – PVC pipe + CIPP liner

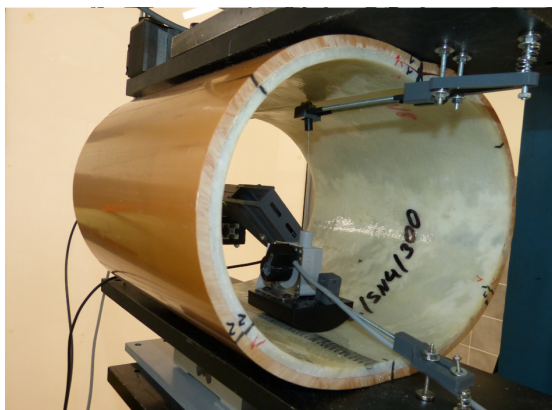
Fig. 10. Testing of the reference sample

During the tests performed for stage I (Figs. 9, 10, 11), the change in the real ring stiffness of the tested models, which was occurred as a result of installing the CIPP lining inside the host pipeline, was determined. The obtained results are presented in the tables below. The research results are presented in Tables 3, 4, 5 and 6.

The first stage of the above-described research, which aimed to determine the initial parameters of the CIPP lining and the level of increase in the ring stiffness of the combined pipe-lining system, will enable the real impact of damage, and its scale on the deterioration of strength parameters, to be specified. Based on the many years of experience [27] in the implementation, design and diagnostics of pipelines, two common groups of irregularities were assumed as representative for most conduits. The first group involves the weakening of the conduit's wall – damage in the form of longitudinal cracks occurring at the top and bottom of the conduit and in its groins (Fig. 10). This group
