**Research paper****Research on static load test of segmental-assembled steel temporary beam buttress of railway line****Wenlong Ma¹, Yucai Ning², Ronghua Ge³,
Bo Shen⁴, Yan Wang⁵, Hanqing Zhuge⁶**

Keywords: bridge engineering, segmental-assembled, static load test, steel structure, temporary beam buttress

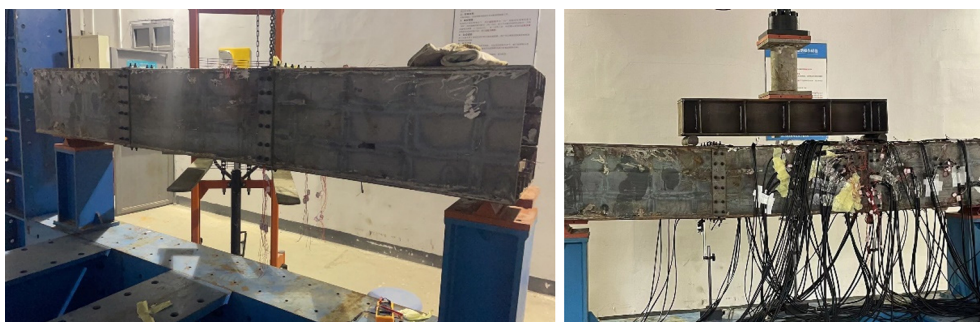
(a) Placement and positioning (b) Ready to load
Fig. 4. Photos of the test site; (a) Placement and positioning (b) Ready to load

In order to analyze the mechanical characteristics and deformation law of the new-type buttress, the experiment adopts the four-point-bending loading mode. This loading form can reproduce the actual force and deformation of the buttress under the vertical load transmitted by the actual temporary beam, which is conducive to observing and analyzing the strain, deformation, and joint gap development of the buttress at each stage of loading. The schematic diagram of the specimen loading is shown in Figure 3. The experiment was conducted at the experimental center of the College of Civil and Architectural Engineering, Zhejiang University of Science and Technology. The photos of the experimental site are shown in Figure 4.

This experiment uses an electro-hydraulic servo actuator and a loading reaction frame to implement loading. The maximum load which can be provided is 500 kN. The electro-hydraulic servo actuator is calibrated in advance through a force sensor and can automatically collect vertical loads at a frequency of 0.5 Hz. In addition, the equipment for collecting experimental data includes 120 Ohm welding free steel bar strain gauges with the measuring range from $-20000 \mu\epsilon$ to $20000 \mu\epsilon$ and static strain data acquisition box.

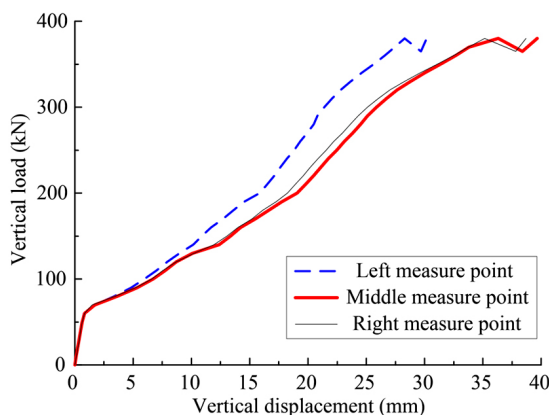
(a) The vertical load-displacement curve of the specimen

The load-displacement curve is an important basis for measuring the vertical bearing capacity and stiffness of a structure. The vertical load-displacement curve of the steel-structure temporary beam buttress is shown in Figure 6(a). The results showed that a complete load-displacement curve of the scaled test specimens of the steel-structure temporary beam buttress was obtained in this experiment, and the vertical ultimate bearing capacity of is 388 kN.

At the beginning of the loading stage, the specimen maintained a high stiffness, but the stiffness significantly decreased when the load reached around 60 kN. This is because the test components were assembled by three independent steel box components through bolts and the maximum preload is 55 kN. The first batch of bolt hole gaps were already tightened during

preloading. When the load is larger than 60 kN, other bolt holes were further tightened, so the vertical displacement includes the displacement caused by the loosening of the bolt holes. When the load reaches around 200 kN, the stiffness begins to increase, indicating that all bolt holes have been tightened and the specimen has entered the overall load-bearing working state. After the load reaches around 200 kN, the stiffness began to decrease again, which is due to the gradual plastic deformation of the mother plate near the bolt holes, and the plastic deformation area continued to increase. When the load increased to 380 kN, accompanied by a sound, a bolt at the bottom plate was cut and collapsed, and the bearing capacity quickly decreased to around 360 kN and stabilized.

1. The vertical load-displacement curve of the specimen was obtained through the experiment, and the ultimate bearing capacity and overall stiffness changes of the specimen were obtained. The structure did not experience local buckling or overall instability, and the overall structural performance was strong. The ultimate load-bearing capacity of the scaled test model is 388 kN. The ultimate bearing capacity of the actual full-size temporary beam buttress can be calculated as 16 times of the test result according to the similarity ratio.

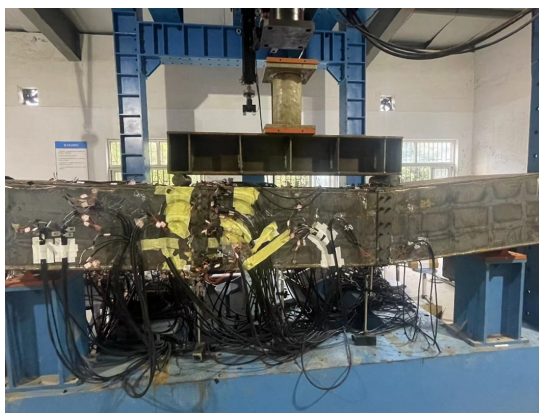
(b) The final failure mode of the specimen

On the premise of ensuring safety, the load continued until 388 kN, and multiple noises occurred continuously. It was observed that the bottom flanges and webs near multiple bolt holes of were severely sheared and damaged. At the same time, multiple bolts were sheared and collapsed, causing a sharp decrease in the bearing capacity of the specimen and the loading was terminated. The final failure mode of the specimen is shown in Figure 6(b). It can be seen from the figure that the specimen did not experience local buckling or overall instability during the loading process.

3. The main failure mode of the test specimen is the punching and shearing failure of the steel plates near the bolt hole caused by the continuous increase in joint gap width. It is indicated that the bending resistance of the joint is relatively low and needs to be properly strengthened during the design process.

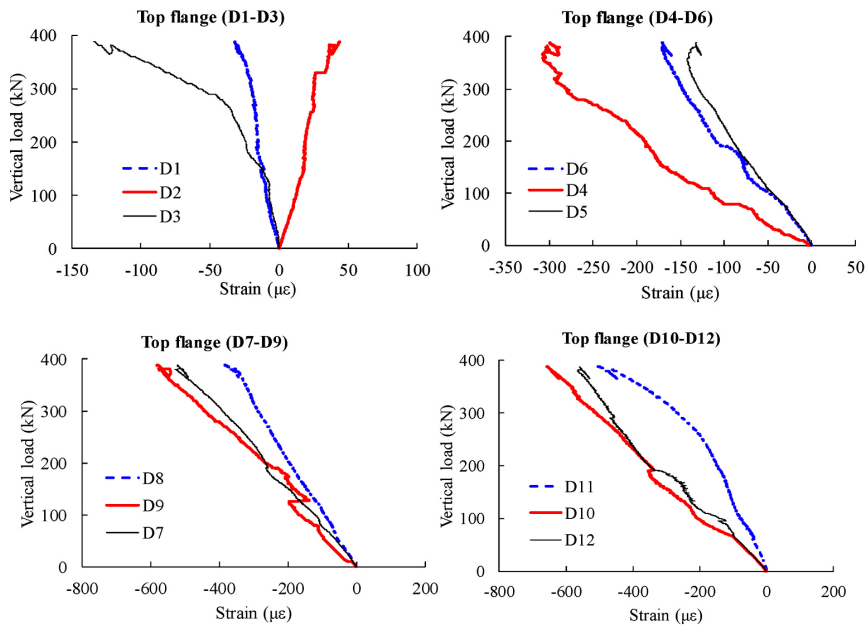
Fig. 7. Vertical load-strain curve at the top flanges

The strain at the top flanges and bottom flanges is relatively small, and almost all of the results are compressive. Due to not reaching the yield strain, the strain at the top flanges increases linearly with the increase of load. At the same time, the strain of the mid span sections (D7, D8, D9) is significantly larger, because the mid span section is in the pure bending section with the maximum bending moment. The strain of each section increases with the increase of the distance to the support, which is consistent with the distribution of bending moment. The strain at the bottom flanges is similar to that at the top flanges, and it is relatively small, with almost all showing tensile strain. Due to not reaching the yield strain, the strain at the bottom flanges increases linearly with the increase of load. At the same time, the strain of the mid span section (d7, d8, d9) is significantly larger, because the mid span section is in the pure bending section, with the maximum bending moment, and the strain is relatively larger compared to other sections.

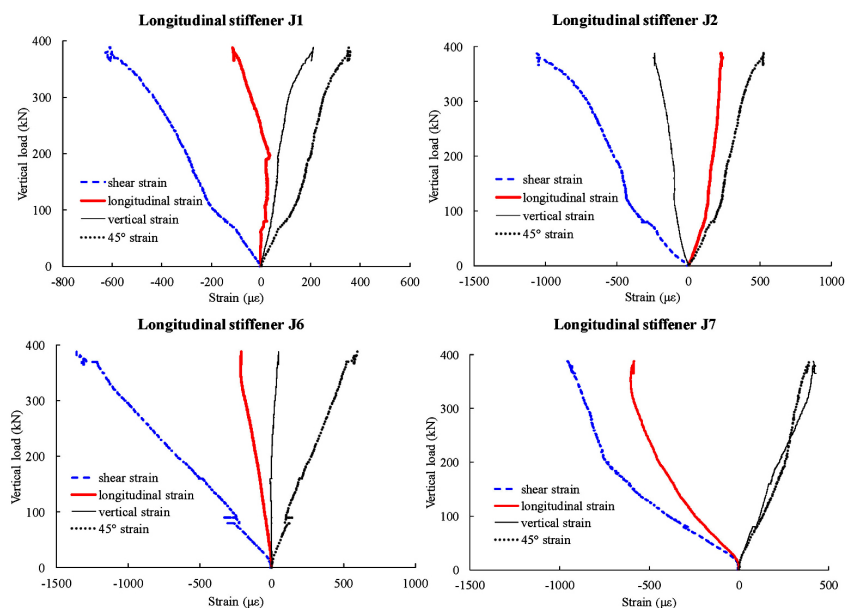
Fig. 12. Load-strain results of longitudinal stiffeners

near the support and the joint surface. As shown in the Figure 12, the strain on the longitudinal stiffeners has not reached the yield strain, and the strain increases linearly with the load, indicating that all measuring points on the longitudinal stiffeners are within the elastic range. Meanwhile, the stress states of each measuring point are also relatively close.

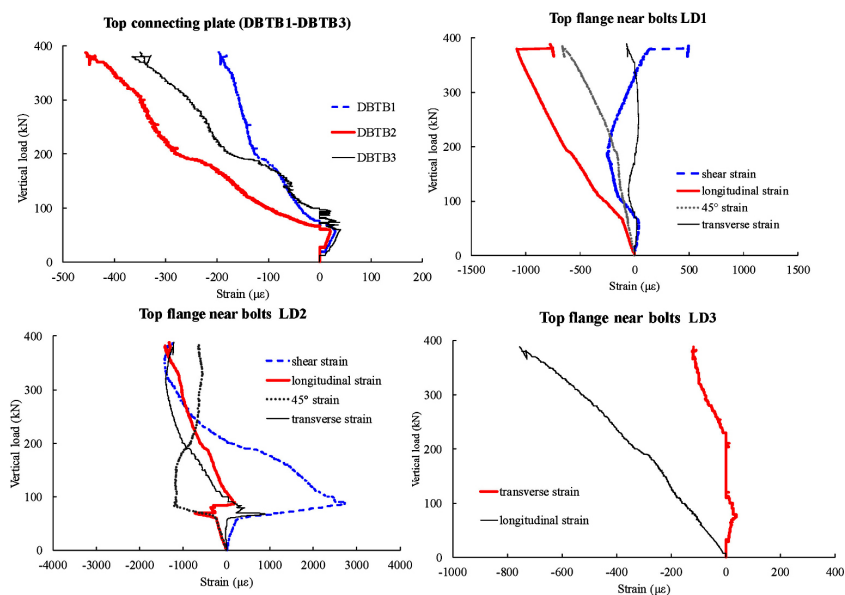
Figure 13 gives the load-strain results of top flanges and top connecting plates near bolts. Under the compressive stress, the top flanges of adjacent segments support each other. As shown in the figure, the stress on the outer panel is relatively small, indicating that the bolts were subjected to small shear forces. The strain of the top plate near the bolt hole has not reached the yield strain and is still within the elastic range, indicating that the mother plate at this position were not subjected to large punching shear stress.

Fig. 13. Load-strain results of top flanges and top connecting plates near bolts (Annotation: 45° strain gage of CD3 is open circuit)

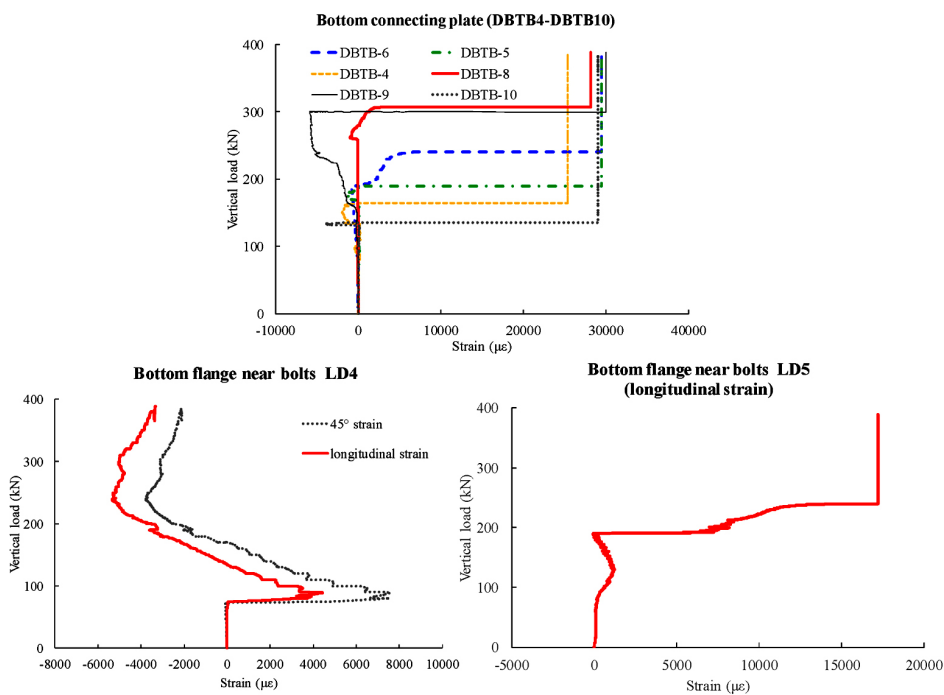
Figure 14 gives Load-strain results of bottom flanges and bottom connecting plates near bolt. As the loading progresses, there is a noticeable gap opening phenomenon from the bottom of the joint surface. As shown in the figure, the bottom connecting plates near bolts near the bolt hole has generated significant plastic strain, and many measuring points have exceeded the strain gauge range (20000 $\mu\epsilon$). The strain on the bottom flanges near the bolt hole is even greater, and a large number of measuring points exceed the range of the strain gauge, even causing the strain gauge to be pulled out and causing the circuit, making it impossible to read strain data normally. The bottom flanges near the bolt hole eventually undergoes serious punching and cutting damage, causing a sharp decrease in the load capacity of the component.

Fig. 14. Load-strain results of bottom flanges and bottom connecting plates near bolts (Annotation: transverse strain gage of LD4 is open circuit)

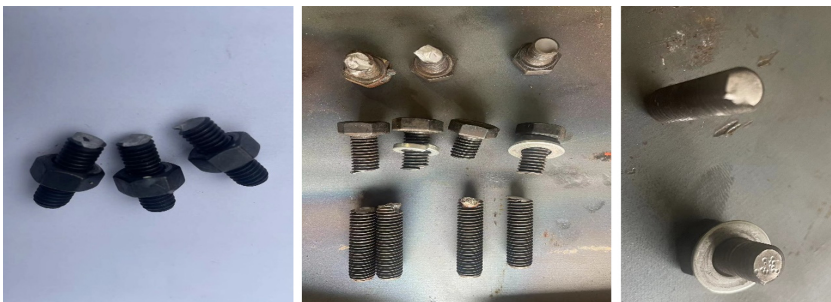
Fig. 18. Photos of bolt failure

Figures 18 and 19 respectively give the photos of bolt failure and mother plates damage. The bolt of the right web was sheared and damaged when loaded to 380 kN, indicating that a significant shear stress occurred near the bottom plate on the right side. The failure cross section of bolt is neat, and the right web underwent significant punching deformation. When the test load reached 388 kN, the bottom flanges near the bolt holes were completely cut and damaged, forming the U-shaped failure gap. Below the axis of the left web, significant tensile stress was applied and significant punching deformation occurred, with bolt holes on the left web being damaged by punching.
