**Research paper**

Identification of damage to a steel I-beam based on changes in frequency and curvature of the mode shape in a steel-concrete composite beam

Małgorzata Jarosińska¹, Tomasz Wróblewski²

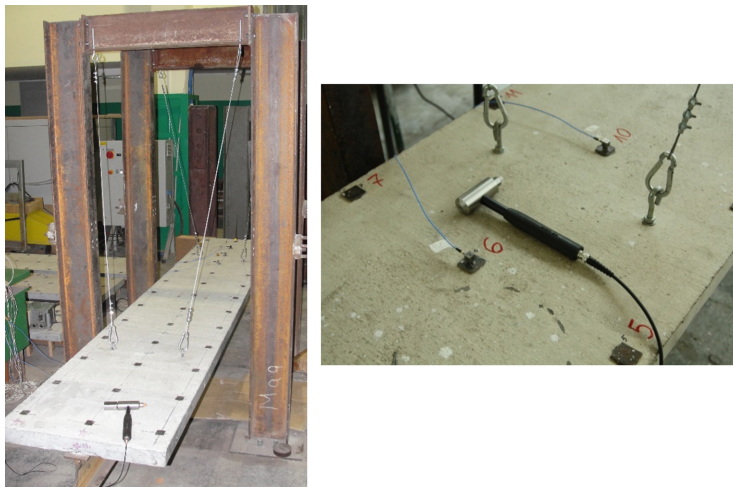
Fig. 3. Experimental test stand and research apparatus

Experiments have been conducted for a free-free beam. The setup allows to ignore the effect of supports' susceptibility on the results. This simplifies the analysis of data. The beam was freely hanged on a set of steel lines. The lines were fixed to the nodes of the initial flexural mode of vibration for of a simply supported beam (Fig. 3).

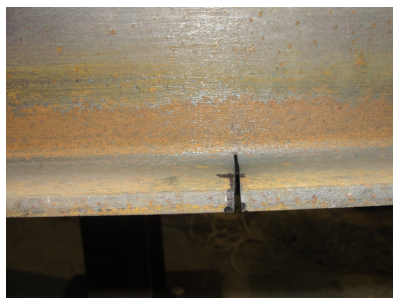
Fig. 5. Damage to the bottom flange – full-depth notch

Damage to the steel I-beam was performed by notching the bottom flange. Two notch depths were introduced: partial and full. The partial notch was made by cutting the flange on both sides of the web up to 50% of width. The full notch was made by cutting through the whole flange, reducing the operating cross-section by 100%. Figure 5 shows the damage (full notch) done to the bottom flange.

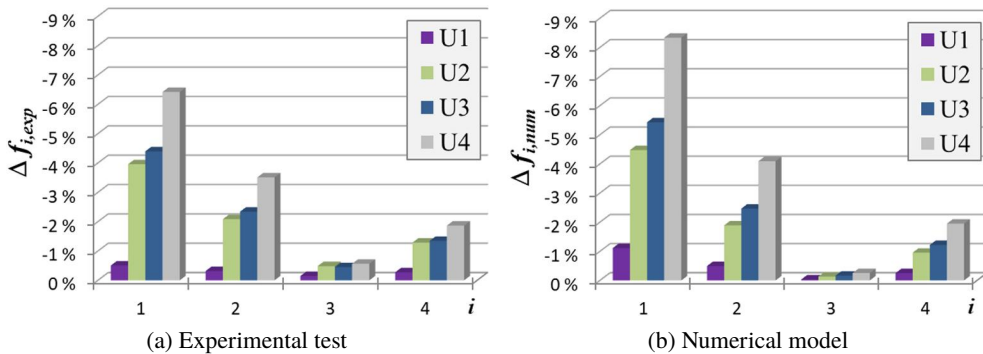
Fig. 9. Changes in the natural frequency as a result of inflicted damage;
(a) experimental test, (b) numerical model

The effect of I-beam damage U1–U4 on the natural frequencies is shown below (Table 5, Table 6). Figure 9 presents the changes in frequencies obtained in the experimentally and numerical evaluations.

As can be seen, the changes in the natural frequencies was similar in experimental and numerical evaluations. As was to be expected, an increase level of damage caused a decrease in the value of the vibration frequency, which is directly related to the loss of stiffness of the beam. The highest value of 8% was obtained in the numerical model for the first vibration frequency. The frequencies of the third mode of vibration remained almost intact with none of the changes exceeding 0.6%. Such small values of frequency changes are most likely due to the proximity of this mode of vibration nodes to the damage location.
