# Corrosion Behaviour of 316 Stainless Steel in Molten $\text{CaCl}_2$ - $\text{CaF}_2$ - $\text{CaO}$ Salts at High Temperature

P. Palimaka \*

AGH University of Krakow, Poland

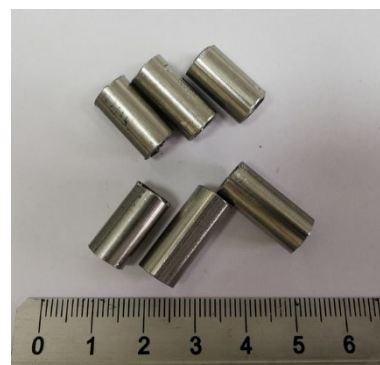
Fig. 1. SS316 samples prepared for testing

Six samples were prepared for the study, cut from a tube with an outer diameter of 8.1 mm and a wall thickness of 0.96 mm, as shown in Figure 1. The samples were washed in 1M NaOH solution, cleaned using acetone, and dried in warm air. The samples were stored in vacuum desiccator to avoid oxidation/corrosion before testing. The weight of the samples was recorded before corrosion test. Metal samples were tested in ceramic (alundum) crucibles (12 cm height, 6.0 cm diameter, and 2 mm wall thickness). Each crucible contained 120.0 g of CaCl<sub>2</sub>-CaF<sub>2</sub>-CaO (12.0 g CaO, 108.0 g eutectic CaCl<sub>2</sub>-CaF<sub>2</sub> molten salt with 86.2/13.8 wt. %, dried at 300 °C for over 48 hours), resulting in a salt height of about 3 cm after melting. During the test, the samples were completely immersed in the molten salt. Corrosion tests were conducted in a Nabertherm muffle furnace. After 40, 80, and 120 hours, the furnace was opened, the crucible was placed on a preheated ceramic brick, and the sample was carefully extracted using tongs (Figure 2).

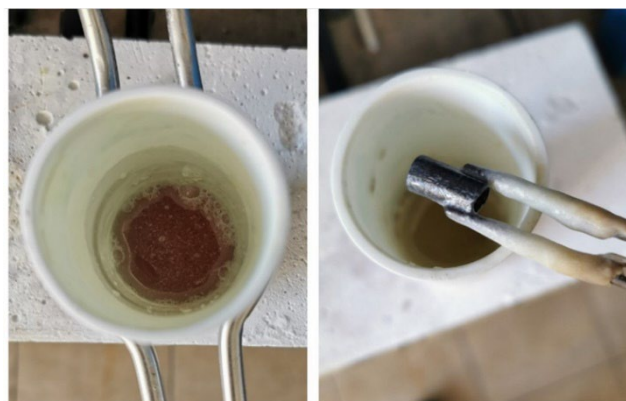
Fig. 2. Crucible with molten salt (left) and the SS316 steel sample immediately after being removed from the molten salts

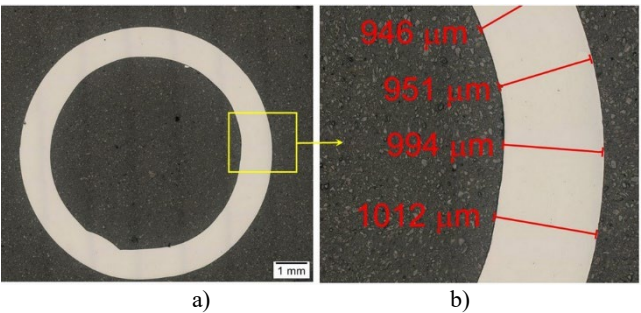
Fig. 3. Macro image of the sample before testing (a) and microstructure with an example of wall thickness measurement (b), unetched cross-section, light microscopy

It was found that the mass loss of samples kept in molten salts at a temperature of 700°C did not exceed 0.5% of their initial mass. Significantly greater mass changes occurred at 950°C, reaching up to 3.85% after 120 hours. The initial sample was subjected to microscopic observations and wall thickness measurements. An example of a thickness measurement is shown in Figure 3b.

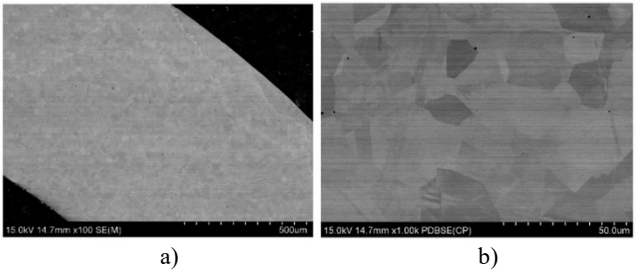
Fig. 4. Microstructure of the sample cross-section before testing: a) magnification 100x, b) magnification 1000x; SEM

The microstructure of the SS316 sample consists of regular austenite grains with sizes ranging from 20 to 40 μm. No large intermetallic phase inclusions or carbides were observed. Figure 5 presents a macro image of the sample after 120 hours of exposure to molten salts at 700°C, along with an example of a wall thickness measurement.

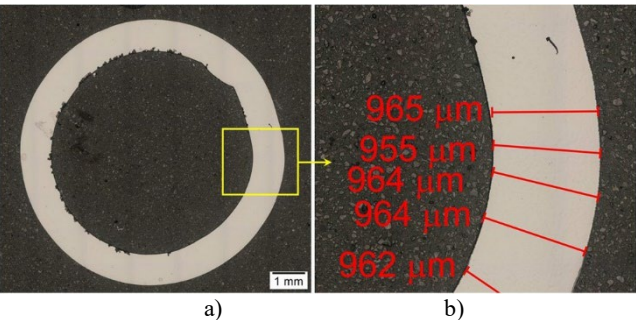
Fig. 5. Macro image of the sample after tests at 700°C (120 h) and microstructure with an example of wall thickness measurement (b), unetched cross-section

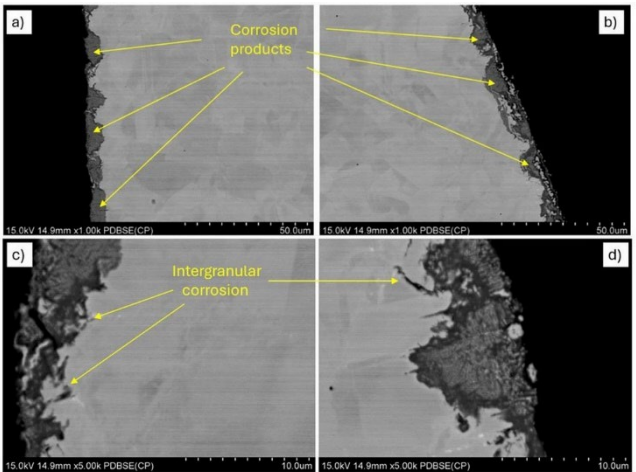
Fig. 6. Microstructure of the sample after tests at 700°C (120 h): a) magnification 5000x, b) magnification 1000x; c) magnification 5000x, d) magnification 5000x; SEM

The results obtained demonstrated the presence of a non-uniform corrosion product layer on both sides of the sample (inner and outer surfaces) (Figure 6a and Figure 6b). Additionally, evidence of intergranular corrosion propagating from the corrosion product layer into the metallic material was observed (Figure 6c and Figure 6d).

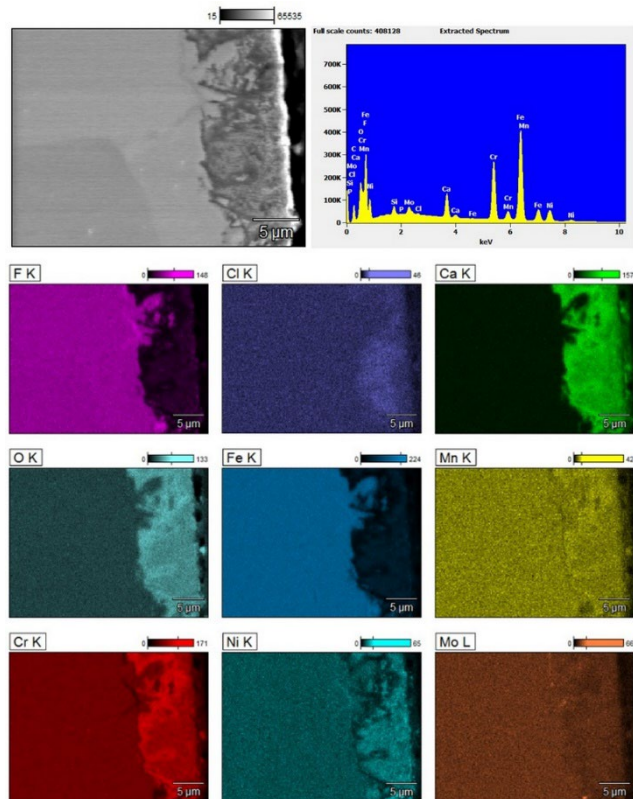
Fig. 7. Microstructure of the sample tested for 120 h at 700°C and elemental distribution maps of components present in the molten salts: F, Cl, Ca, O, as well as primary alloying elements of AISI 316 steel: Fe, Mn, Cr, Ni, Mo

The results of the chemical composition analysis in microareas, presented as elemental distribution maps (Figure 7), indicate an enrichment of the corrosion layer with Cl, Ca, and O. These elements originate from the molten salts in continuous contact with the tested material. Additionally, at the interface between the corrosion layer and the metallic material, segregation of alloying elements such as Cr and Mn, as well as enrichment in O, was observed. Furthermore, the corrosion product layer exhibited increased Ni and Cr content compared to the base material. This suggests chemical reactions between these elements and the molten salts, leading to the formation of solid corrosion products on the surface of the tested material. These observations are confirmed by the results of linear analysis, as shown in Figure 8.

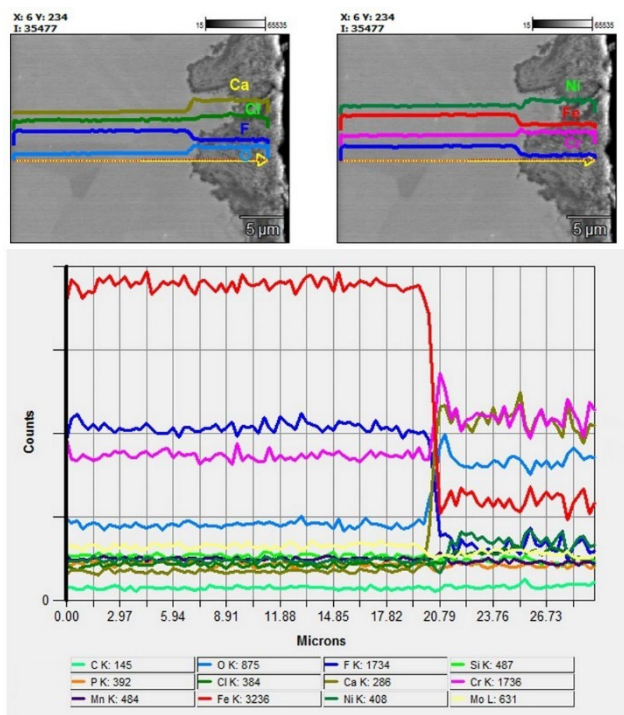
Fig. 8. Results of linear analysis of the microstructure area (sample tested for 120 h at 700°C) on a cross-section containing the corrosion product layer and the base material; SEM

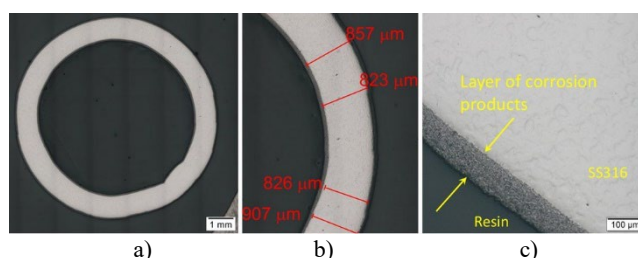
Fig. 9. Macro image of the sample after tests at 950°C (120 h) (a), microstructure with an example of wall thickness measurement (b), and the appearance of the corrosion product layer with a fragment of SS316 (c). Unetched cross-section, light microscopy

The sample tested at 950°C for 120 hours was also subjected to microscopic observations and wall thickness measurements (Figure 9a and Figure 9b). Meanwhile, Figure 9c presents a view of a fragment of the sample with a visible corrosion product layer.

The example measurements shown in Figure 9b indicate significant thinning of the sample wall compared to the material before the experiments. Meanwhile, the cross-sectional image presented in Figure 9c reveals the presence of a relatively thick corrosion product layer on the surface of the analyzed material. Figures 10 and 11 display microstructure images of the sample and elemental distribution maps obtained using SEM.

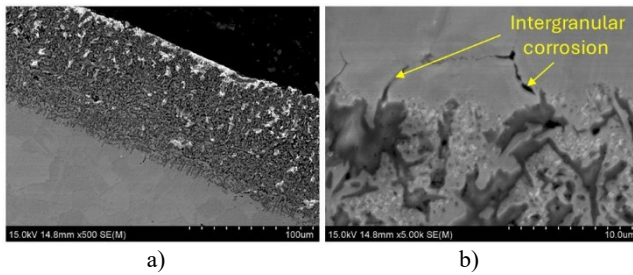
Fig. 10. Microstructure of the sample tested for 120 h at 950°C; image (a) shows the morphology of the corrosion layer, and image (b) displays evidence of intergranular corrosion; SEM

The cross-sectional images shown in Figure 11 indicate the presence of a corrosion layer uniformly distributed on the surface of the tested sample. The transition between the sample material and the corrosion product layer is continuous. The layer consists of micro-areas differentiated in terms of chemical composition and exhibits a "spongy" morphology. Additionally, localized traces of intergranular corrosion spreading from the scale into the material were observed (Figure 10b).

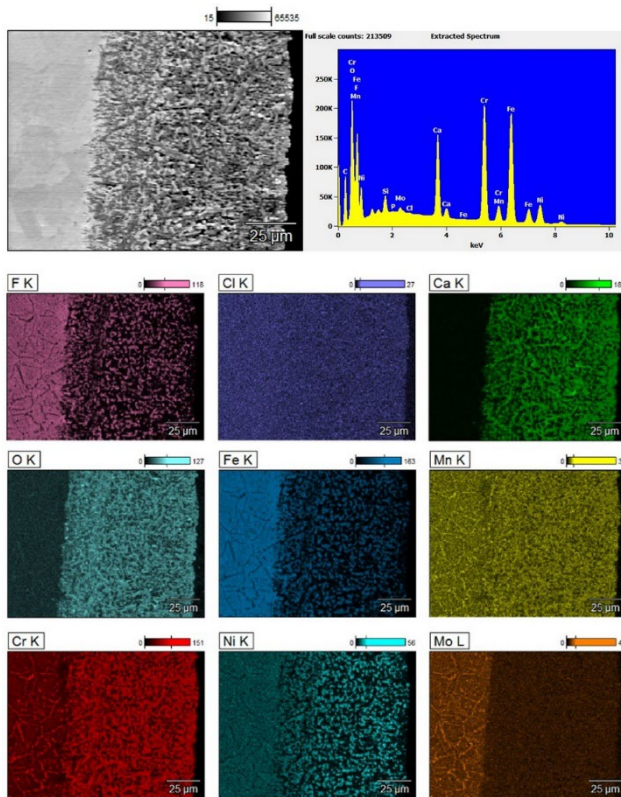
Fig. 11. Microstructure of the sample tested for 120 h at 950°C and elemental distribution maps of components present in the molten salts: F, Cl, Ca, O, as well as primary alloying elements of SS316 steel: Fe, Mn, Cr, Ni, Mo

The results of the chemical composition analysis in microareas, presented as elemental distribution maps (Figure 11) and linear

The observed segregation of Cr, Mn, and Mo (local increase in the concentration of these elements at grain boundaries), as shown in Fig. 11, may lead to the initiation of corrosion or cracking due to the formation of stresses. This type of corrosion is one of the most common in molten salt environments [21]. However, overall degradation was relatively minimal. Such existence of SS316 steel at lower temperatures indicates its potential applicability in processes requiring moderate thermal conditions. In the context of using SS316 for constructing components in  $\text{CO}_2$  capture devices in molten salts, these conditions prevail in the absorber, where the  $\text{CO}_2$  absorption temperature does not exceed 700°C.

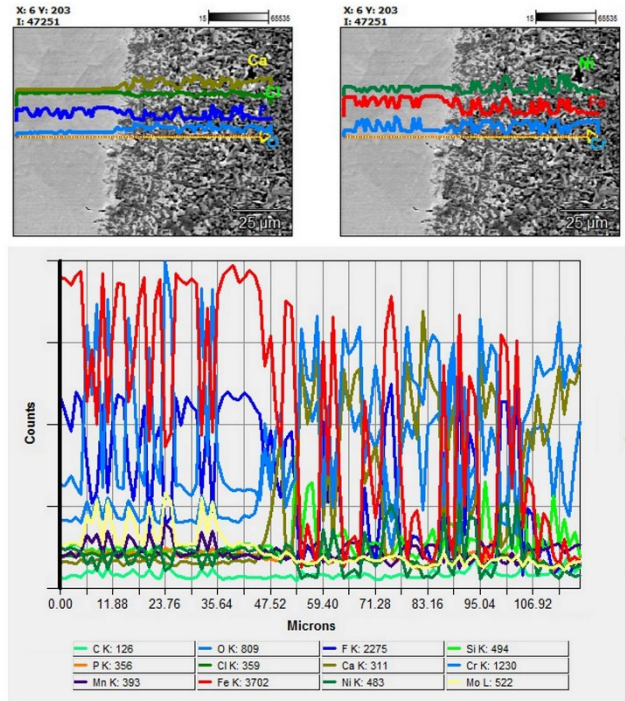
Fig. 12. Results of linear analysis of the microstructure area of the sample tested for 120 h at 950°C, showing a cross-section containing the corrosion layer and the tube material; SEM

analysis (Figure 12), demonstrate enrichment of the layer with Ca and O.

Additionally, segregation of Cr, Mn, and Mo to the grain boundaries in the tube was observed, which may reduce the material's corrosion resistance. The corrosion layer is multi-component, as confirmed by the EDS chemical composition analysis results. Furthermore, some micro-areas in the sample are enriched in Ni and Cr. These observations are corroborated by the results of the linear elemental analysis (Figure 12). The thickness measurements of the walls of the tested samples, both before and after testing at 700°C and 950°C for 120 hours, as well as the thickness of the scale formed on the samples, are summarized in Table 3.

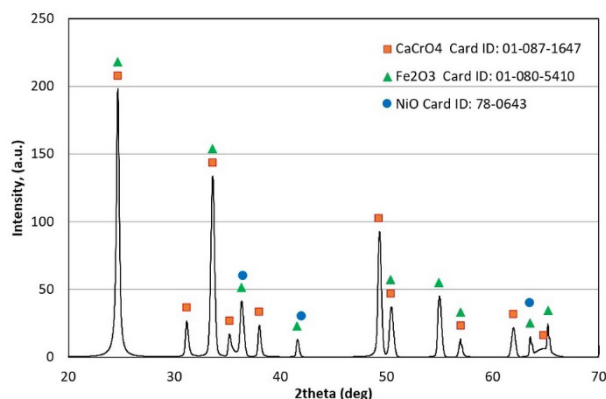
Fig. 13. XRD pattern of the corrosion products formed at 950 °C on the surface of SS316

The results of the XRD analysis indicate the presence of metal oxides, which suggests the possibility of reactions occurring between the alloying elements of SS316 and the components of the molten salts or the furnace atmosphere.

Due to the highest vapor pressure of  $\text{CrCl}_3$  [20] and the most negative standard Gibbs free energy associated with the formation of  $\text{Cr}_2\text{O}_3$ , reaction (7) will proceed preferentially. The resulting  $\text{Cl}_2$  will then diffuse through cracks and pores in the oxide layers back to the oxide/metal phase boundary, where it will react with the metal again. Reaction (9) is also possible. The formation of  $\text{CaCrO}_4$  was corroborated by XRD analysis of the corrosion products, as shown in Figure 13.

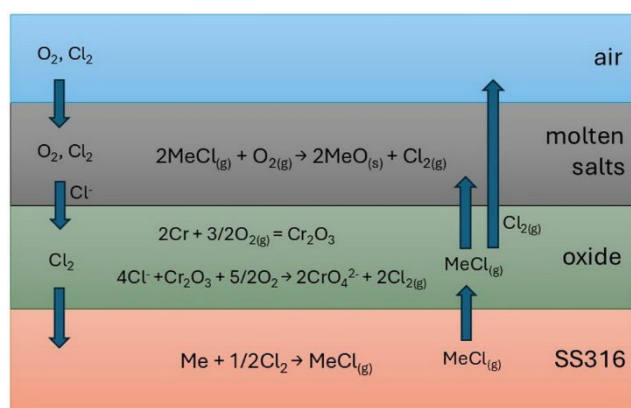
Fig. 14. Schematic diagram of activated oxidation.

The mechanism of high-temperature corrosion in a chlorine-containing environment is not fully understood. However, it is believed [19] that the accelerated corrosion of steel in a high-temperature, chlorine-containing environment is mainly due to the lower melting and boiling points of chlorides present in the corrosion products compared to the corresponding metal oxides. One of the models used to interpret corrosion in chloride salts is the active oxidation model [20], which, in relation to the system studied in this work, is schematically illustrated in Figure 14.

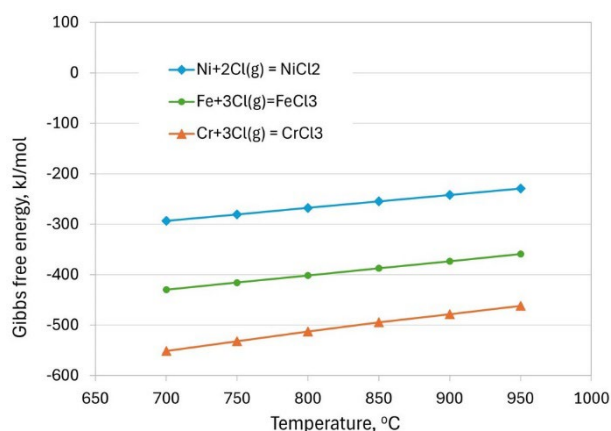
Fig. 15. The Gibbs free energy for the formation reaction of Ni, Fe and Cr chlorides in the temperature range of 700-950°C [22]

Chlorine can react with metals such as Ni, Fe and Cr. However, as demonstrated in Figure 15, the formation of  $\text{CrCl}_3$  is the most favored reaction due to its most negative Gibbs free Energy (calculated based on the HSC Chemistry 7.0 software).
