VANCHO ADJISKI¹*, VÁCLAV ZUBÍČEK¹²

INTEGRATED ENVIRONMENTAL IMPACT ASSESSMENT OF THE SASA TAILING DAM FAILURE USING REMOTE SENSING TECHNIQUES

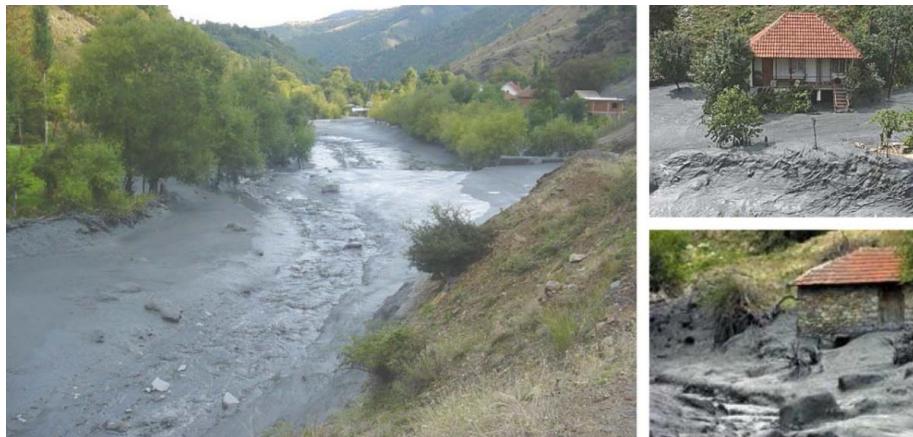
Fig. 3. Post-event impacts on the river path and surrounding environment following the Sasa tailing dam incident
