A. ZIEWIEC*, A. ZIELIŃSKA-LIPIEC*, E. TASAK*

MICROSTRUCTURE OF WELDED JOINTS OF X5CrNiCuNb16-4 (17-4 PH) MARTENSITIC STAINLEES STEEL AFTER HEAT TREATMENT

Keywords: Weld metal, heat treatment, martensitic PH stainless steels , 17-4PH steel

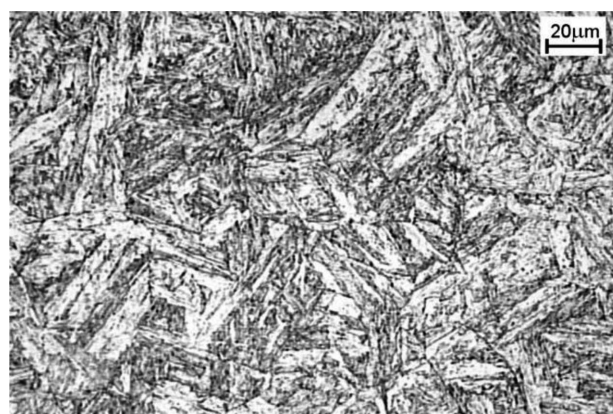
The microstructure of base metal used for the welding consists on tempered martensite with fine carbides precipitates inside the martensite laths and at their boundaries (Fig. 1).

Fig. 1. Microstructure of the base metal after welding; martensitic microstructure

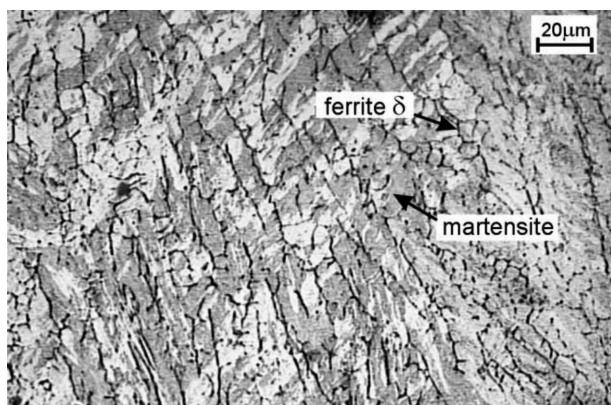
The solidification mode of the 17-4PH weld is ferritic, therefore during the welding and the subsequent cooling the sequence of the phase transformations in the weld is the following:

Fig. 2. Weld microstructure without heat treatment

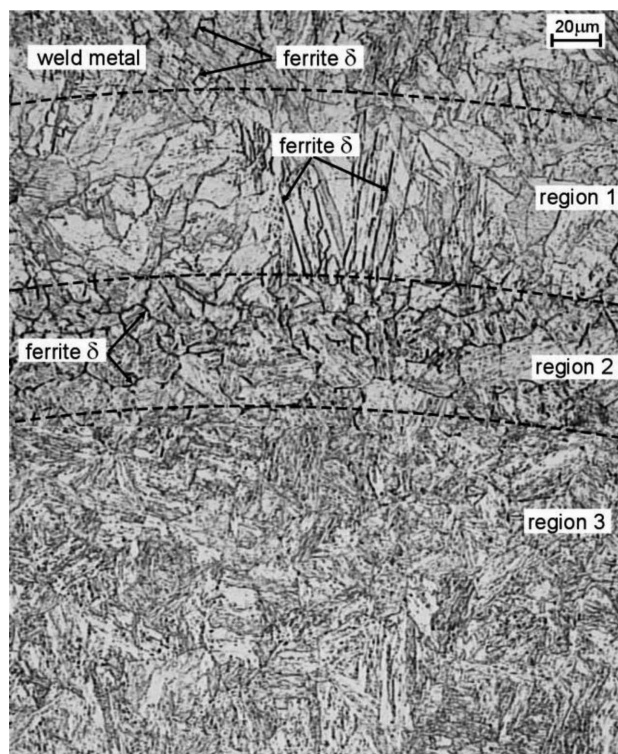
Fig. 4. Microstructure near the fusion line and the high-temperature regions of the HAZ from the place marked "A" in Fig. 3

The light microscopy study shows the evidence that there are the phase transformations in the HAZ during the welding of the 17-4PH steel. The four areas can be distinguished in the HAZ (Fig. 3). Directly at the fusion line a coarse grained δ ferrite can be observed. The δ ferrite transforms into austenite during cooling and below the M_s temperature turns into martensite (Fig. 4). Finally, some remnants of non-transformed δ ferrite may be found in the microstructure. At lower temperatures the area that was heated during welding to the range of γ austenite + δ ferrite can be found (region 2). The δ ferrite is located at the grain boundaries and during the subsequent cooling sequence will not transform into austenite and in the martensite. The martensite with a network of intergranular δ ferrite can be visible on Fig. 4. Below 1200°C there is an area which is heated during welding to the temperature range of austenite. After cooling the martensite can be observed in the microstructure (region 3). The region heated up to the temperature range Ac_1 - Ac_3 consists of the austenite coexisting with martensite, and after cooling transforms into the newly formed martensite and the tempered martensite. Figure 5 shows the example of the region heated up to the temperature slightly higher than Ac_1 . The grains of the newly formed martensite (difficult for etching) martensite within the tempered martensite are observed.

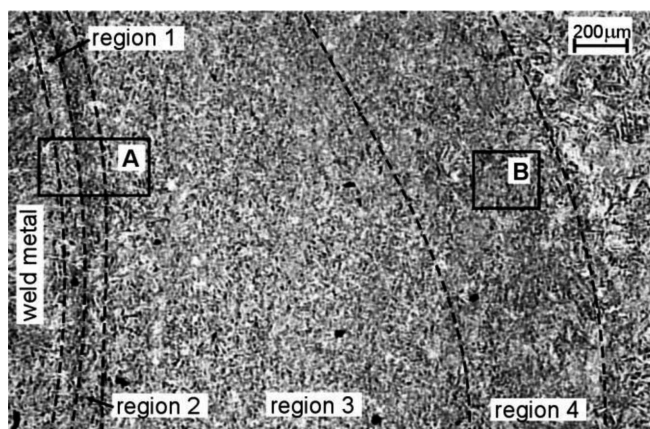
Fig. 3. HAZ microstructure with the characteristic regions marked with dashed lines

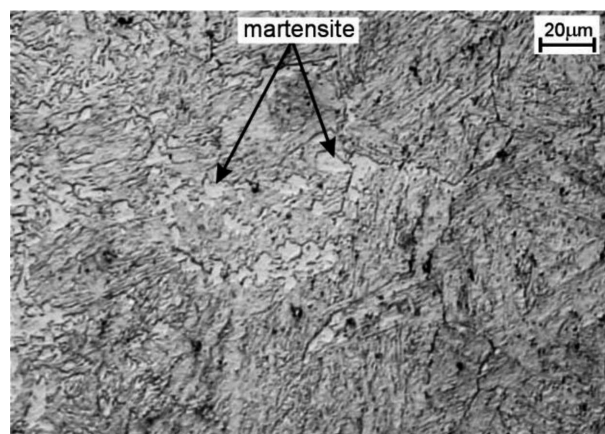
Fig. 5. Microstructure of the region no 4 from the place marked "B" on Fig. 3 heated to the temperature slightly higher than Ac_1 . The "fresh" martensite within the tempered martensite

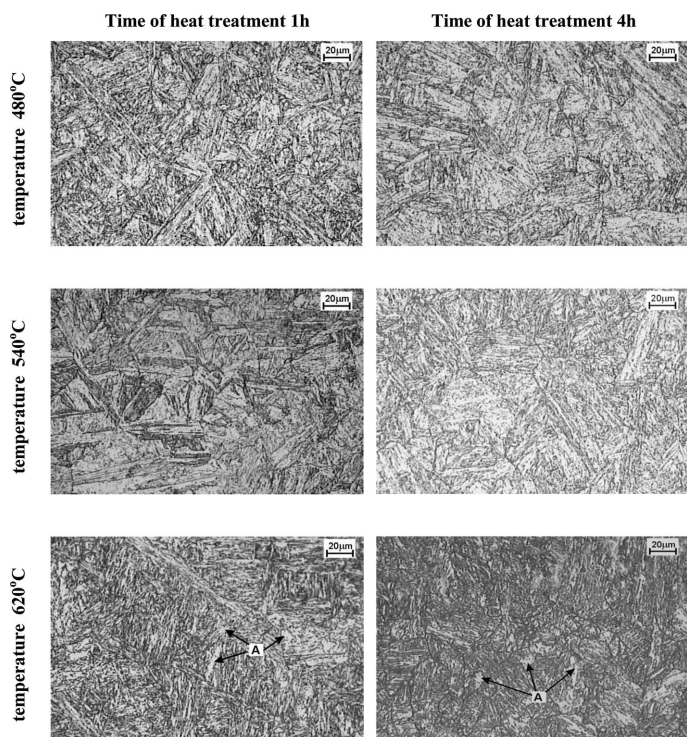
Microstructure of the base metal after aging at 480°C and 540°C (Fig. 6) does not show any distinct differences from that one in the as-welded state. However, only a lightly stronger etching of the grain boundaries is observed. For of the sample aged at 620°C for 1h and 4h the stronger etching is visible. This is most probably related with precipitation of the hardening phases. The dilatometric studies shown that the Ac_{1s} onset temperature is 614°C (Fig. 7). The heat treatment temperature at 620°C is higher than the temperature of austenite formation and during the subsequent cooling the austenite may transform into martensite. In the case of high stability of austenite, the γ - α' transformation will not occur.

Fig. 6. Base metal microstructure after heat treatment. The bright regions visible between the plater of austenite (marked by arrows and capital letter "A")

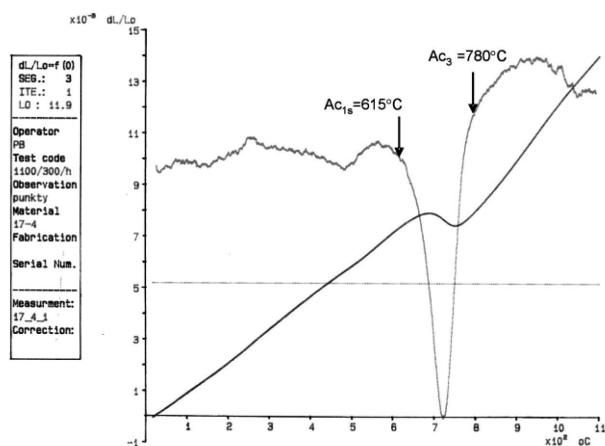
Fig. 7. Dilatometric heating curve (heating rate 0.1°C/s) and differential curve with the temperature values of the critical points A_{c1} and A_{c3}

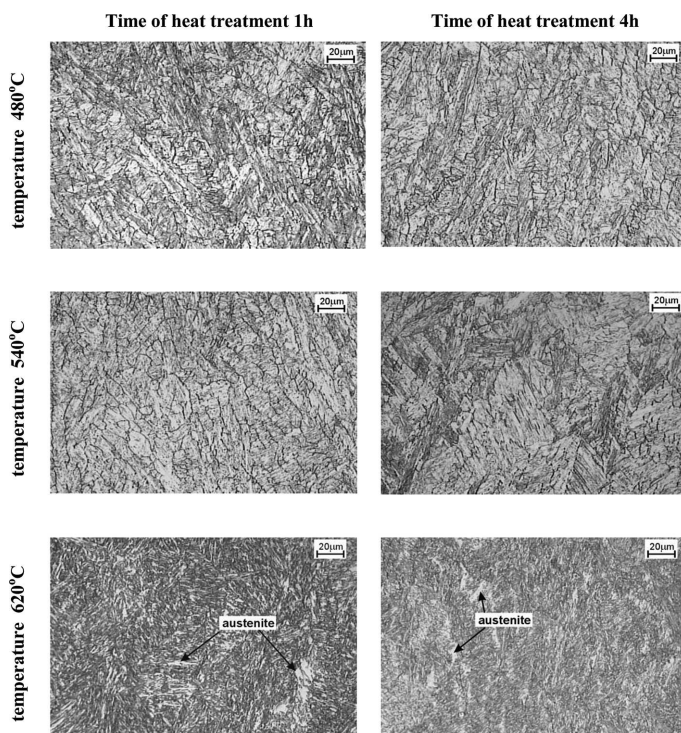
Aging up to 540°C does not affect significantly the microstructure of the weld metal observed by light microscopy (Fig. 8). The only effect is a slightly more pronounced etching due to the precipitation of carbides and hardening phases. Starting from the aging temperature of 620°C the microstructural changes are observed. In areas where the segregation is observed at the grain boundaries and cell boundaries where A_{c1} temperature is lower the austenite is formed. The austenite transforms into martensite after cooling. In the case of high stability of austenite, it cannot undergo phase transformation, similarly to base material.

Fig. 8. Weld metal microstructure after heat treatment

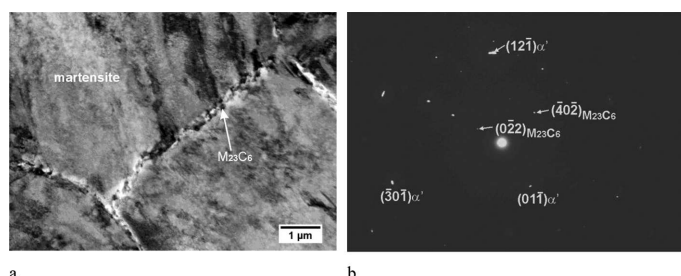
microstructure of the lath martensite with $M_{32}C_6$ precipitates at the grain boundaries (Fig. 9). No precipitates within crystallites are observed. This can be related with an extensive segregation of chromium occurring upon the solidification treatment. Such segregation promotes the nucleation of precipitates on boundaries of the primary crystallites. The small amounts of the δ ferrite (Fig. 10) are observed near the boundaries of the crystallites. The tin film of the retained austenite occurs on the boundaries of lath martensite (Fig. 11). In the regions where segregation of the chemical elements occurred, a stable austenite is formed as a result of $\alpha \rightarrow \gamma$ transformation. The aging process proceeds in martensite. A numerous nanoparticles of Cu-rich fcc precipitates are observed (Fig. 12a). Prolongation of the time of annealing up to 4 hours at 620°C leads to further progress of the aging process. The fcc Cu-rich precipitates are growing (Fig. 12b). The $M_{23}C_6$ precipitates and a few remnants of δ ferrite are still observed at the crystallite boundaries. The austenite, stable down to the room temperature, formed during $\alpha \rightarrow \gamma$ transformation exhibits a lower dislocation density (Fig. 13). The increase of copper solubility in the austenite causes dissolution of the fcc-Cu precipitates and stabilization of austenite.

Fig. 9. Weld microstructure after annealing 620°C / 1 hour, b) electron diffraction pattern, $[\bar{1}22]M_{23}C_6$, $[\bar{1}23]_{\alpha}$

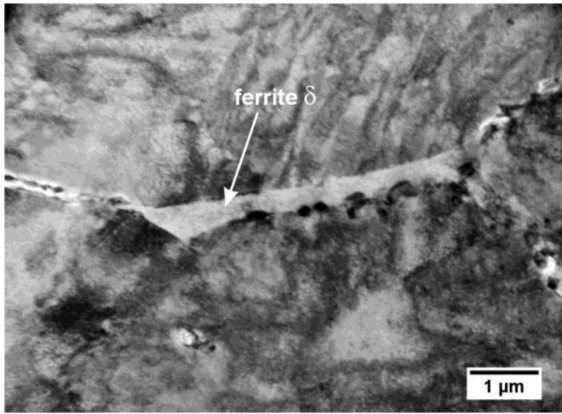
Fig. 10. Weld microstructure after annealing at 620°C for 1 hour. The remnants of δ ferrite are indicated by arrow

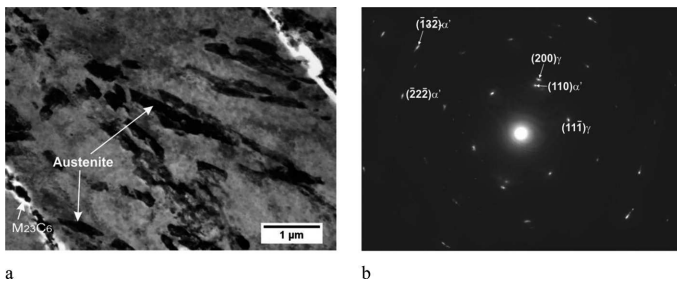
Fig. 11. Retained austenite in the middle of the grains of the weld of 17-4PH steel after annealing at 620°C for 1 hour; a) bright field, b) electron diffraction pattern $[011]_{\gamma}$, $[\bar{1}12]_{\alpha}$, $[011] M_{23}C_6$

the presence of the thin film of austenite. The retained austenite occurs inside the grains and at the grain boundaries of martensite laths. The increase of the aging time up to 4 hours results in the formation of the austenite due to the $\alpha \rightarrow \gamma$ transformation. Such austenite is stable after cooling down to the ambient temperature.

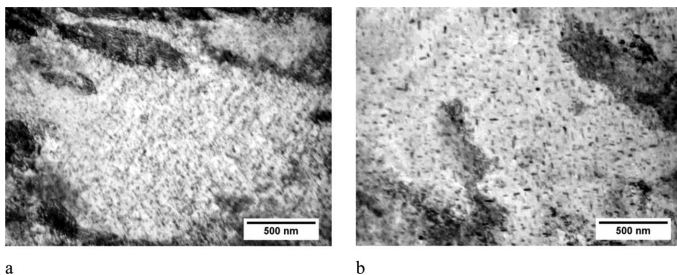
Fig. 12. a) Fine highly dispersed fcc-Cu precipitates inside the laths of martensite after annealing at 620°C for 1 hour, b) Larger fcc-Cu precipitates inside the laths of martensite after annealing at 620°C for 4 hour

Transmission electron microscopy investigations showed that the aging of the welds with the martensitic microstructure at 620°C causes an intensive precipitation of the strengthening copper-rich particles. The size of the particles increases with the aging time. There are $M_{23}C_6$ carbides precipitate on the boundaries of the primary crystallites what is accompanied by

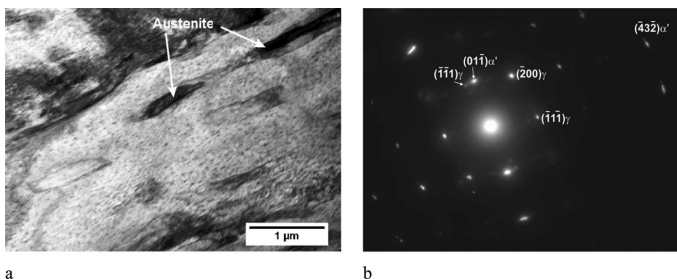
Fig. 13. Retained austenite in the of 17-4PH steel after annealing at 620°C for 4 hour; a) bright field, b) electron diffraction pattern $[011]_{\gamma}$, $[\bar{1}44]_{\alpha}$

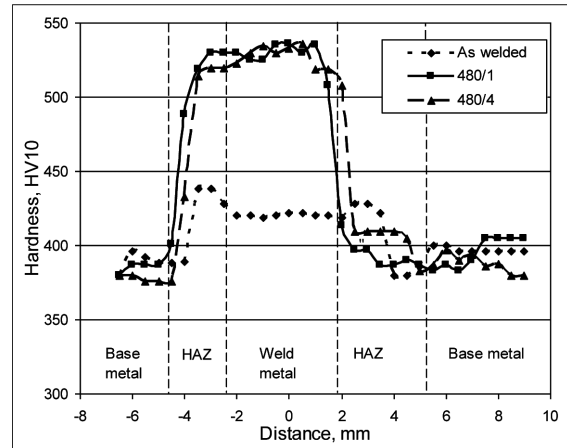
The results of hardness measurements are presented on Figs. 14-16. The hardness profile for the examined samples shows that after aging at 480°C hardness of the weld is the

largest. The significant drop of hardness at 540°C is observed in the weld and HAZ. The weld metal did not changed its hardness in comparison with the sample heat treated at 480°C. The overaging at 620°C caused significant decrease of hardness in the weld below 400 HV10, while the corresponding value in the weld metal decreased to ca. 350 HV10.

Fig. 14. Distribution of hardness vs. distance after welding and aging 480°C /1h, 480°C/4h

The changes in hardness depend on the temperature and time of tempering. At the temperature 480°C the highly dispersive coherent precipitations of copper are strongly contributing to hardening of the alloy. This influences the high hardness at this temperature. Due to the fact that the drop of hardness at 540°C was small, it can be concluded that the coherence of the hardening precipitates at this temperature is still preserved. A distinct decrease of hardness after treatment at 620°C is caused by overaging of the martensite and formation of austenite. After the prolonged overaging at this temperature, copper diffuses to the grain boundaries and boundaries of the martensite laths. This is the reason of the depletion of martensite in copper and other chemical elements stabilizing the austenite [4]. Furthermore, the character of weld solidification is attributed with strong segregation of the elements that promote formation of austenite at grain boundaries. This causes that these regions are enriched in the elements decreasing the A_{c1} temperature. Depending on the stability, the austenite formed during the

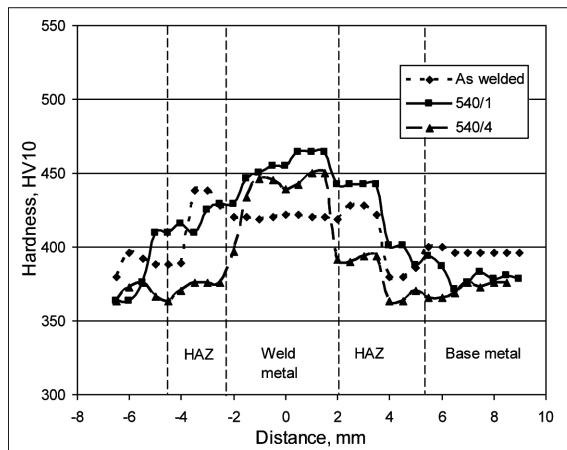
Fig. 15. Distribution of hardness vs. distance after welding and aging 540°C/1h, 540°C/4h

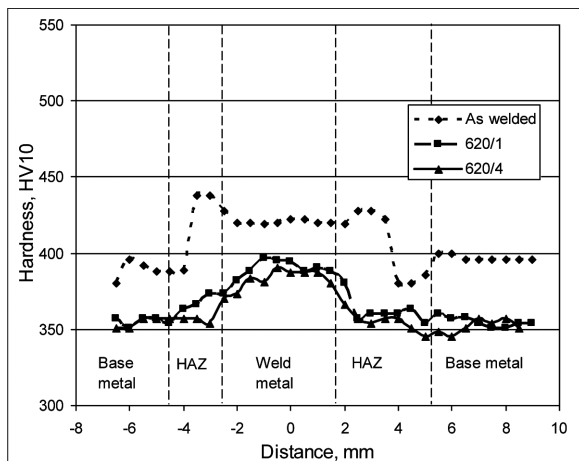
Fig. 16. Distribution of hardness vs. distance after welding and aging 620°C/1h, 620°C/4h

The aging of X5CrNiCuNb16-4 (17-4 PH) steel leads to the tempering of the martensitic microstructure and precipitation of the carbides and strengthening phases. The hardness decreases with the increase of the aging temperature above 540°C. The reason of the hardness decrease is the drop of the dislocation density and the reverse transformation of martensite into austenite. The maximum hardness will occur in the welds aged at 480°C and 540°C where the copper-rich strengthening particles coherent with the matrix are uniformly distributed in the alloy. The increase of the aging temperature leads to intensification of the precipitation processes and the increase of the diffusion rate of alloying element in the steel. Non-equilibrium solidification conditions of the weld metal, segregation and the diffusion of copper and the elements stabilizing the austenite promote the occurrence of the reverse transformation of the martensite into austenite even after only 1 hour at 620°C. As the base material was in the as-aged condition at 540°C, its hardness during the heat treatment at 570°C did not change significantly. Annealing at 620°C caused the decrease of the hardness in the base material down to 350 HV10.
