AIXIANG WU*, SHUNMAN CHEN*[#], YIMING WANG*, XUN CHEN*

FAILURE MECHANISM AND SUPPORTING MEASURES FOR LARGE DEFORMATION OF SOFT ROCK ROADWAY IN BALUBA COPPER MINE

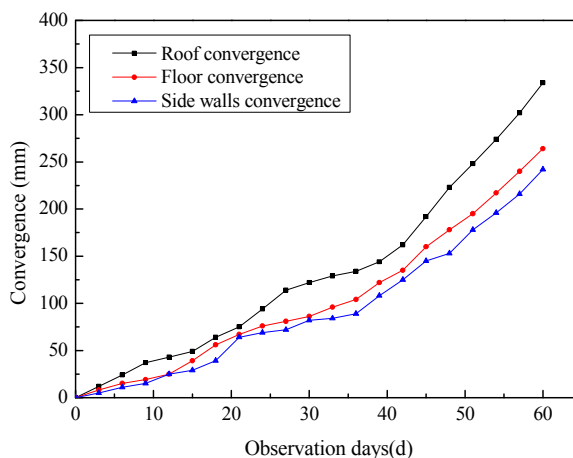
Fig. 3. Roadway deformation observations

(1) The deformation of the roadway is serious. Based on field monitoring, the general convergence and deformation of the roadway is more than 300 mm. Besides that, the failure is mainly induced by large horizontal and lateral pressures. The U-steel shelf arch is twisted and destroyed with large deformation in the short time (as shown in Fig. 2). Floor heave is serious and the deformation of the side walls is severe.

cross section is a irregular semicircular arch, its left side and right side is asymmetric. The height and width of the roadway before deformation is 3500 mm and 3600 mm, respectively. While the height and width of the roadway after deformation is 3200 mm and 3100 mm, respectively. This is because the geological condition of the roadway is complicated.

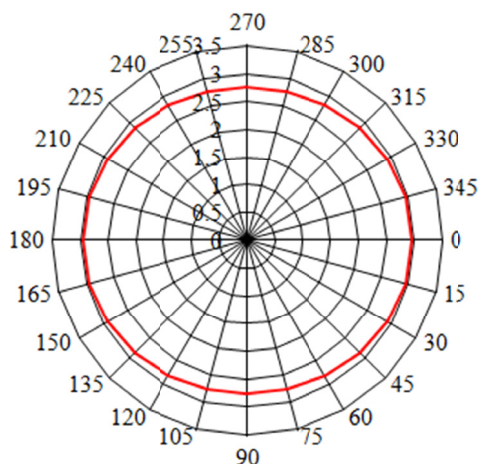
Fig. 5. Plastic zone distribution of soft rock roadway

increase θ from 0 to 360 degrees, the plastic zone distribution of soft rock roadway is shown in Fig. 5, it can be seen that the plastic zone distribution is symmetrical. Moreover, the range of the plastic zone is large, the plastic zone width of the roof, side walls and floor are 2.7 m, 2.9 m and 2.7 m, respectively. The results show that the plastic zone distribution of two side walls is the maximum., and followed by the roof and floor. According to the computational formula, the uniform supporting force is applied to it, actually there is no supporting on the floor, so the distribution of the plastic zone on the floor should be larger, so the floor supporting should be reinforced.

According to the theoretical calculation, the two side walls and the floor are the main areas to be reinforced, so the floor mudsill and grouting anchor cable are applied to the repair of the soft rock roadway. Firstly, the floor mudsill is the important channel to release stress. Moreover, it is a key factor to influence the deformation of the U-steel shelf arch, the floor mudsill should be used for the reinforcement of the floor. Secondly, the long anchor cable can provide active support, which reduces the deformation of the surrounding rock so as to improve the bearing capacity of the rock mass. For one thing, the anchor cable hole is injected with the slurry, which enhances the strength of the surrounding rock, for another thing, by applying the high pre-stress, the surrounding rock can form the bearing arch (Jing et al., 2005).

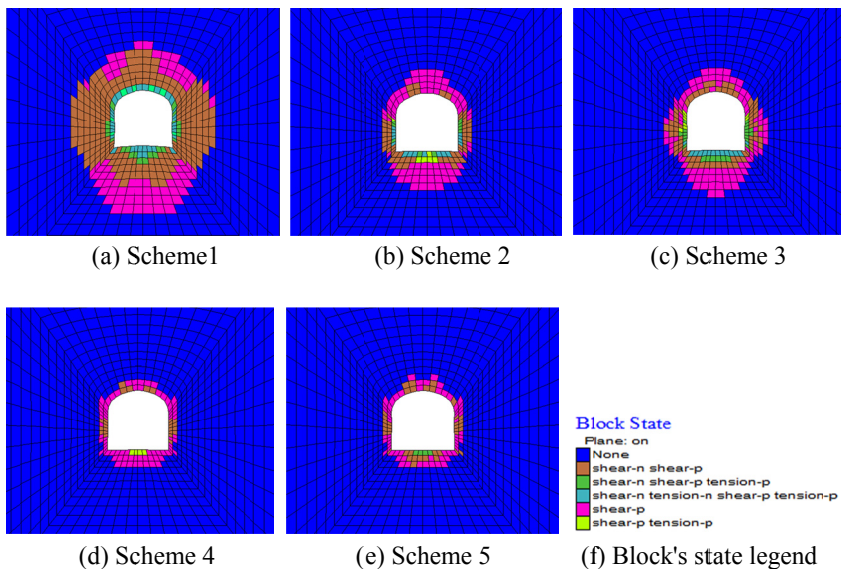
Fig. 7. Roadway plastic zone distribution

As shown in Fig. 7 and Table 4, with the original support scheme, the plastic zone radius of roof, two side walls and floor are 2.54 m, 2.54 m and 3.72 m, respectively. For the new support schemes, the radius of plastic zone on two side walls decreases from 2.54 m to 0.47 m, and the radius of plastic zone on the roof decreases from 2.66 m to 0.58 m, while the floor decreases from 3.72 m to 0.98 m. When the reinforcement of U-steel shelf arch array pitch decreases from 1.6 m to 0.8 m, the radius of plastic zone decreases significantly. However, When the array pitch of the grouting anchor cable increases from 1.2 m to 2.4 m, the plastic zone radius on the two side walls and floor are the same, the plastic zone radius on the roof decreases from 0.91 m to 0.58 m, compared with the plastic zone radius on the roof under original support scheme, there is no obvious influence for the array pitch of the grouting cable increases from 1.2 m to 2.4 m.

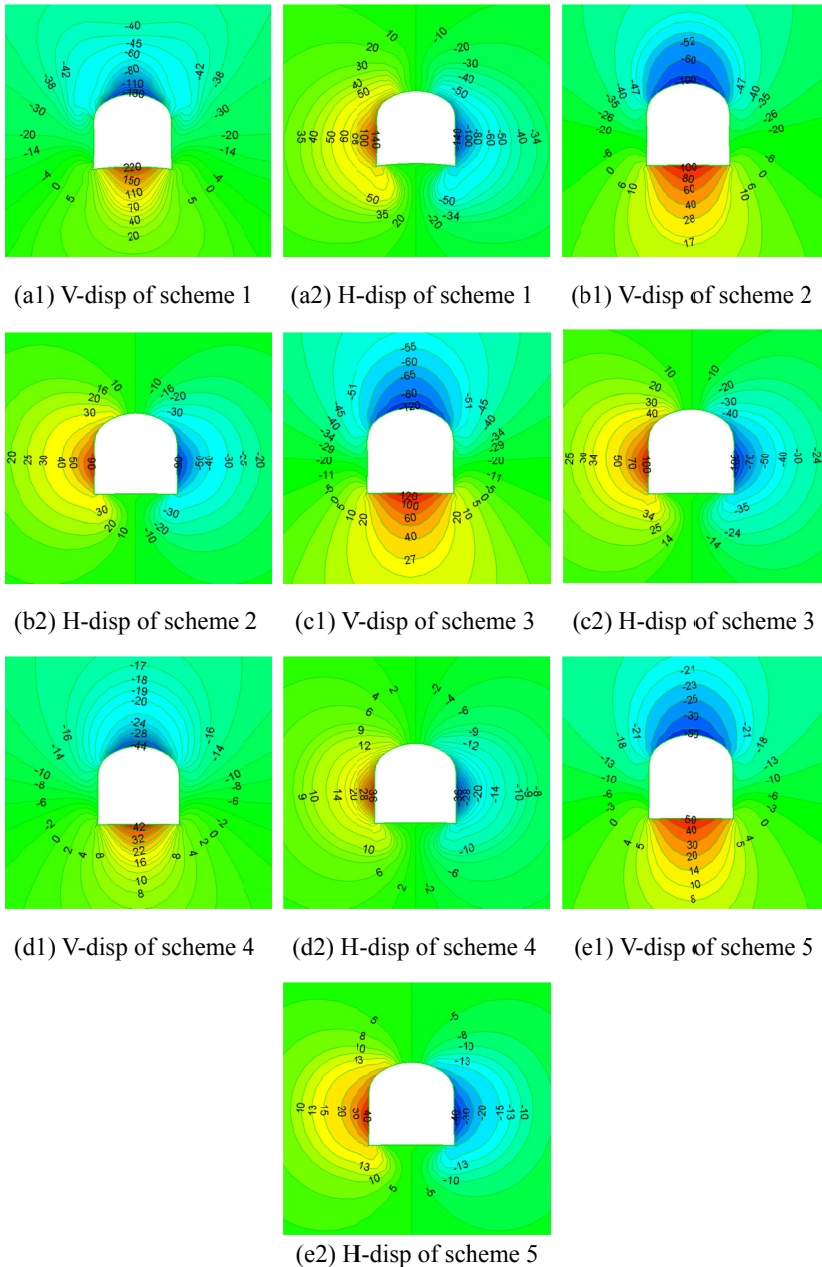
Fig. 8. Displacement of surrounding rock

The nephogram of vertical displacement (V-disp) and horizontal displacement (H-disp) with different support parameters are shown in Fig. 8, and the convergence of two sides walls, roof and floor are listed in Table 5. It is evident from the above that the roadway deforms severely with the original support pattern. The convergence of the roof and floor are 195.8 mm

and 224.9 mm, respectively, while the convergence of two side walls is 153.9 mm. By applying the new support schemes, the deformation of the roadway's surrounding rock decreases greatly. Irrespective of array pitch of the grouting anchor cable, as the array pitch of the U-steel shelf arch decreases, the deformation of the roadway decreases significantly. However, when the array pitch of the grouting anchor cable increases from 1.2 m to 2.4 m, the largest convergences of the roof are 47.5 mm and 54.8 mm, respectively, and the largest convergences of two side walls are 38.3 mm and 44.2 mm, while the largest convergences of the floor are 47.9 mm and 52.1 mm. Hence, according to the comprehensive analysis of displacement distribution and plastic zone distribution of the main haulage roadway for different support schemes, the optical array pitch of the U-steel shelf is 0.8 m, and the optimized array pitch of the grouting anchor cable is 2.4 m.

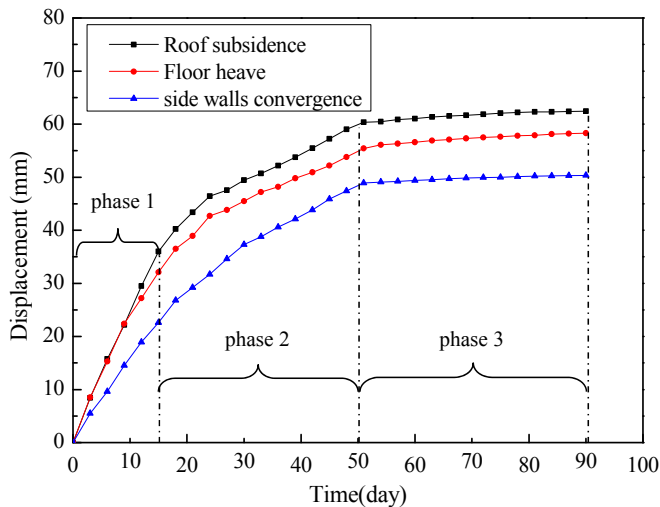
Fig. 9. Displacement of the soft rock roadway

In order to verify the effect of the new reinforcement scheme, the displacement monitoring was done all over the several deformed main haulage roadway, there are 10 monitoring stations all over every monitoring cross section, the space of every two monitoring cross section is 30~50 m. According to the monitoring results, the displacement of the station 1 is the largest, so only the displacement of station 1 is analyzed, the displacement of two side walls, roof and floor is listed in Fig. 9, it can be seen that the maximum convergence of the roof and the floor are 62.44 mm and 58.35 mm, respectively. While the maximum convergence of the two side walls is 50.39 mm.

It is founded that with the new reinforcement scheme, the changing process of the deformation is divided into three phases. The first phase is that the displacement of the main haulage roadway accelerates fast, also the deformation rate is more than 1.0 mm/d, its during time is 0~15 d. Because this phase is just after the new support schemes is implemented, the time is needed for the grouting anchor cable playing a role in the controlling of the roadway. On the second phase, the deformation rate is less than 1.0 mm/d, the deformation increases gradually with time, this stage mainly takes place from 15 to 50 days after adopting the new support scheme, this is because the cement slurry in the anchor cable hole has been solidified, the strength of the surrounding rock increases with time, it indicates that the new support scheme plays an important role in the reinforcement of the main haulage roadway. On the third phase, the displacement remains almost the same value with time, the changing rate of the displacement is nearly stable. This shows that by applying the new support scheme, it realizes the control of the roadway surrounding rock.

In addition, compared with the filed monitoring results and numerical simulation results, it can be seen that the numerical simulation results are consistent with the field monitoring results, the maximum displacement of the two side walls, floor and roof over the deformed main haulage

roadway are 50.39 mm, 58.35 mm and 62.44 mm, respectively. While in the numerical simulation, the maximum displacement of the two side walls, floor and roof over the deformed main haulage roadway are 45.2 mm, 51.10 mm and 54.80 mm, respectively. So the results of the numerical simulation and field monitoring are consistent with each other, which shows that the deformed main haulage roadway is effectively controlled by applying the new reinforcement technology.
