FAILURE CHARACTERISTICS OF W STRAP IN COAL MINE SUPPORT

Keywords: W strap; field observation; laboratory tests; coal mine support; failure characteristics

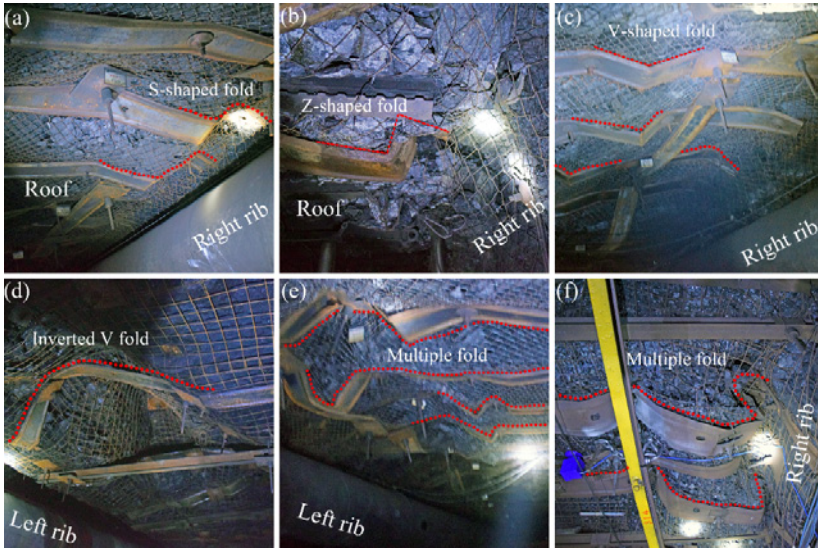
Failure patterns of W strap in the engineering field are exemplified in Fig. 2. The supporting pattern consisted of rock bolts, cable bolts, W straps, meshes, and faceplates, which is a conventional supporting pattern. The strap distortion can be classified as either an S-shaped fold, Z-shaped fold, V-shaped fold, inverted V fold, or multiple folds. These distortion types are representative, as all types of strap distortions in the field can match their type to a specific form in the figure.

Fig. 2. Overall distortions of W straps based on in situ observations

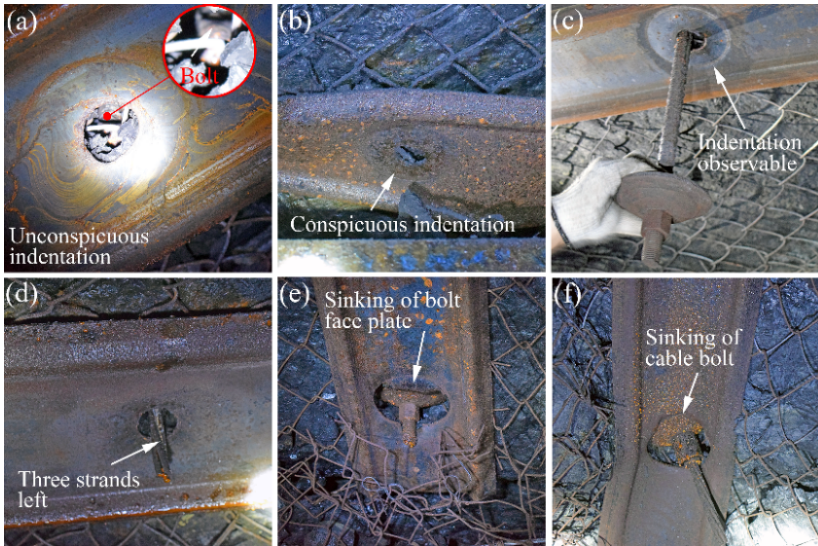
Detailed breakage patterns of the strap-bolt supporting system are shown in Fig. 3. In summary, the rupture of the rock bolt, decoupling, and the rupture of the cable bolt are typical failure patterns for the bolting unit[16], thereby leaving either indentation or shearing through (sinking) on the strap.

Fig. 3. Detailed failure patterns of the strap-bolt supporting system

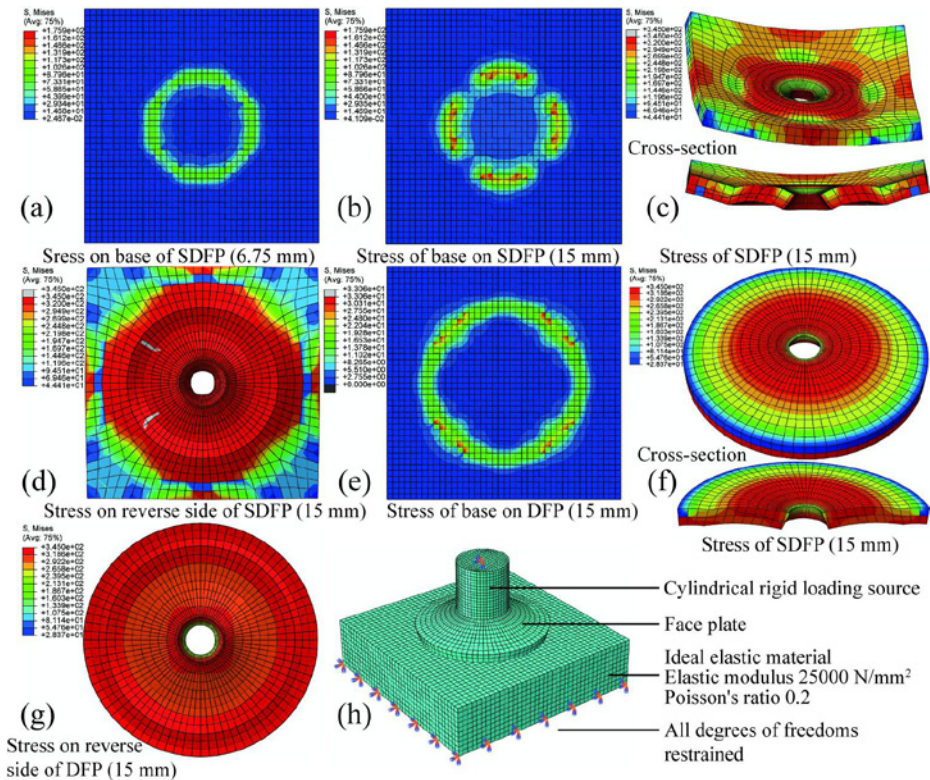
Fig. 4. Numerical simulation results for the square domed face plate and domed face plate

Figs. 4a-b present the stress fields on the base of SDFP configuration at different loading strokes, the diameter of the ring-like stress pattern is just the same as the diameter of the domed part of SDFP when the stroke is 6.75 mm. When the stroke reaches 15 mm, the ring splits into four sections because of the overlarge stress concentration at the edge of the domed part due to the corners warp. Stress patterns in Figs. 4f-h further demonstrates that the domed part of the SDFP is the core for mechanical performance, and the flat section can not provide enough support, especially after the corners warp.

In Fig. 4e, the stress distribution on the base of DFP is exhibited, a vivid ring-like concentration area can be seen, and the diameter is also the same as the diameter of DFP, indicating that the circular edge of DFP is pivotal for loading and transferring. The maximum stress here is lower than that of the SDFP configuration (Fig. 4b) since the load is distributed on a relatively larger 'ring', and the incurred stress will decrease accordingly. The stress pattern on DFP at the end of the stroke (15 mm) also demonstrates an inside-out transferring process, the stress decreases as the distance to the hole centre increases (Figs. 4f-h), and the centre part plays a key role here.

Given the above results, the mechanical behaviour of the DFP configuration, under the numerical simulation setting, can be better than that of the SDFP configuration under identical predefined deformation values.

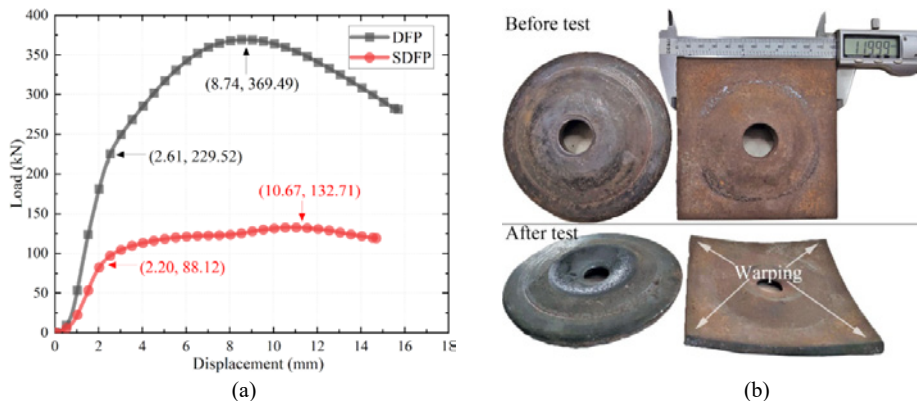
Laboratory compression tests on the faceplates are shown in Fig. 5a. Both stiffness and the peak load for the DFP are much larger than the SDFP. The peak force for the DFP is 369.49 kN, which is 2.78 times the peak load (132.71 kN) of the SDFP. In Fig. 5b, the failure patterns are presented. Warping of the corners is shown for the SDFP, and this phenomenon conforms with the numerical results. Overall, the mechanical property of the SDFP is mainly determined by the outer edge of the domed part. For the DFP, the outer edge is the load bearing ring before the failure.

Fig. 5. Compression test results on the domed face plate and square domed face plate

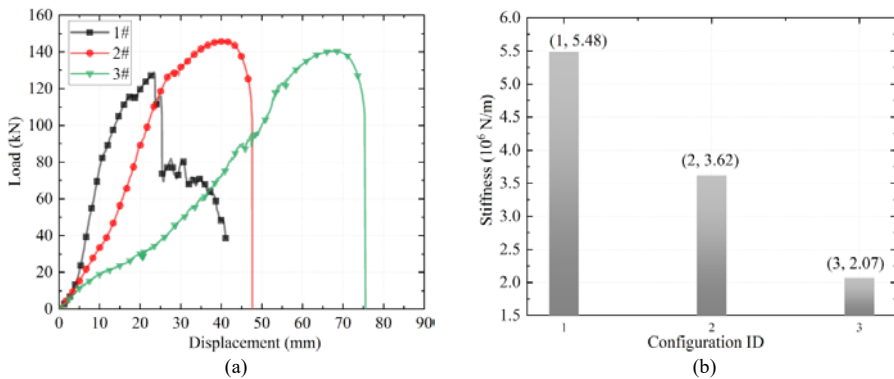
Fig. 9. (a) Load-displacement relationship for configuration #1~#3,
(b) stiffness decreasing trend for configuration #1~#3

Testing configurations were labelled as configurations #1, #2 and #3 in accordance with the patterns in Fig. 8. The loading rate is set as 10 mm/min, and then the results are plotted in Fig. 9a. The peak loads and displacements at the peak for configurations #1, #2 and #3 are 128.62 kN, 23.47 mm, 145.78 kN and 40.22 mm, and 140.43 kN and 67.67 mm, respectively, and the stiffness is plotted in Fig. 9b. For configuration #1, since the gravelled layer is compact, the buckling of the strap can be avoided, and the bearing capacity of the system is more likely to be determined by the strength of the bolt, faceplate, or nut. This result is supported by field observations where some supporting systems failed with a bolt rupture while the affiliated components were undamaged, as shown in Fig. 3a.

The inner wall of the circular hole in configuration #2 is not stable because it was constructed with gravel which will collapse under loading. Therefore, a relatively small stiffness is expressed, or an apparent sinking of the faceplate is observable. For configuration #3, it is unlikely for the inner concrete wall of the circular hole to collapse. The stiffness of the system is even smaller because the sinking and shearing of the faceplate are the main factors that should be considered.

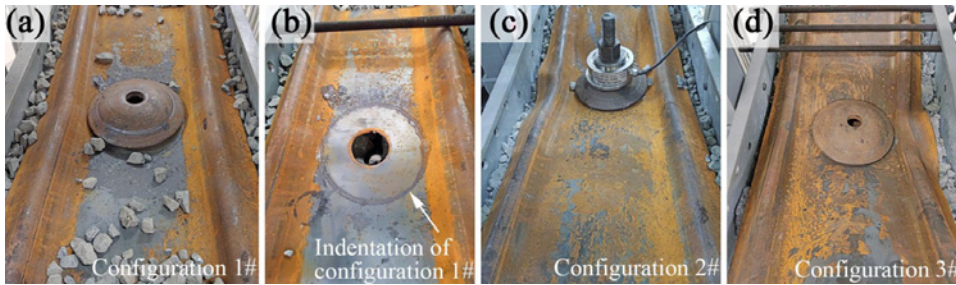
Fig. 10 lists the eventual failure patterns for all specimens. All tests are terminated by bolt rupture. The faceplates barely express the deformation and no distortion can be observed since the maximum loading to deformation of the faceplate is 369.5 kN (Fig. 5a), which is much higher than the peak values in Fig. 9a. Regarding the distortion of the strap, the strap in configuration #1 exhibits the smallest distortion, and only some small-scale bend can be seen (see Fig. 10a). The shearing stress on the concentration ring of the faceplate is co-sustained by the gravel and the strap. Fig .10b shows an indentation on the strap.

For configuration #2, the strap distortion becomes apparent (Fig. 10c). The pre-prepared hole beneath the centre hole of the strap amplifies the shearing role (sinking) of the faceplate. However, a collapse of the hole is unavoidable, thus diminishing the shearing stroke of the faceplate and alleviating the strap distortion. For configuration #3, the inner wall will not collapse if the load is appropriate. Then, the shearing stroke will not be diminished, eventually leading to even more apparent distortion of the strap, as seen in Fig. 10d.

Fig. 10. Distortion patterns for straps

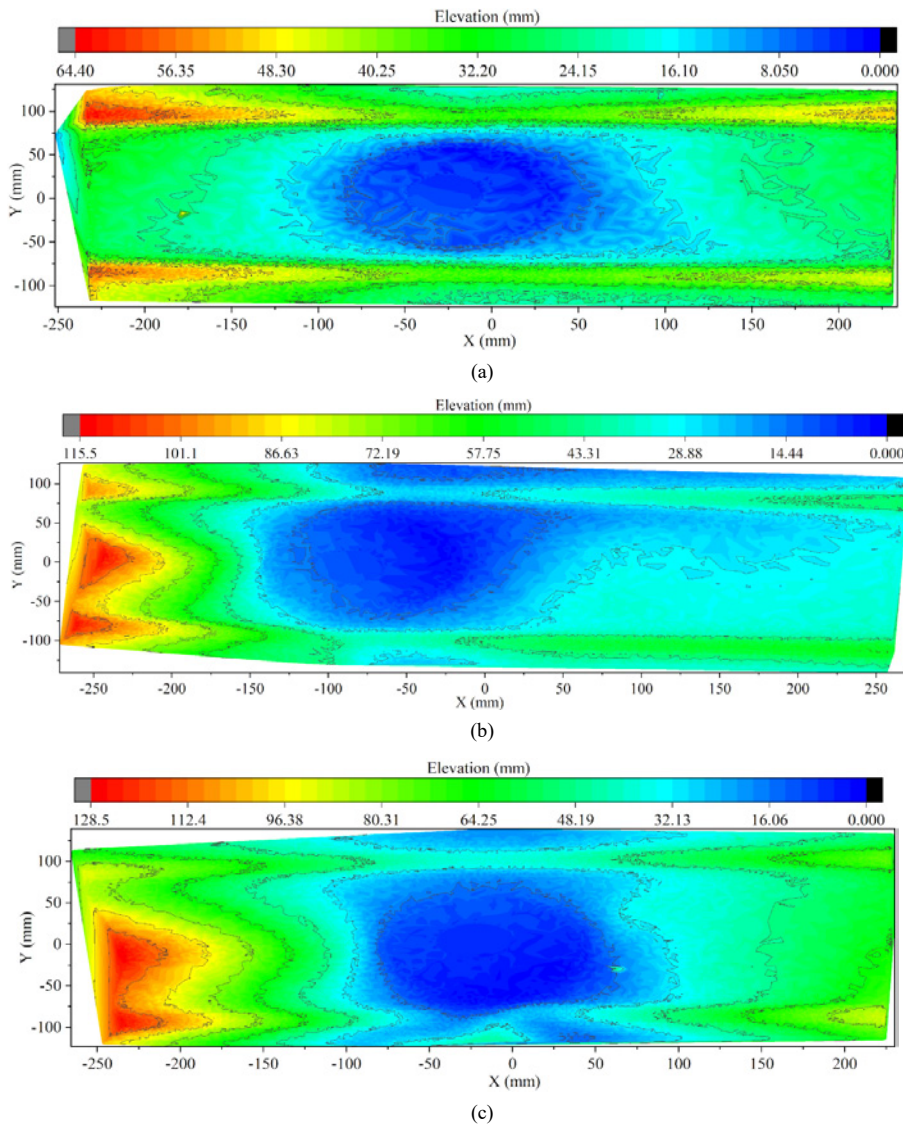
For configuration #1 (Fig. 11a), the distortion field has a good symmetry property, and the deep blue area indicates the indentation scope due to compression of the faceplate. Overall, the distortion looks similar to the V-shaped fold proposed in Fig. 2. For configuration #2, the left section has a comparatively intense distortion, while the distortion in the right section is relatively gentle. The large scope of the blue areas in Fig. 11b indicates a high degree of sinking due to the shearing of the faceplate. For configuration #3, the V-shaped fold distortion is more apparent (Fig. 11c). The deep blue area indicating a sink is roughly rectangular-shaped, and the spreading scope is limited because the inner wall of the reserved hole is unlikely to collapse. The distortion degree is the highest in all configurations.

Fig. 11. Cloud maps for deformed straps in configuration #1~#3

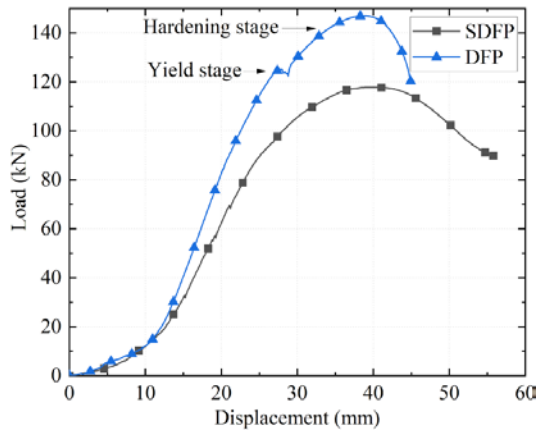
Fig. 12. Displacement-load relationship for a DFP and SDFP configuration

The mechanical behaviours of the SDFP and DFP are compared in this section. The configuration is the same as the No. 3 in Fig. 8, the dimensions of the SDFP are 120*120 mm in edge length and 10 mm thick. All of the loading conditions are unchanged. The testing results are shown in Fig. 12. The peak load and the displacement at the peak for the SDFP and DFP are 117.77 kN-39.22 mm and 146.97 kN-38.84 mm, respectively, and the stiffness for the SDFP and DFP are $3.00*10^6$ N/m and $3.78*10^6$ N/m, respectively. The above result proves that the DFP has a higher strength. The loading relationship for the DFP configuration is very similar to the bolt tensile curve, as can be revealed by the yield stage, hardening stage, and necking stage. The mechanical response is comprehensively dependent on the tensile behaviour of the bolt and the sinking of the faceplate.

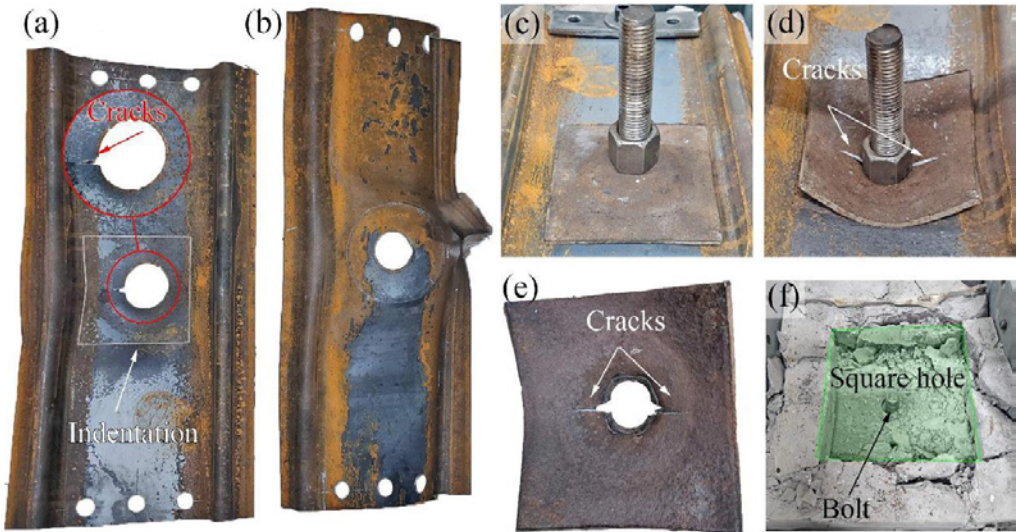
The strap distortion of the SDFP configuration is not very severe when compared with that of the DFP configuration (Fig. 13a-b). The middle right section of the strap for the DFP configuration is extremely warped. A sharp crack is noticed in the strap of the SDFP configuration (Fig. 13a). The crack was caused by squeezing the nut when the faceplate was reversely deformed (Fig. 13d). The pattern before the test is shown in Fig. 13c. The reverse side of the SDFP is appended in Fig. 13e, where cracks can also be seen. The morphology of the concrete hole beneath the strap after the test is shown in Fig. 13f.

Fig. 13. Test photos for the SDFP and DFP configuration. Strap distortion of the SDFP configuration (a) and the DFP configuration (b), (c) SDFP configuration before the test, (d) failure pattern of the SDFP configuration after the test, (e) wrong side of the SDFP after the test, (f) breakage pattern of the simulated square hole after the test

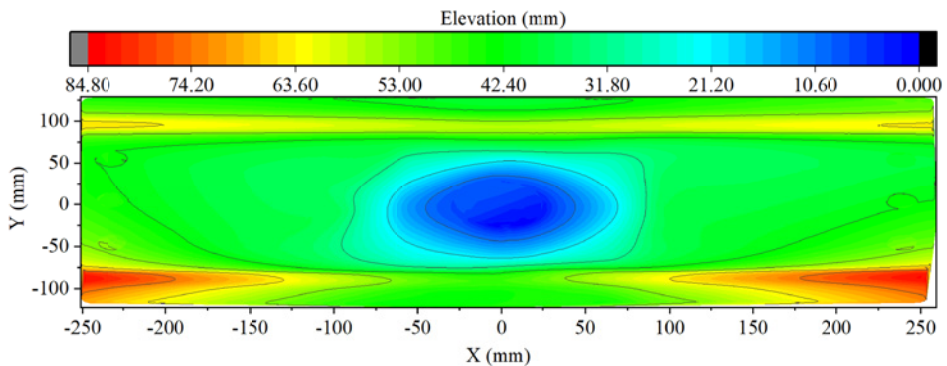
A cloud diagram revealing the surface elevation of the strap in the SDFP configuration is shown in Fig. 14. In Fig. 14a, most areas on the surface of the strap express no apparent distortion, the centre area behaves with the lowest elevation, and the outer contour line in this area is quite similar to the size of the square domed faceplate. To be more specific, the oval-shaped blue area at the centre indicates a severe sinking and is influenced by the sinking of the nut at a later stage.

Fig. 14. Scanned cloud view of strap distortion in the SDFP configuration

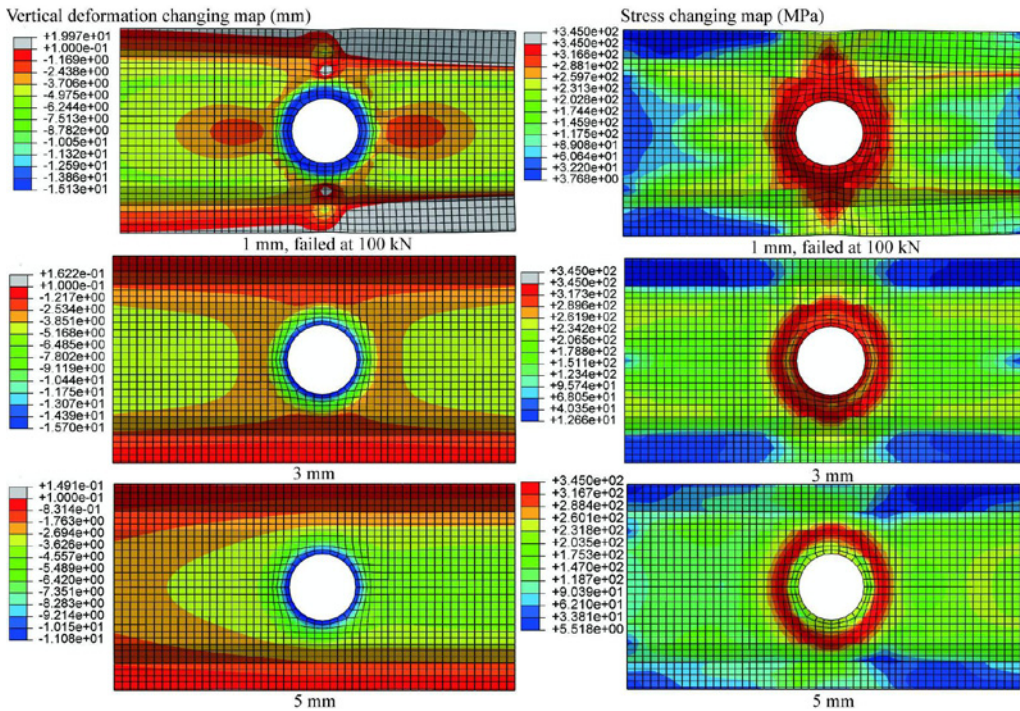
Fig. 15. Mechanical responses of straps with different thickness based on numerical simulation

The results are listed in Fig. 15 and show that the 1 mm strap failed when the load reached 100 kN. The left three cloud maps are deformation changing fields for straps with a thickness of 1 mm, 3 mm and 5 mm, respectively. The deformation values were comparatively conservative compared with the experimental scenario. It was mainly due to the boundary conditions of the numerical model that could be more precisely controlled. When the strap thickness is 1 mm, the upward warp at the lower flanks can be seen, and the maximum value is 19.97 mm. For a 3 mm and 5 mm strap, no apparent warp can be noticed, and an insignificant difference can be seen between them, considering the deformation values were at different parts.

The right three cloud maps in Fig. 15 are stress changing fields for the straps. The stress distribution of the 1 mm strap can be more extensive, buckling and stress concentration are observable, and it failed at 100 kN. Comparing the 3 mm and 5 mm strap, the stress patterns at a 200 kN loading indicate that the 3 mm strap can be more sensitive in transmitting stress to its flanks and the loading circle is more influential, and the overall lower stress on the 5 mm strap demonstrates more favourable reliability. Nonetheless, the 3 mm thickness strap can satisfy the supporting effects considering the material cost and mechanical characteristics at the same time. Therefore, a 3 mm strap is a reasonable selection for coal mine support if the maximum load on the faceplate is lower than 200 kN, and a 4 mm or 5 mm W strap should be more acceptable if the rock stability diminishes.

(4) Additional numerical simulation indicates that a strap with 3 mm thickness is a proper selection, and favourable supporting effects can be obtained when it cooperates with DFP. The shearing strap failure due to the DFP edge should be discussed further by considering the influence of stress corrosion and humidity.
