Characterization of oxide layers formed on 10CrMo9-10 steel operated for a long time in the power industry

Abstract. This paper presents the results of diagnostic examinations conducted on the coils of super-heaters made of 10CrMo9–10 steel that were operated in industrial conditions at 480°C for 130 thousand hours. The tube was exposed in a coal-fired boiler. The chemical and phase composition of the oxide/deposit layers formed on both sides of the tube walls (outside – flue-gas side and inside – steam side) and their sequence was examined using optical microscopy, scanning electron microscopy with electron backscatter diffraction and energy-dispersive X-ray spectroscopy, and X-ray diffraction. The changes in the mechanical properties caused by corrosion and aging processes were concluded from the hardness measurements. In addition, the nature of cracks in the oxide layers caused by pressing a Vickers indenter was determined. The results of these examinations have shown a high degradation of steel on the flue-gas inflow side and identified the main corrosion products and mechanisms.

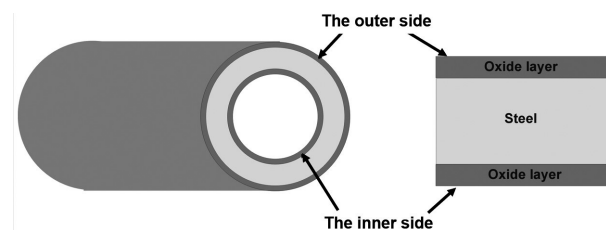
Fig. 1. Positions of the samples used for microstructure analyses

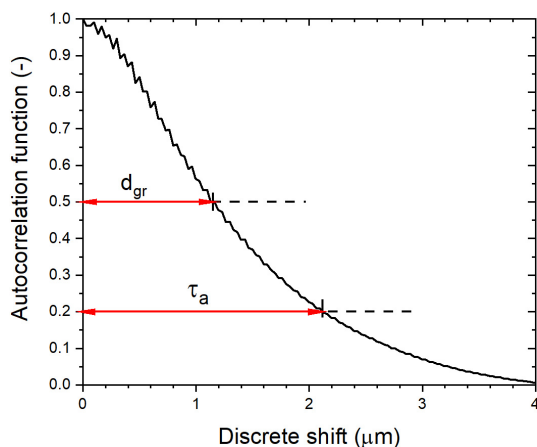
Fig. 11. Example of the autocorrelation function demonstrating the method of estimation of the grain size d_{gr} and lateral autocorrelation length τ_a

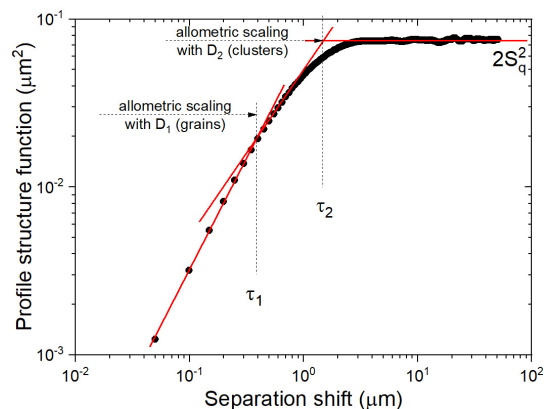
Fig. 12. Example of a log-log plot of the structure function demonstrating the method of estimation of the fractal dimension D and corner frequency τ that separates scaling behaviors of structures of various orders (particles and their aggregates)

Table 3 summarizes the spatial characteristics of the surfaces derived from SEM images. Both surfaces turn out to be bifractal, which means that there are two regimes of the allometric scaling behavior, as seen in Fig. 12. Differences in the scaling exponents can be traced back to the cluster morphology of the structures on the surface reflected by alignment patterns of various length orders. The first regime, limited to the elements of the clusters, is described by the fractal dimension D_1 , which determines the relative scaling behavior of the surface variations between the particles, and the corner frequency τ_1 , that
