J. PIKUŁA*[#], M. ŁOMOZIK*, T. PFEIFER***THE INFLUENCE OF MANUAL METAL ARC MULTIPLE REPAIR WELDING OF LONG OPERATED WATERWALL ON THE STRUCTURE AND HARDNESS OF THE HEAT AFFECTED ZONE OF WELDED JOINTS**

Keywords: repair welding, waterwall, manual metal arc welding, power engineering, HAZ

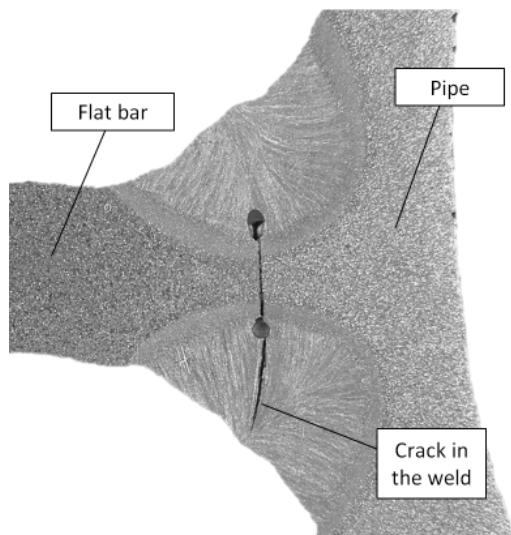
Fig. 1. Crack in a weld of a long operated waterwall

The operation of waterwalls leads to various defects generation, including [8]: the distortion of a panel by more than ± 50 mm, a crack passing through the thickness and along a flat bar, cracks in welded joints located along flat bar and opening on the tube wall side (Fig. 1), cracks in the base material of tubes, tube material delamination reaching the surface and fragments torn out of the tube wall reducing its thickness. Cracks

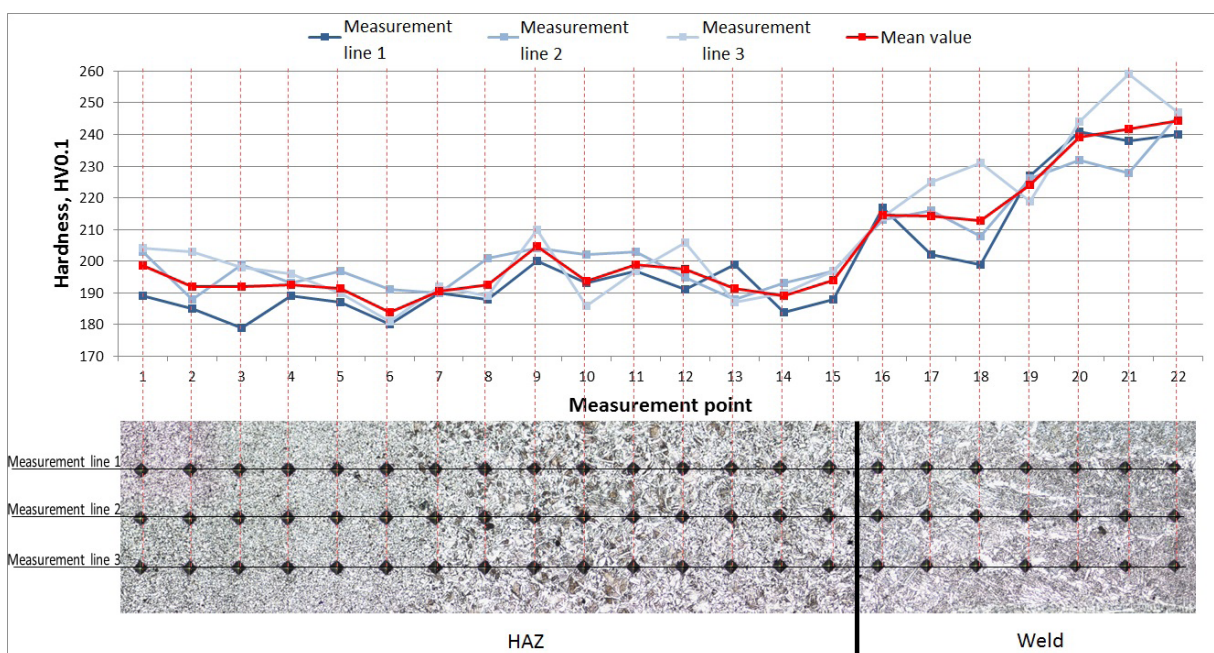
Fig. 5. Microhardness distribution in the HAZ and in the weld of the second MMA welded repair joint, the weld on the right

The grain refinement in the HAZ near the fusion line, presented in Fig. 3, decreased the HAZ hardness in this area (measurement points 12-15 in Fig. 5). In spite of the coarse-

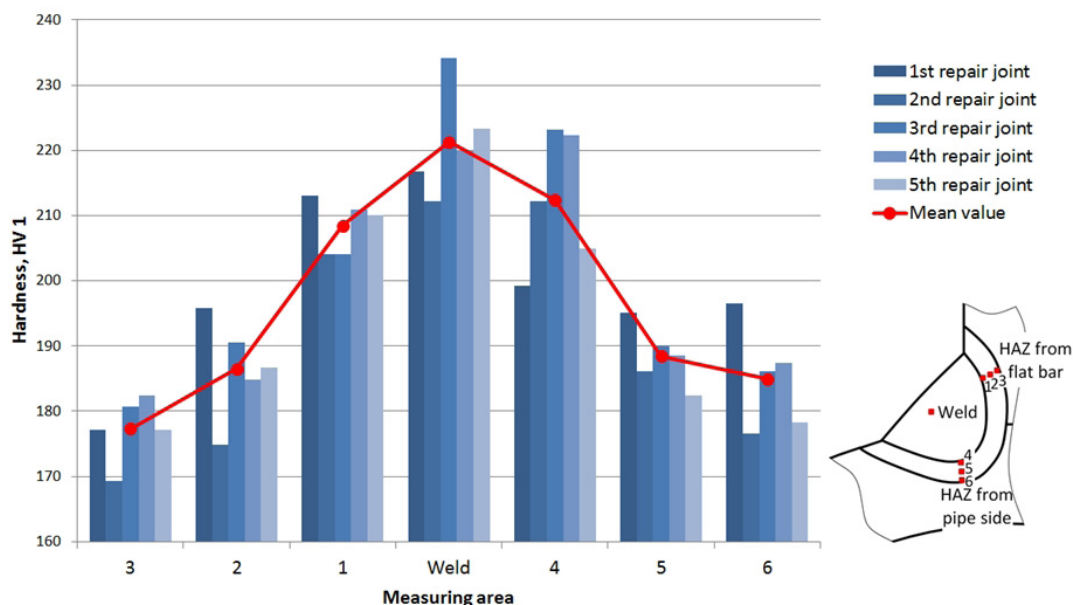
Fig. 11. Values of hardness in the weld and in the individual HAZ areas of the successive MMA welded repair joints; measurement areas according to diagram on the right

distribution in the HAZ. The HAZ of the joint near the fusion line was characterised by lower hardness values than those present further from the weld (the red arrow in Fig. 10). The successive repair welding processes affected hardness in the individual HAZ areas (Fig. 11), yet that influence did not result from the number of repair welding processes but from the manner in which the weld was made in the joint.
