M. UHRÍČIK^{1*}, P. PALČEK¹, M. CHALUPOVÁ¹, P. HANUSOVÁ¹, L. KUCHARIKOVÁ¹**ANALYSIS OF THE PROPERTIES OF EN AC 51200 ALUMINUM ALLOY**

The article will be focused on analysis of properties of aluminum alloy for the casting of type Al-Mg. As an experimental material was used aluminum alloy EN AC 51200, supplied in a cast state without a heat treatment. It was produced by the continuous casting method. Experiments deal with microstructural material analysis, fractographic analysis, mechanical and fatigue tests. The microstructure of the testing sample was examined using an optical microscope Neophot 32. Fatigue properties of aluminum alloy was tested by three-point bending cyclic loading. The fracture surface of the testing sample was examined using scanning electron microscopy (SEM), where sample was observed on various stages of the fatigue process, its characteristics and differences of fracture surfaces.

Keywords: aluminum alloy, Al-Mg cast alloy, three-point bending loading, fatigue, fracture surface

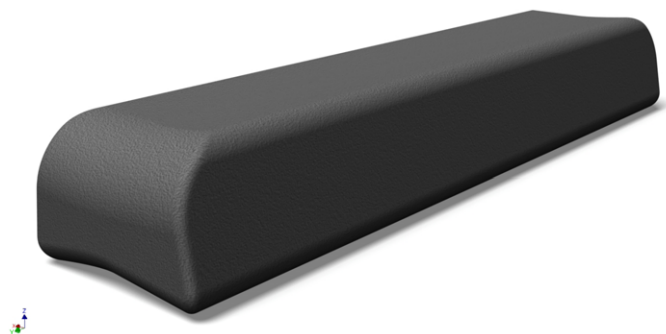
Fig. 1. An ingot of aluminum alloy EN AC 51200

Commercial aluminum alloy EN AC 51200 was used as an experimental material, supplied by its respective manufacturer in a cast state without heat treatment in the form of ingot (Fig. 1). It was produced by the continuous casting method. The real chemical composition of this alloy was examined by spark emission spectrometer SPECTROMAXx and result is shown in Table 1.

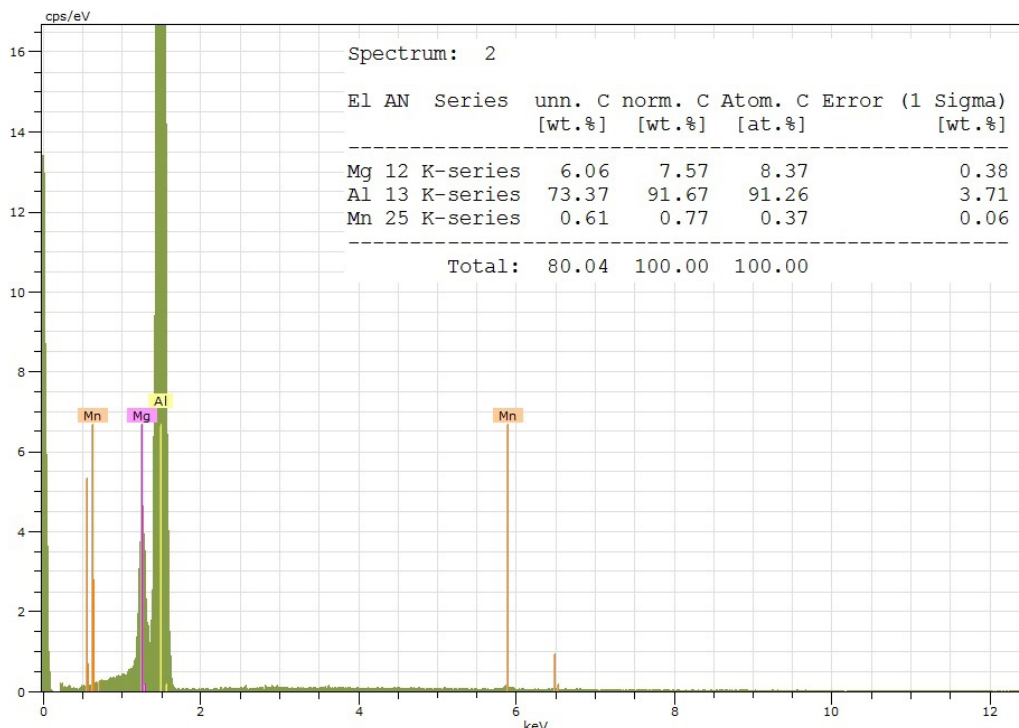
Fig. 5. Spectrum and quantified content of elements in the microstructure for the point 2 from Figure 3 – a matrix

on which the point microanalysis was performed. From Figures 4 to Figures 7, there are spectrums which confirm the presence of individual phases.
