ARCHIVES FOUNDRY ENGINEERING

Physicochemical Properties of Silicon **Cast Iron**

The article presents results of pitting corrosion studies of selected silicon cast irons. The range of studies included low, medium and high silicon cast iron. The amount of alloying addition (Si) in examined cast irons was between 5 to 25 %. Experimental melts of silicon cast irons [1-3] were conducted in Department of Foundry of Silesian University of Technology in Gliwice and pitting corrosion resistance tests were performed in Faculty of Biomedical Engineering in Department of Biomaterials and Medical Devices Engineering of Silesian University of Technology in Zabrze. In tests of corrosion resistance the potentiostat VoltaLab PGP201 was used. Results obtained in those research complement the knowledge about the corrosion resistance of iron alloys with carbon containing Si alloying addition above 17 % [4-6]. Obtained results were supplemented with metallographic examinations using scanning electron microscopy. The analysis of chemical composition for cast irons using Leco spectrometer was done and the content of alloying element (silicon) was also determined using the gravimetric method in the lab

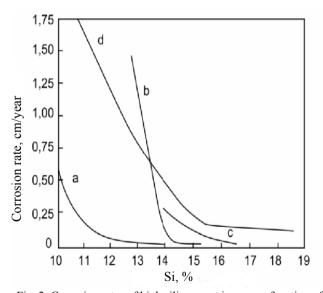
Fig. 2. Corrosion rates of high silicon cast irons as a function of silicon content and corrosive media.

a – 70% HNO₃ solution, boiling point, b – 20% H₂SO₄ solution, boiling point, c – 10% HNO₃ solution, boiling point, d – 10% HCl solution, temp. 80°C [12]

Figures 1 and 2 show the effect of silicon content on the corrosion rate according to the corrosive environment and temperature.

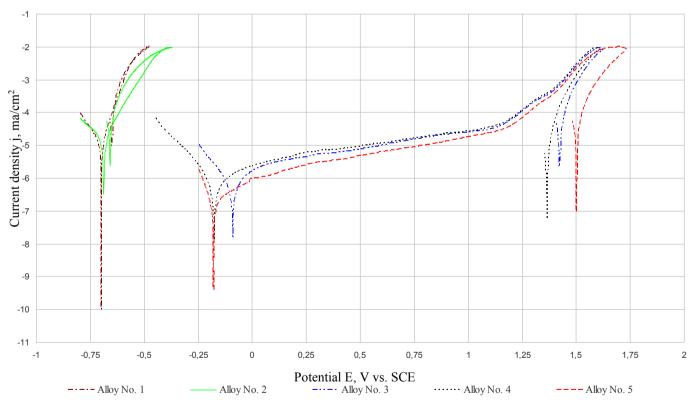
Results of potentiodynamic tests of pitting corrosion resistance were shown in Table 2 and Figure 9.

Fig. 9. Polarization curves for the tested alloys

The confirmation of obtained results (Fig. 9) of potentiodynamic testings are the photos of pitting type defects (Fig. 10, Fig. 11) on the surface of samples Alloy No. 1 and Alloy No. 2, while for the melts with the content of Si above 16% compact passive layer and no pitting type defects were noticed (Fig. 12).
