MATERIAL ULTRASONIC ATTENUATION INFLUENCE ON CONVENTIONAL ULTRASONIC NON-DESTRUCTIVE COPPER ALLOY CAST TESTING

Keywords: Ultrasonic testing, ultrasonic attenuation, copper alloy casting, centrifugal casting

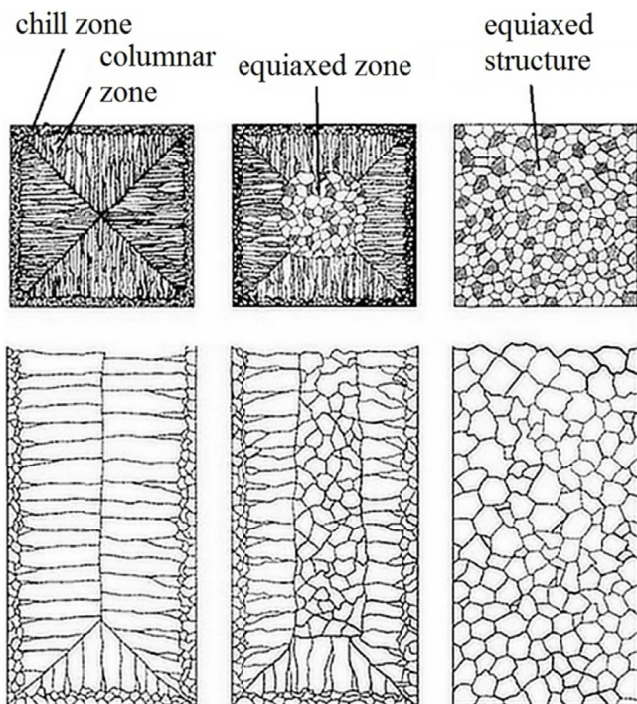
Fig. 1. Schematic illustration of three cast structures of metal: a) pure metal, b) solid-solution alloys, c) structure obtained by using nucleating agents [1]

Ultrasonic testing of castings is difficult because castings have usually a large anisotropic structure grain. The heterogeneous anisotropic cross-sectional structure of a casting is caused by a different cooling conditions during solidification of the casting in the mold (Fig. 1) [4,7,9].

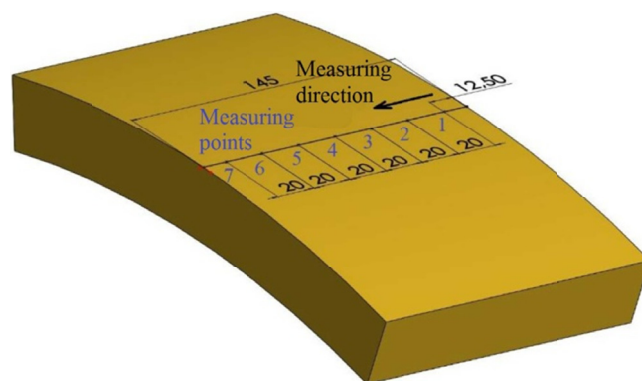
Fig. 2. Scheme of measuring direction and probe position for experiment

The probe with a frequency of 5.00 MHz has a type designation SM-A551, 3.50 MHz probe has designation A550S-SM, probe with frequency 2.25 MHz has designation C606 and probe with frequency 1.00 MHz has designation C603. The experiment was conducted on the outer surface of the ring in the seven points. The measurement line was positioned parallel to the axis of the ring. The measurement scheme is illustrated on Fig. 2.

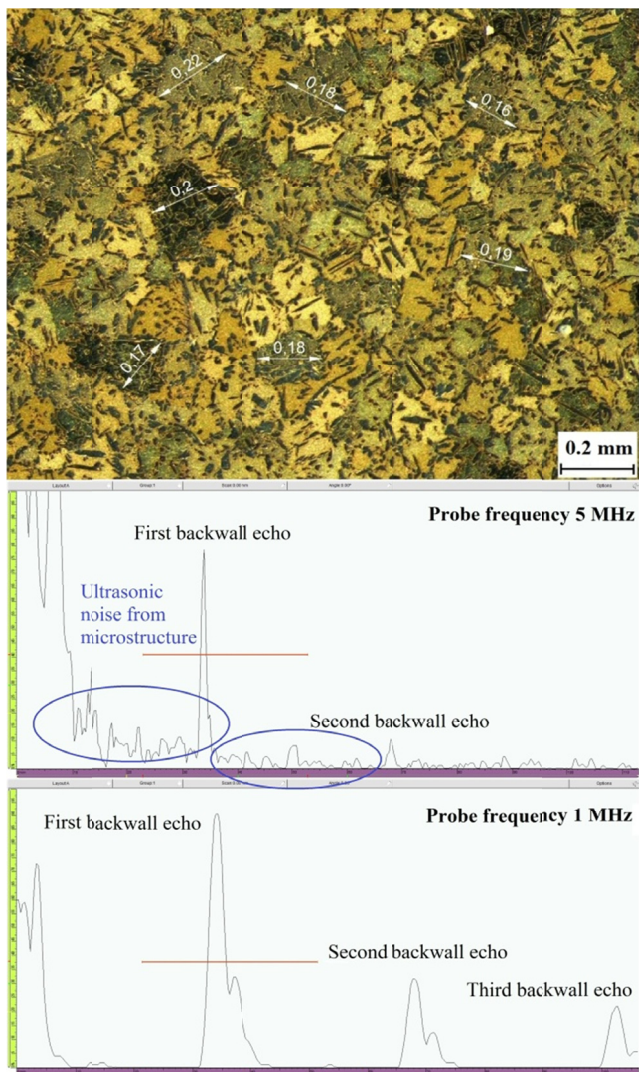
Fig. 4. Brass microstructure in point No. 1 (top), 5 MHz echogram (middle) and 1.00 MHz echogram (bottom)

Microstructure photo in point 1 with echoes obtained with 5.00 MHz and 1.00 MHz probes is on Fig. 4. The average grain size in point 1 is 0.19 mm. This grain size causes a significant attenuation at the 5 MHz frequency. Significant attenuation is visible on the echogram as the ultrasonic signal noise from microstructure located between the transmitting pulse and the backwall echoes. Only two echoes are present on an echogram at a 5.00 MHz frequency. The attenuation noise from microstructure is not visible when using a 1 MHz frequency probe, which is due to a lower attenuation due to a lower frequency. Three backwall echoes are on echogram.

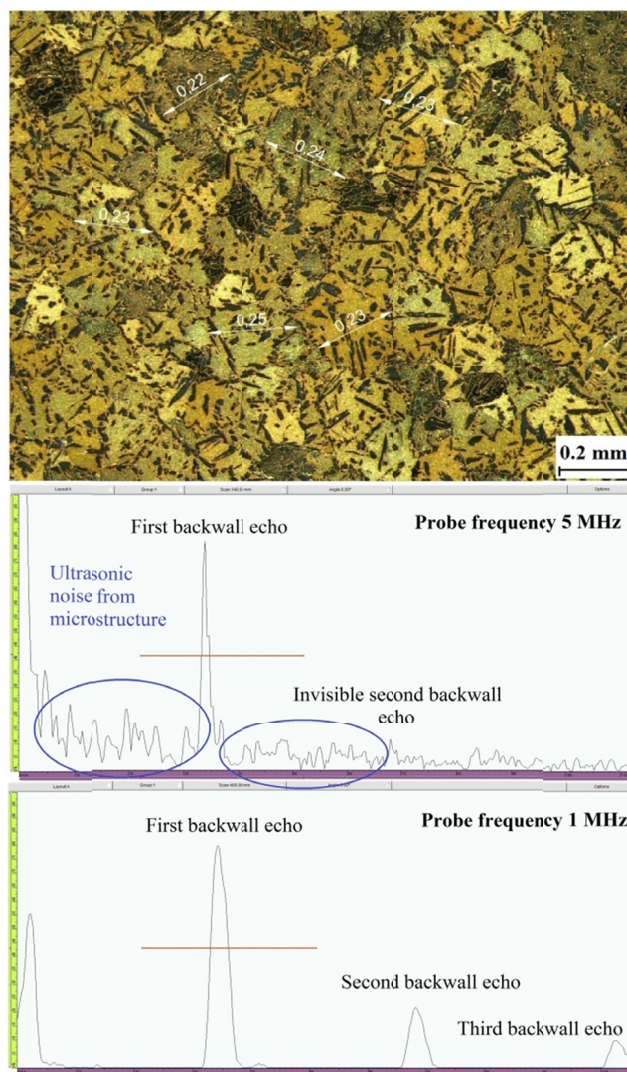
Fig. 5. Brass microstructure in point No. 2 (top), 5 MHz echogram (middle) and 1.00 MHz echogram (bottom)

The average grain size in point 2 is 0.24 mm. The increasing grain size is caused by increasing attenuation at the 5 MHz frequency. The increasing ultrasonic signal noise from microstructure is visible on the echogram located between the transmitting pulse and the backwall echoes again. Only one backwall echo is present on an echogram at a 5.00 MHz frequency, second backwall echo is invisible, due to high attenuation. The 1.00 MHz echogram is without visible attenuation from microstructure.

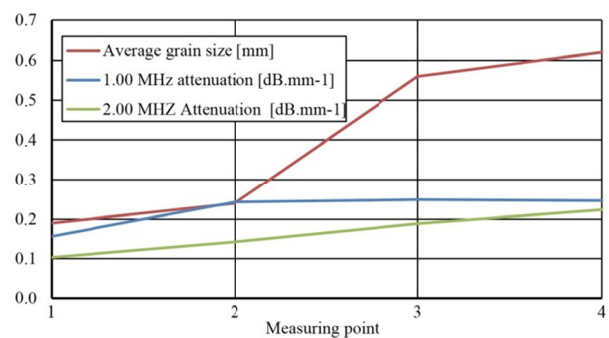
Fig. 8. The dependence of the attenuation on the grain size

The results of attenuation measurements and microstructure evaluation confirmed that increasing grain size increases ultrasound attenuation, which is directly proportional to the used probe frequency. The dependence of the attenuation on the grain size is on Fig. 8.
