Research paper

Experimental and numerical verification of the standard procedure for determining the load capacity of GFRP composite lighting columns

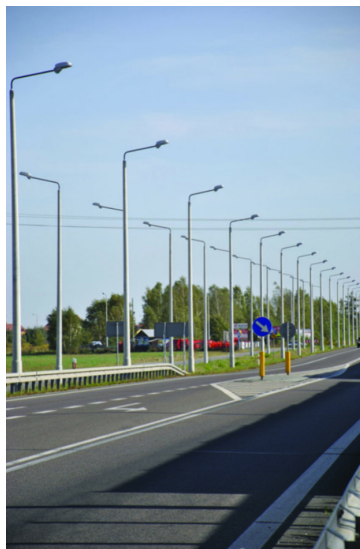
Fig. 1. Composite circular GFRP lighting poles [2]

It was necessary to introduce new, secure, and environmentally friendly technological and material solutions in response to the increasing demand for column load-bearing structures in the energy, road, and railway industries that better functional properties would distinguish. Traditional building materials, like wood, steel and concrete, which have been used for many years to construct transmission and lighting poles, only partially meet the criteria for sustainable development and environmental preservation [1]. Over the last 25 years, significant progress has been made in introducing lighting and transmission poles made of polymer composites reinforced with various fibres (FRP) to the energy market. FRP fibre-reinforced composite poles represent a modern engineering solution where sustainability plays an important role (Fig. 1).

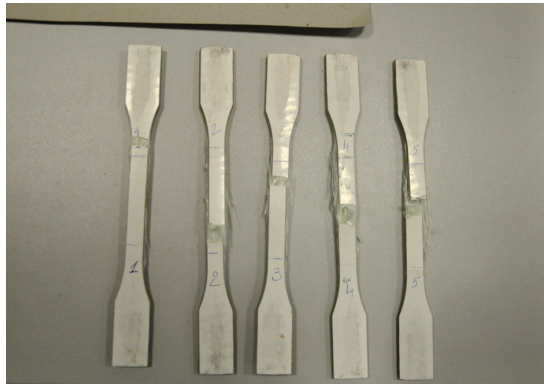
Fig. 2. View of the samples after a static tensile test

The strength of lighting columns should be determined, taking into account the cross-sectional features giving the lowest values of the bending load capacity. The verification of the bending resistance of the column was carried out according to [5], taking into account the amendments contained in [12]. The characteristic strength of the material of the lighting columns made of polymer composites was determined according to [13]. The mechanical properties of the composite material taken from the tested elements were determined on the basis of tests carried out on the Zwick Roell BPS-HP004 machine, including the determination of mechanical properties during static tension of fiber-reinforced composites and a bending test (Fig. 2).

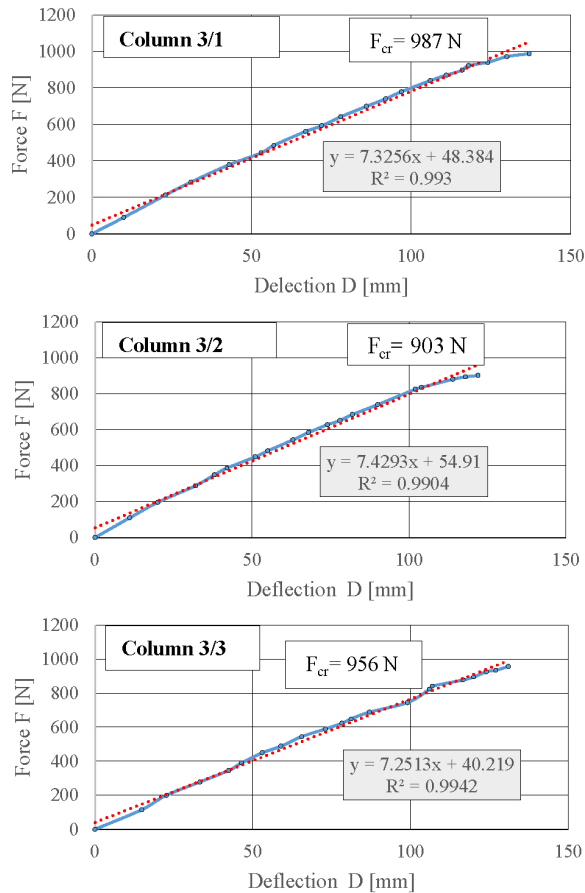
A static equilibrium path was used to describe the behaviour of the tested columns, described in the coordinate system: loading force F and column end deflection Δ . The recorded $F - \Delta$ relationships for the 3 m column are shown in Fig. 7.

The graphs also show the equations of straight lines approximating the course of the graphs and the values of the coefficient of determination R^2 , showing that the equations fit the graph (R^2 value close to one). The course of the equilibrium path and the linear form of the straight line mapping the graphs testify to the elastic behaviour of the columns during their loading until failure. Based on the diagrams, the columns' stiffness and ultimate load capacity were determined. The stiffness S_j was determined as the tangent of the inclination angle of the approximation line.

Fig. 7. Static balance paths ($F - \Delta$) columns 3.0 m high
