PIOTR STRZAŁKOWSKI¹

Resource management in conditions of occurrence of linear discontinuous deformations

mining extraction influences, mining deformations, steps in ground

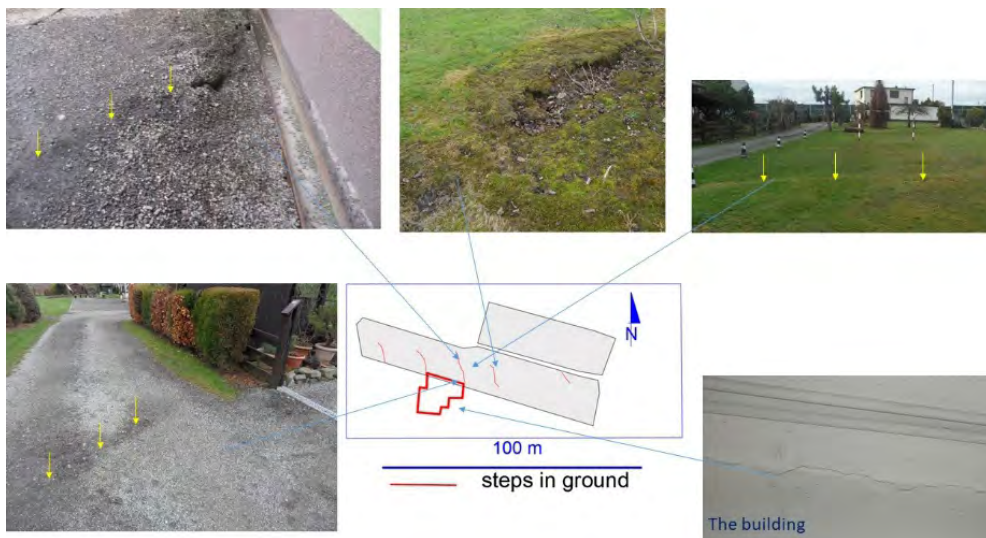
Fig. 3. View of discontinuous linear deformations formed in years 2015–2021

A series of linear discontinuous deformations were observed in the study area as ground steps with heights up to about 20 cm. These deformations traversed the terrain of the southern plot marked in Figure 3. The course of the deformations is marked with red lines. Two of these deformations reached the north wall of the building and likely affected the building itself, causing cracks in its load-bearing walls. Photographs documenting the course of deformations and damage to the walls are also shown in Figure 3, with arrows indicating which deformations they refer to. While discontinuous linear deformations are not uncommon nowadays, micro-sinkholes with oval shapes and diameters of up to about 0.5 m and depths of up to several tens of centimeters were observed along their course.
