Field test and numerical studies of the scissors-AVLB type bridge

Abstract. Scissor bridges are characterized by high mobility and modular structure. A single module-span consists of two spanning parts of the bridge; two main trucks and the support structure. Pin joints are used between modules of the single bridge span. Some aspects of the experimental test and numerical analysis of the scissor-AVLB type bridge operation are presented in this paper. Numerical analyses, presented here, were carried out for the scissors-type BLG bridge with treadways extended as compared to the classical bridge operated up to the present in the Armed Forces of the Republic of Poland. A structural modification of this kind considerably affects any changes in the effort of the force transmitting structure of the bridge. These changes may prove to be disadvantageous to the whole structure because of torsional moments that additionally load the treadways. Giving careful consideration to such operational instances has been highly appreciated because of the possibility of using this kind of bridges while organizing the crossing for vehicles featured with various wheel/track spaces (different from those u

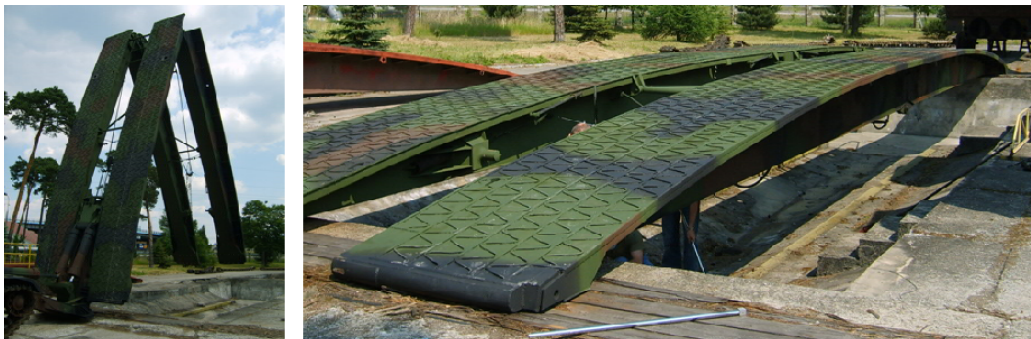
Fig. 1. A view of the tested BLG bridge during the deployment process, the stand intended for tests and examinations of BLG bridge that is deployed to a crossing position

Field tests on an actual structure of a BLG scissors-type bridge were performed in Military Engineering Works. A fully efficient BLG bridge that underwent a general overhaul in Military Engineering Works was used for that purpose (see Fig. 1). The bridge was deployed to a crossing position on a test stand intended for tests and examinations of bridge structures that

are repaired, modernized and produced in Military Engineering Works. The test stand in the form of a dry pool with concrete abutments located on the premises of Military Engineering Works is illustrated in Fig. 1.

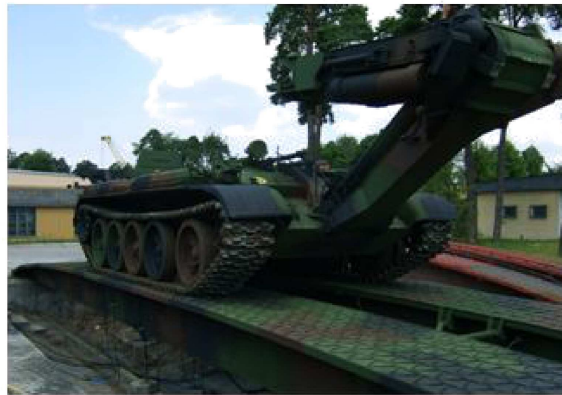
Fig. 2. A BLG tracked carrying chassis without the transported span during the load test and a schematic of the location of the contact between caterpillar tracks and the bridge span at the point where the vehicle had stopped; PM 1-4 – points of measure

Prior to beginning actual load tests on a span of the BLG bridge, a test drive of a BLG tracked carrying chassis onto the bridge span laid on concrete pool abutments was realized (see Fig. 2). The purpose of the operation was to initially locate metal anchorages built at the bottom of the abutments of the bridge girders on pool edges under the influence of an external load. Once the chassis/carrier had left the bridge span, it was performed a calibration of the measuring apparatus that corresponded with the state of being loaded only by the deadweight of the span structure. Subsequently, load tests on the BLG span were performed. A BLG tracked carrying chassis without the transported span constituted load in this test. A vehicle in such a configuration, which is presented in Fig. 2, has a mass of 33.3 tons.

After the vehicle had driven onto the bridge, it moved to the mid-length of the bridge. The traces of the contact between caterpillar tracks and the bridge span at the point where the vehicle had stopped are marked in Fig. 2. Measurements that describe the locations of the edges of caterpillar tracks in relation to the edges of the tested bridge treadway are also provided in Fig. 2.

A numerical analysis of a single bridge span was conducted with the use of the MSC.Nastran program. The conditions that corresponded with the variant of stand tests described above (Fig. 7) were reproduced. Calculations were performed within the scope of nonlinear statics with accounting for contact phenomena in the mating zone of particular segments of both bridge girders. In the presented variant of the analysis, load that corresponded with the weight of a chassis driving across the bridge was represented in the model. The weight was 33.3 tons. The load was applied in the form of pressure to the surface of the adherence of the caterpillar track to the bridge treadway. Once the vehicle had stopped at the mid-length of the span, it was found that caterpillar tracks were not evenly laid in relation to the bridge axis. Therefore, in the numerical model, it was accounted for the asymmetry of the position of caterpillar tracks in relation to the bridge treadways, which is illustrated in Fig. 2, by distributed load applied to particular elements that modelled the bridge deck.

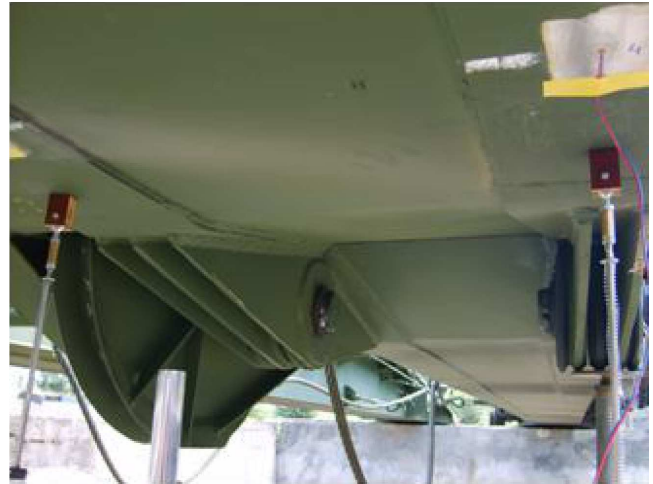
Fig. 3. A view of the location of potentiometric indicators used for displacements measuring

For measuring the bridge deflections, two mechanical indicators were used. The indicators were placed at the bridge span's mid-length under the lug of the main joint. A view of such an indicator prepared for measuring dislocation in the axis of the main joint as well as its location can be observed in Fig. 3. The indicator has a slip-ring which, once the structure has been unloaded, is blocked in the final position that has been reached and indicates the value of deflection directly on a scaled sleeve.

Apart from comparing maximum deflections of girders, a comparison of displacement values in the section located at the distance of 560 mm from the main joint axis (Fig. 3) was performed. A correlation of results recorded by means of potentiometric indicators located in measurement sections as well as displacements determined numerically in particular span model sections are presented in Table 2.

To evaluate the torsion value of the elements of the construction resulted from inaccuracy of placing of the crossing vehicle on the bridge and appearance of the eccentricity of the external load, the measurements of vertical displacement of bottom plate of the girders by means of potentiometric indicators were applied. To gather the essential data and more precise description of deformation including torsion of treadways, four potentiometric indicators, two on each girder of the tested bridge, were applied. The scheme of the potentiometric indicators location under the bottom plates of the right and left girders and their view on the real object are presented in the photo in Fig. 3 and in the scheme (Fig. 10).

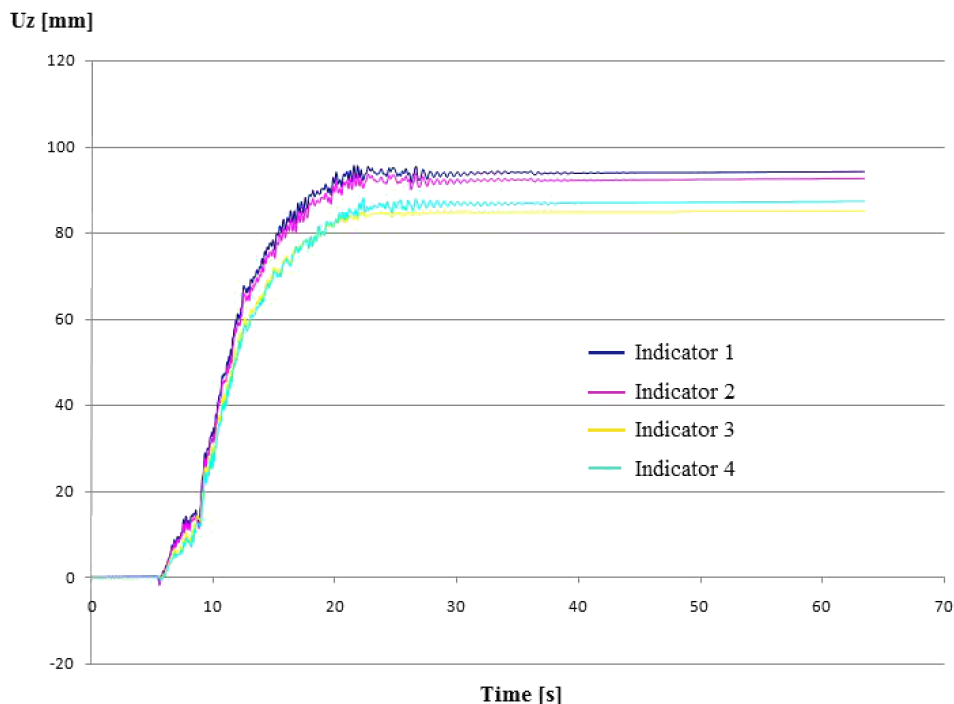
Fig. 4. Vertical displacements vs. time recorded during load test

Displacement values measured by means of particular potentiometric indicators (Fig. 10) were recorded while the tracked chassis was driving across the bridge. Displacements history in the function of the duration of load action on the bridge is shown in diagram presented in Fig. 4.

The maximum deflection value was recorded for the left span and was equal to 94 mm in the analyzed section. The value which was taken from the scale of the mechanical indicator for the left girder was 95 mm. For the right girder, the maximum deflection value measured by means of the mechanical indicator was 87 mm and was equal to the value recorded with the use of potentiometric indicators.
