K. ŻABA\*

## WEAR RESISTANCE OF ALUMINIZED STEEL PLATES

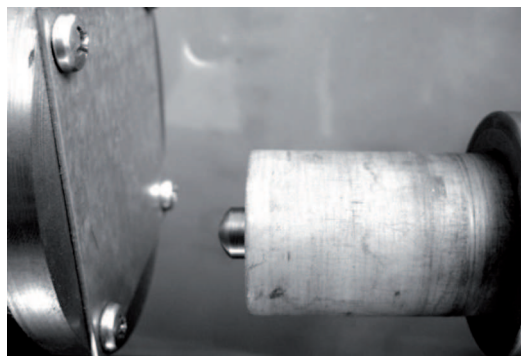
Fig. 1. Device for the abrasion resistance testing

The abrasion resistance tests were performed for samples after the heat treatment. Tests were performed in the specially designed and constructed stand (Fig. 1). The Al-Si coated strip samples, before and after the heat treatment, were cut for dimensions of 150 $\times$ 150mm. Four openings were drilled in each sample for fixing it to the disk. Samples were degreased in C<sub>2</sub>H<sub>5</sub>OH solution in the ultrasound washer, dried in the laboratory dryer and weighted with the accuracy of four decimal places by means of the laboratory scale. Then samples were fixed to the disk. The counter sample, in a form of a roll

(of a diameter 12mm) ended with a semicircular cap, constituted the Hardox 500 steel.

Investigations were performed in the described below way. The steel sample was put into an angular motion with a velocity of 9rot/min. The counter sample was pressed into the sample with a constant pressure of 200N. During the angular motion of the coated sample its counter sample was doing a plane-rotary motion with an amplitude of 10mm. Tests were performed under the fluid friction conditions. As a lubricating-cooling medium 10% water solution of the emulsifiable oil Emulgol ES12 was used. One test cycle took 2 minutes. In order to determine the mass losses all samples were weighted before and after the test. Changes of the coating surface roughness, before and after an abrasion, were determined in the contact place of the sample with the counter sample. The coating roughness tests were performed on one side of the sample. Each time the average value of the surface roughness parameters  $R_a$  and  $R_z$  was calculated from ten measurements. The coating surface roughness after an abrasion was measured in the direction perpendicular to the sample motion. Measurements were done by means of the Form Talysurf device of the Taylor Hobson Company. The obtained results are presented in diagrams. For the possibility of comparisons the tests were also carried on for samples without the heat treatment. For each type of test three samples with and without the heat treatment were used.

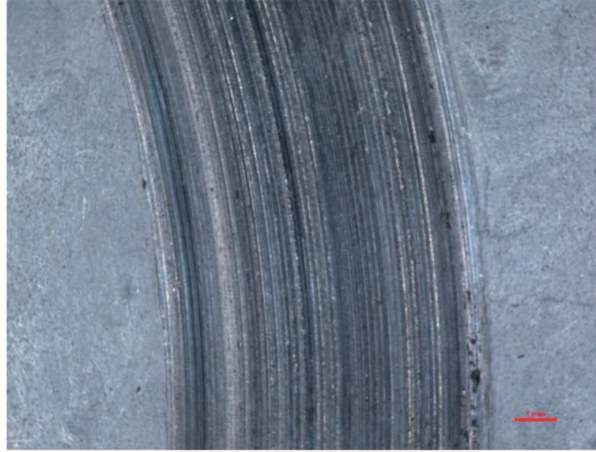
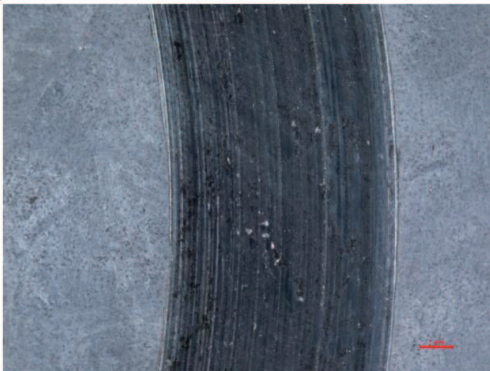
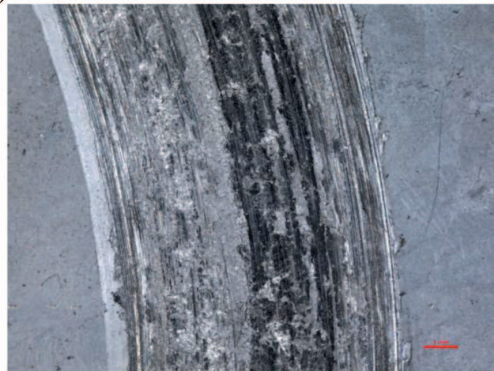
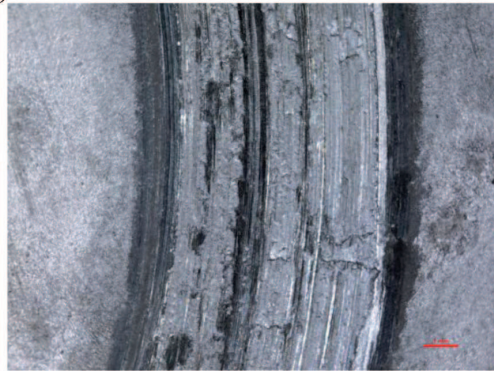
Fig. 3. The observation results of the selected coating surfaces after the heat treatment and abrasibility tests  
a) Initial state, b) 200°C-180min., c) 200°C-5760min., d) 500°C-180min., e) 500°C-1440min., f) 600°C-5min., g) 600°C-30min.,  
h) 700°C-5min., i) 700°C-10min., j) 800°C-2min., k) 800°C-5min., l) 900°C-1min., m) 900°C-5min., n) 1000°C-2min., o) 1000°C-5min

The observation results of the selected coating surfaces after the heat treatment and abrasibility tests are presented in Fig. 3.

At the coating observation, apart from the abrasion zones, changes in the coating appearance from bright and glossy (Fig. 3a-d) to partially (Fig. 3e-h, j, l) or completely dark and matt (Fig. 3i, k, m-o) attract attention. The results of observations of the coating surface – after an abrasion - are highly correlated with the coating appearance.

During an abrasive wear of a relatively soft material the mechanisms of grooving and microcutting are dominating and mutually competing. Gradual passing from one wear mechanism to another was occurs and in consequence grooving and microcutting of various proportions coexist in a wide range (Fig. 3a-d). Such influence is accompanied by a minimal or small coating mass loss, presented in Fig. 4.

A characteristic adhesive wear occurs in the samples, which surface became dark and matt under the heat treatment influence. Hard, but very brittle, particles present on the coating surface are torn off during an abrasion process. A continuation of the abrasion process intensifies the adhesive sticking, sinking of particles deep inside the coating, mixing with it and in consequence the coating fragments are tearing off and craters are formed (Fig. 3i, k, m-n). These tribologic effects cause an uneven, deep wearing out of a material, which is proofed by the mass loss results. The coating surface roughness results, which reflect the surface unevenness after abrasion, are shown in Fig. 5-6. Examinations are accompanied by acoustic effects intensifying with progressing tests, giving evidence to a high and constantly increasing friction coefficient. When the coating surface after the abrasibility tests is in certain areas dark and in other bright it means, that two or even three mechanisms of wear are simultaneously occurring: adhesive in darker places while microcutting and grooving in brighter ones (Fig. 3e-h, j, l).

Completely different wearing character occurs in the samples after the heat treatment at a tempera-

ture of 1000°C for 5 minutes (Fig. 3o). None of the previously identified wearing mechanisms occurs during the abrasion. The coating surface becomes smooth, micro-unevenness is removed, no scratching or craters are seen and none acoustic effects are heard – during the tests. On the other hand, the counter sample surface (Hardox 500 steel) undergoes some wearing in contact with the coating. This indicates the complete change of the coating hardness after the heat treatment. Surface and structural changes of the coating are confirmed by mass loss tests, roughness, friction depth and force.

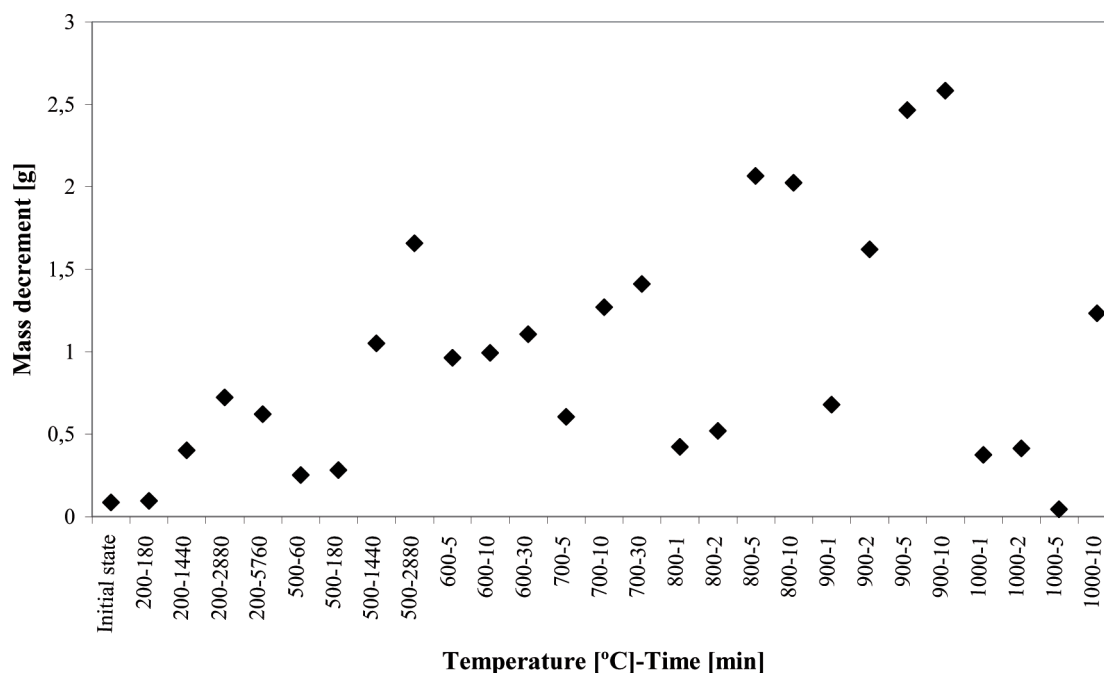
Fig. 4. The obtained results of the mass loss in dependence of the heat treatment conditions

The obtained results of the mass loss in dependence of the heat treatment conditions are illustrated in Fig. 4.

The diversified mass loss after the abrasibility tests correlates with the surface appearance changes resulting from the heat treatment conditions – temperature and time (Fig. 4). The biggest mass loss occurs for a heating temperature of 900°C (for 10 and 5 minutes) and of 800°C – for the same time range – and equals more than 2g. The distinct loss, app. 1.5g, occurs after the following heat treatments: 500°C – 2880 minutes, 700°C – 10 and 30 minutes, 900°C – 2 minutes, 1000°C – 10 minutes. The smallest mass loss is found in the samples, which surface did not change, or only insignificantly changed, after the heat treatment. The smallest loss was observed in the sample heat treated at a temperature of 1000°C for 5 minutes.

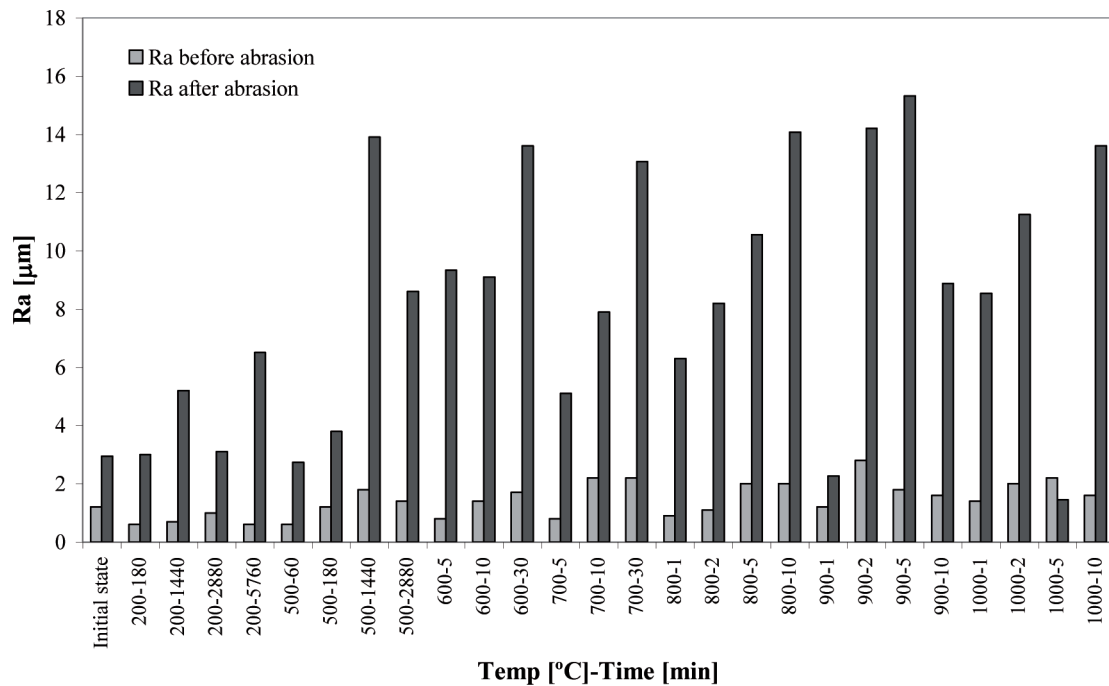
Fig. 5. Medium  $R_a$  values of coating surface roughness before and after the abrasion depending on heat treatment parameters

The results of coating surface roughness before and after the abrasion are presented in Fig. 5-6.

For the majority of samples after the heat treatment and abrasion the results indicate the increased roughness – from several dozen to a few hundred percent in relation with the after heating value - determined by  $R_a$  and  $R_z$  parameters. The highest  $R_a$  and  $R_z$  values are in the samples of the coating surface being completely dark and matt. The coating surface smoothing occurs in the

samples, which underwent the heat treatment at 1000°C for 5 minutes.

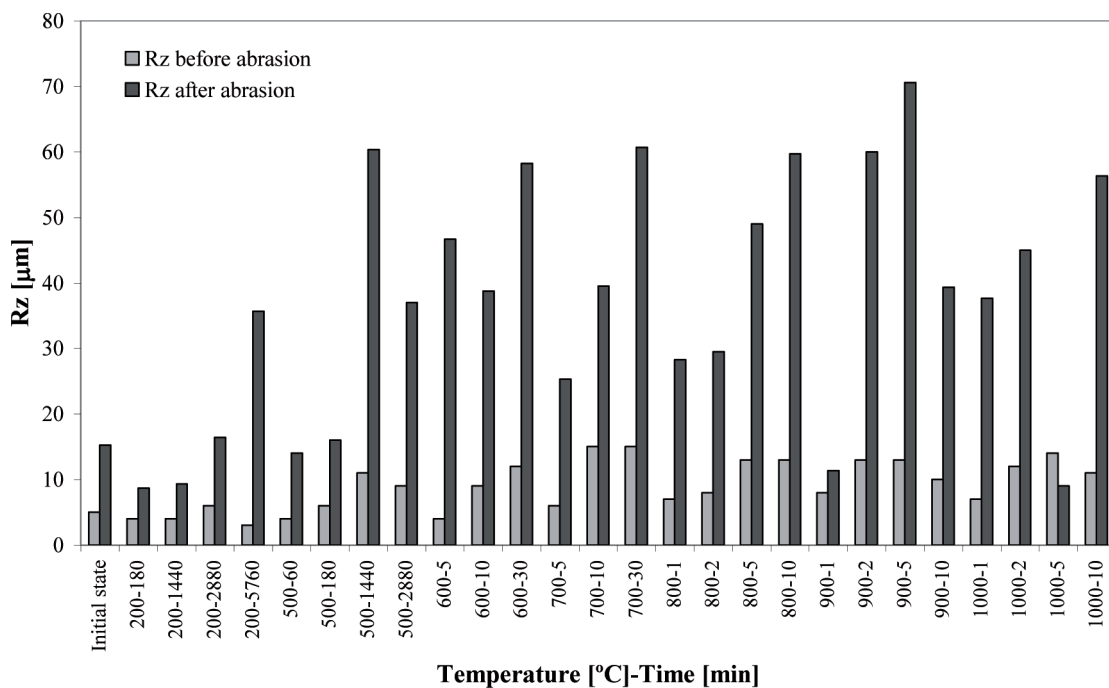
Fig. 6. Medium  $R_z$  values of coating surface roughness before and after the abrasion depending on heat treatment parameters
