R. BURDZIK*, T. WĘGRZYN*, Ł. KONIECZNY*, A. LISIECKI**

RESEARCH ON INFLUENCE OF FATIGUE METAL DAMAGE OF THE INNER RACE OF BEARING ON VIBRATION IN DIFFERENT FREQUENCIES

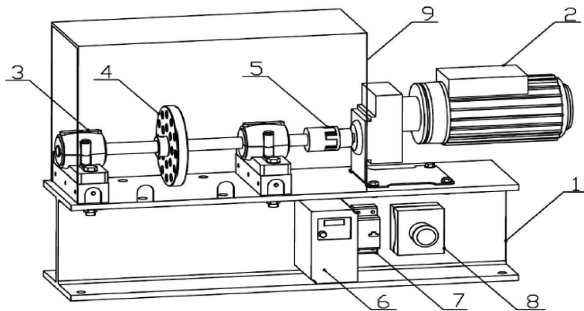
Fig. 1. Research test bench: 1 – support (steel frame), 2 – asynchronous motor, 3 – bearing with casing, 4 – disc with threaded holes, 5 – coupling, 6 – frequency inverter, 7 – electrical fuse, 8 – safety switch, 9 – housing made of organic glass

The research was conducted on special research-educational test bench for vibration monitoring for rotaring machinery – Vibstand (Fig. 1). The laboratory bench enables testing of application of vibroacoustics methods for applied structural health, usage and condition monitoring. It consists of the mechanical part and the vibration based condition monitoring and diagnostics system. The mechanical part, placed on a stiff support, includes three-phase asynchronous motor with frequency inverters, a gearbox, a shaft supported on two rolling element bearings. The shaft has got a disc with holes designed for imbalance simulation. The diagnostic part is comprised of a full featured condition monitoring system VIBex. The sensors can be mounted in one of the prepared holes or with a magnet,

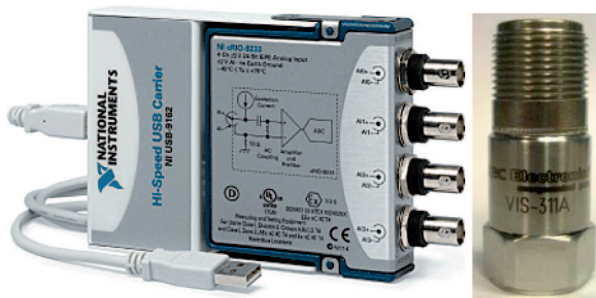
Fig. 2. Elements of measurement system

Measurement system (Figure 2) consisted of NI USB-9233 data acquisition device with signal conditioning and VIS-311 accelerometers. The main parameters of the elements has been presented in Table 1.

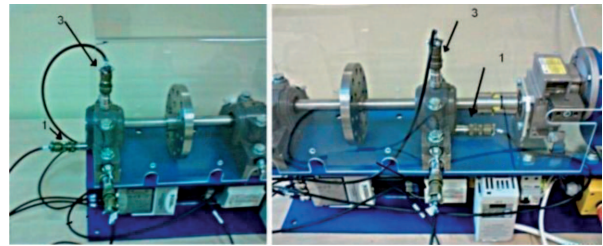
Fig. 3. Location of the sensors

During the research the acceleration of vibration were measurement on casing of bearing in two orthogonal axes. One along the shaft and the second vertical perpendicular. The location of sensors has been depicted in Fig. 3.

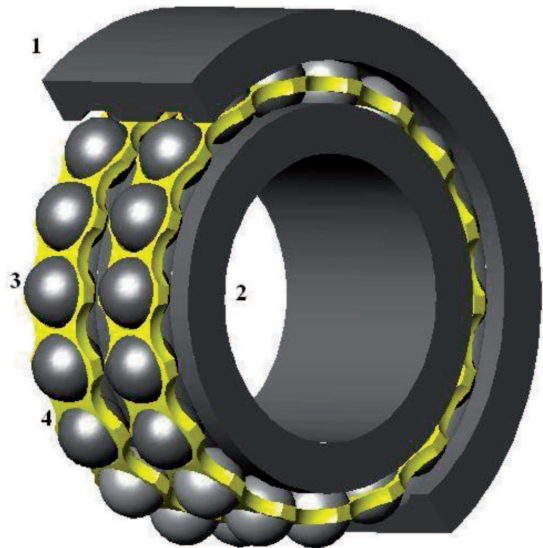
Fig. 4. Roller bearing 1 – outer ring, 2 – inside ring, 3 – rolling elements, 4 – separator

Chosen defect of elements of the machine have been simulating. The defected element was the bearing. Construction of a typical roller bearing is shown in Fig. 4.

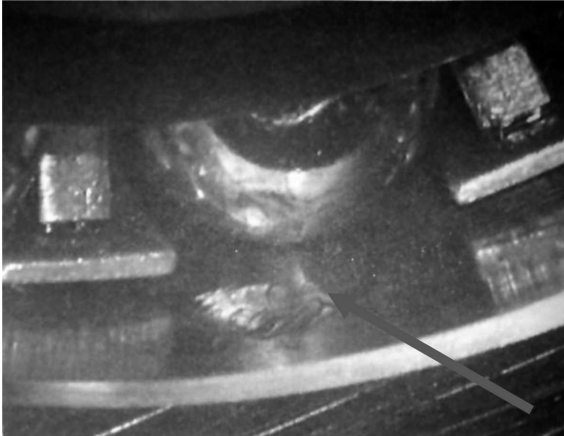
Fig. 5. Damage of the inner race of bearing

The defected element was the bearing. In the one bearing damage of the inner race was done (Fig. 5).

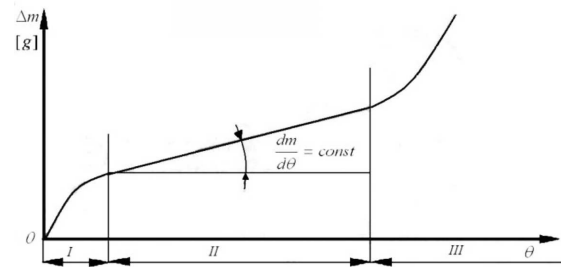
Fig. 6. The process of accumulation of mass losses in kinematic pairs as a function of time

The wear of kinematic pairs can be characterized as the weight loss in the function of time (Fig. 6). There are three stages. The first stage (I), which occurs while starting the machine and is characterized by increased wear during the grind in of co-acting parts. In the second stage (II) the wear is gradually normalized. The third stage (III) is characterized

by a rapid increase of mass loss, which leads to failure of the element or the whole machine.

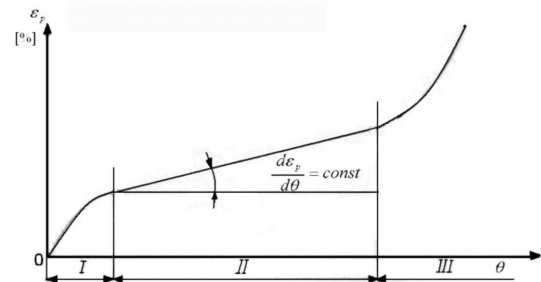
Fig. 7. The qualitative picture of the curve creep loaded machine components as a function of time

A similar character has the process of changing the dimensions and shape of the creep-induced material (Fig. 7). Changes in this case depends mainly on the temperature and the size of stress. The first phase shows a decreasing relative velocity of plastic deformation ε_p . In the second stage there is constant speed rise $\varepsilon_p / d\theta = \text{const}$. The third stage reveals a very rapid increase in plastic deformation, which leads to the destruction of the element.

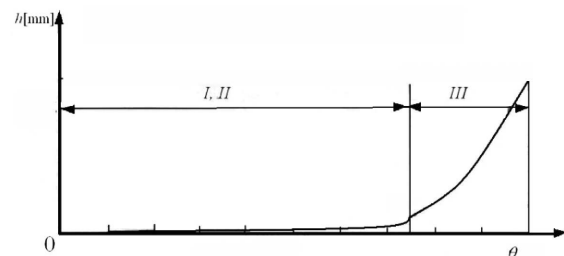
Fig. 8. The depth of fatigue cracks in the material as a function of operating time

Destruction of fatigue is due to the gradual propagation of microcracks (Fig. 8).

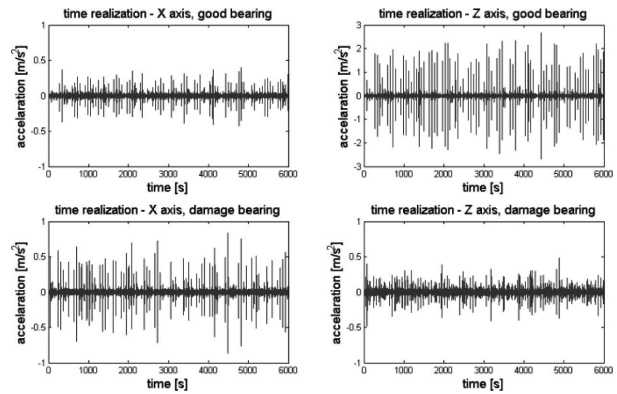
Fig. 9. Comparison of vibration signals registered on casing of good technical condition and damage bearings in X and Z axes (drive shaft – 496 rpm, bearing shaft 177rpm)

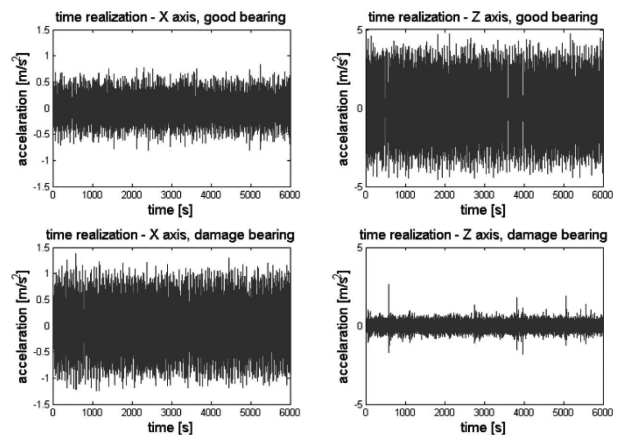
Fig. 10. Comparison of vibration signals registered on casing of good technical condition and damage bearings in X and Z axes (drive shaft – 2296 rpm, drive shaft – 820 rpm)

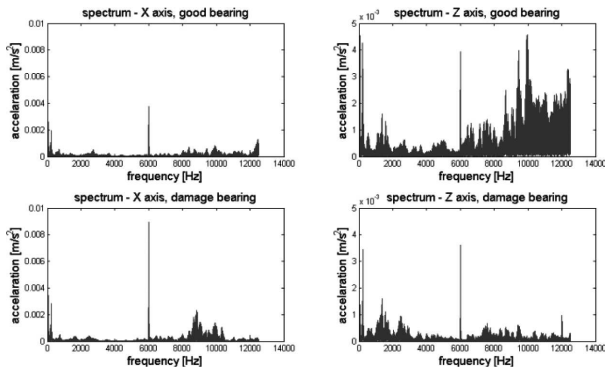
Fig. 11. Comparison of spectrums of vibration signals registered on casing of good technical condition and damage bearings in X and Z axes (drive shaft – 496 rpm, bearing shaft 177rpm)

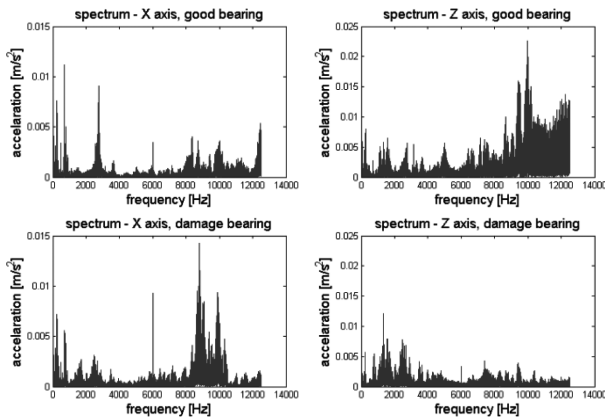
Fig. 12. Comparison of spectrums of vibration signals registered on casing of good technical condition and damage bearings in X and Z axes (drive shaft – 2296 rpm, drive shaft – 820 rpm)

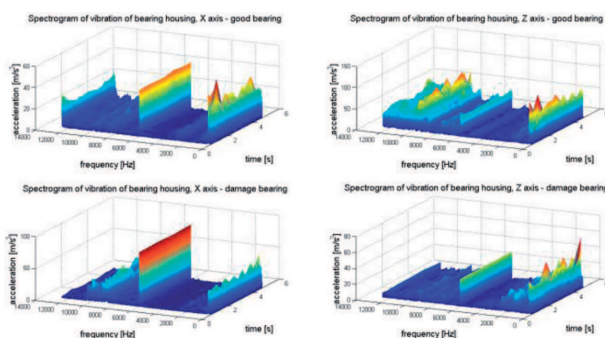
Fig. 13. Comparison of spectrograms of vibration signals registered on casing of good technical condition and damage bearings in X and Z axes (drive shaft – 496 rpm, bearing shaft 177rpm)

For this purpose the spectrograms were determined. Spectrograms computes the short-time Fourier transform of a signal by default, x is divided into segments. During the transformation the Hamming window and noverlap were used. Noverlap is the value that produces 50% overlap between segments.

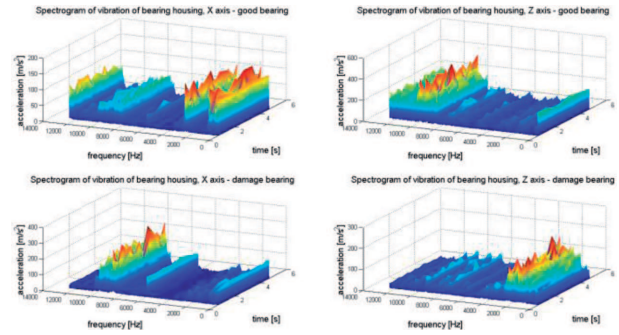
Fig. 14. Comparison of spectrograms of vibration signals registered on casing of good technical condition and damage bearings in X and Z axes (drive shaft – 2296 rpm, drive shaft – 820 rpm)

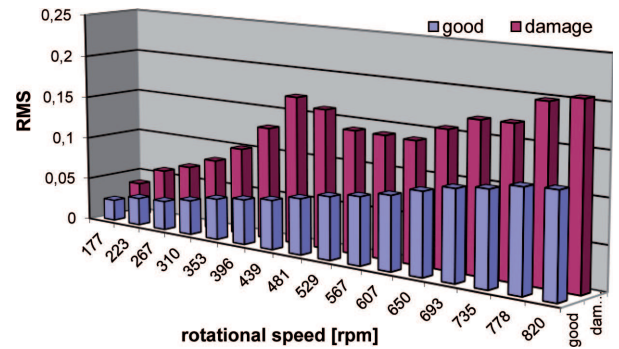
Fig. 15. Comparison of RMS of good and damage bearing in X axis

For the purpose of comparison and analysis of technical condition changes symptoms of vibration signals some comparison have been presented. The changes of the energy of the signal have been compared as the root mean square (RMS) values.

it is important to observe signal in time and frequencies domains. For the results of the experiments the presented analysis showed dominant component of the vibration and time of the excitation. It can be observed the increase of the signal for chosen frequency band for the damage bearing. The 2-D time and frequency distributions of the signals shows many of properties of the element. But to improve the sensitivity of the diagnosis the spectrograms transformation of the vibration are much better. It allows observing the changes of the dominant components of the dynamics of vibration during time of operating of machine. Thus the changes of the dominant frequencies can be observed. Comparison of RMS of vibration for increase of rotational speed shows interesting results. For the vibration in direction along the shaft it can be assumed constant increase of the energy of the vibration and higher values for vibration of damage bearing. This trends cannot be confirmed by the results of vibration in direction vertical perpendicular to the shaft. The vibration of the bearing in good technical condition are higher. For the vibration of damage bearing the maximum values of RMS can be observed for rotational speed in range of 400-500 rpm.

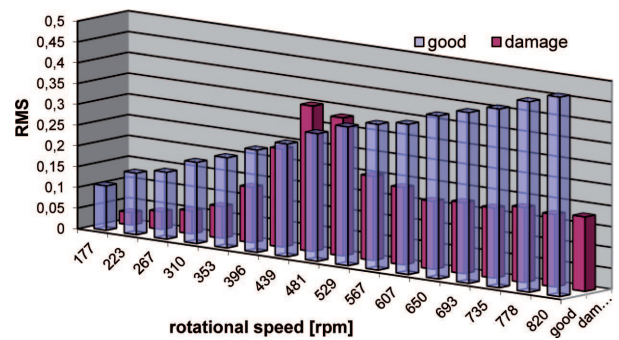
Fig. 16. Comparison of RMS of good and damage bearing in Z axis
